Re: Construction Damage Assessment - Engineering Report

File Name:	Casey Slone
Address:	303 North Washington Avenue, Marshall, Texas 75670
Claim No.:	W2C22131
Reported Date of Damage:	February 14, 2024
J.S. Held No.:	240500935

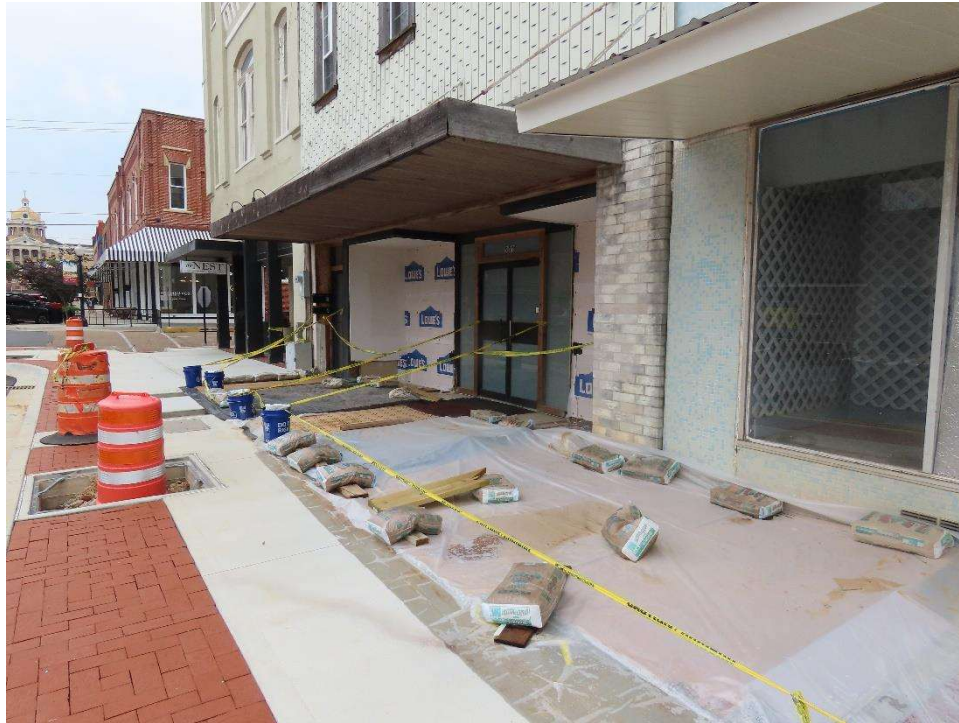
- The storefront windows at the entrance to the building had been demolished, and the ground was covered with sloped plywood and tarps to address alleged insufficient drainage (**Photos 1 through 3**).

Photo 1: Overview of the east-facing storefront showing the absence of the allegedly damaged storefront windows and brick.

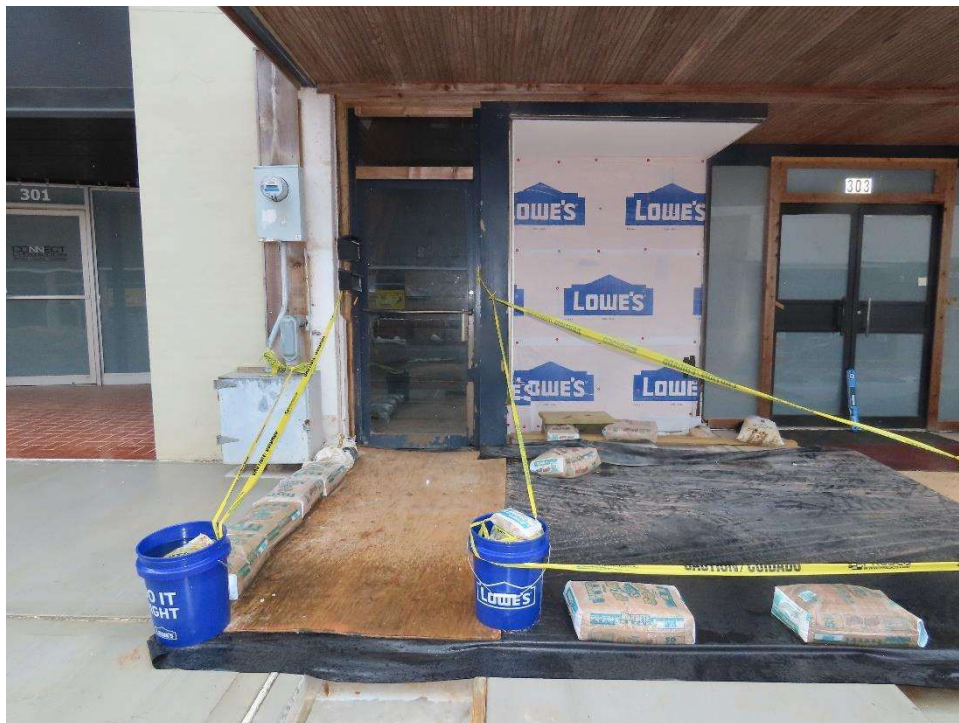
Photo 2: Overview of the south portion of the east-facing storefront showing the absence of the allegedly damaged storefront windows and brick.

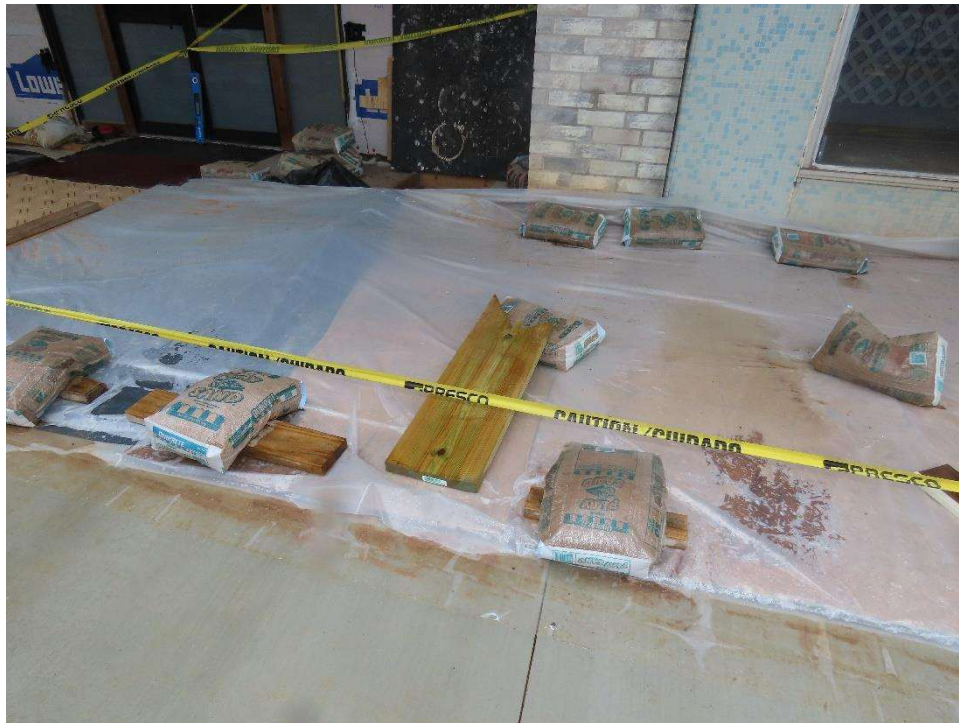
Photo 3: Overview of the north portion of the east-facing storefront showing the absence of the allegedly damaged storefront windows and brick.

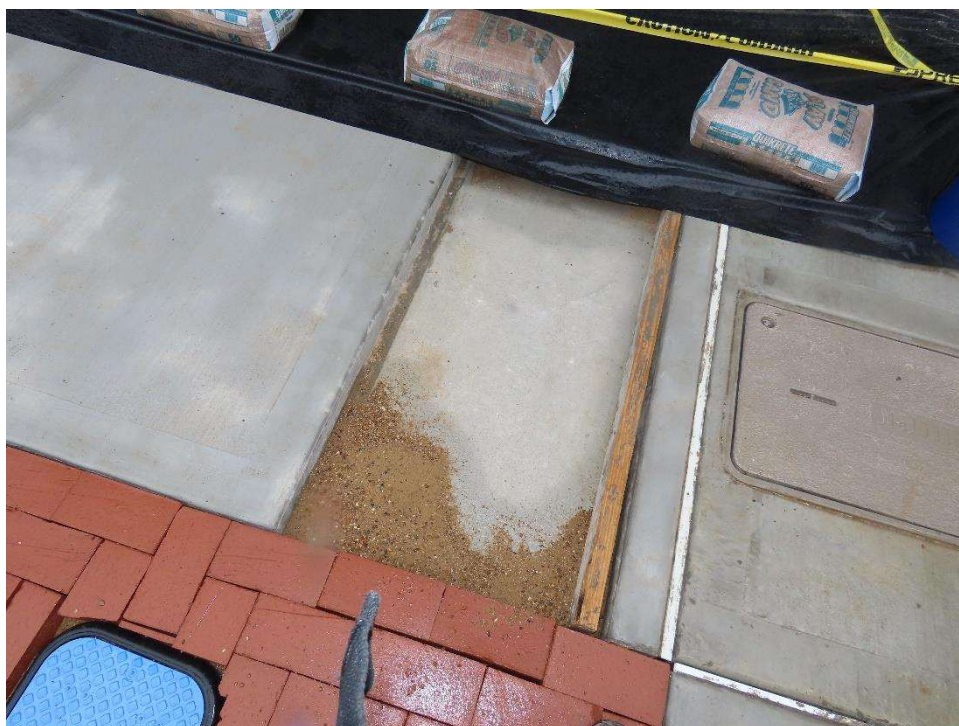
- There were two concrete troughs in the concrete adjacent to the property that were meant to be filled with brick paving (accent) that had accumulated dirt and sediment (**Photo 4**).

Photo 4: Accumulated dirt and sediment in a concrete trough not yet filled with brick.

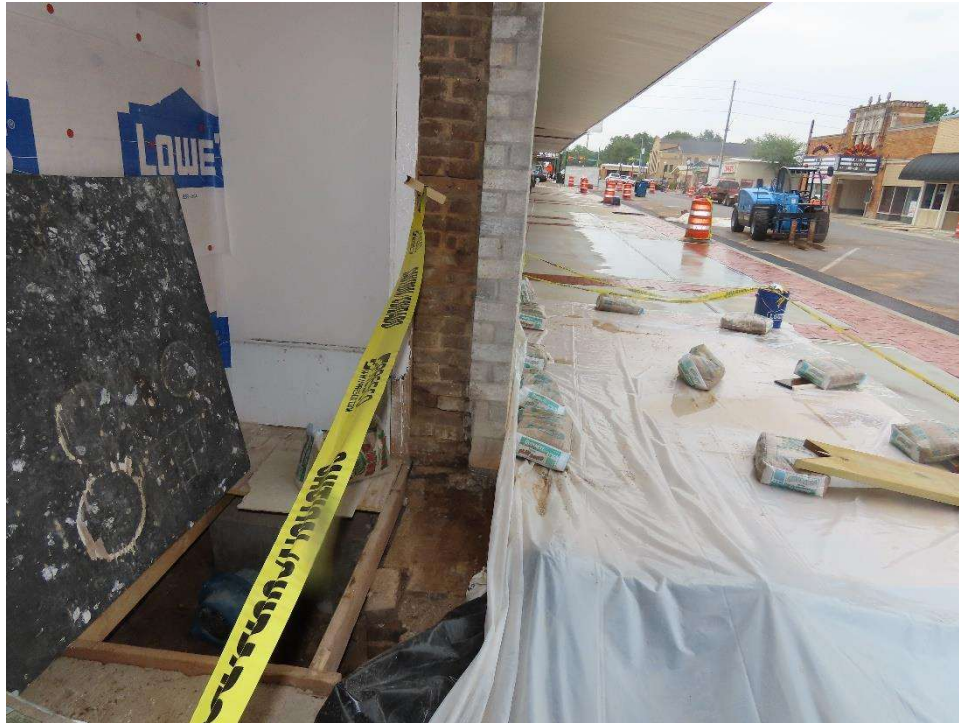
- A small portion of the brick veneer remained at the edges of the property, and it could be seen that demolition had been performed down to the top of a concrete grade beam that supported the structural brick behind the brick veneer. However, while the structural brick was directly supported by the grade beam, there was a several inch tall gap between the top of the grade beam and the veneer brick. The landing leading to the front door, which still had the concrete base intact, illustrated that the concrete base (sidewalk), that supported the veneer was not integral with the top of the grade beam (**Photos 5 through 9**).

Photo 5: Remaining veneer brick and structural brick behind it at the north edge of the entryway.

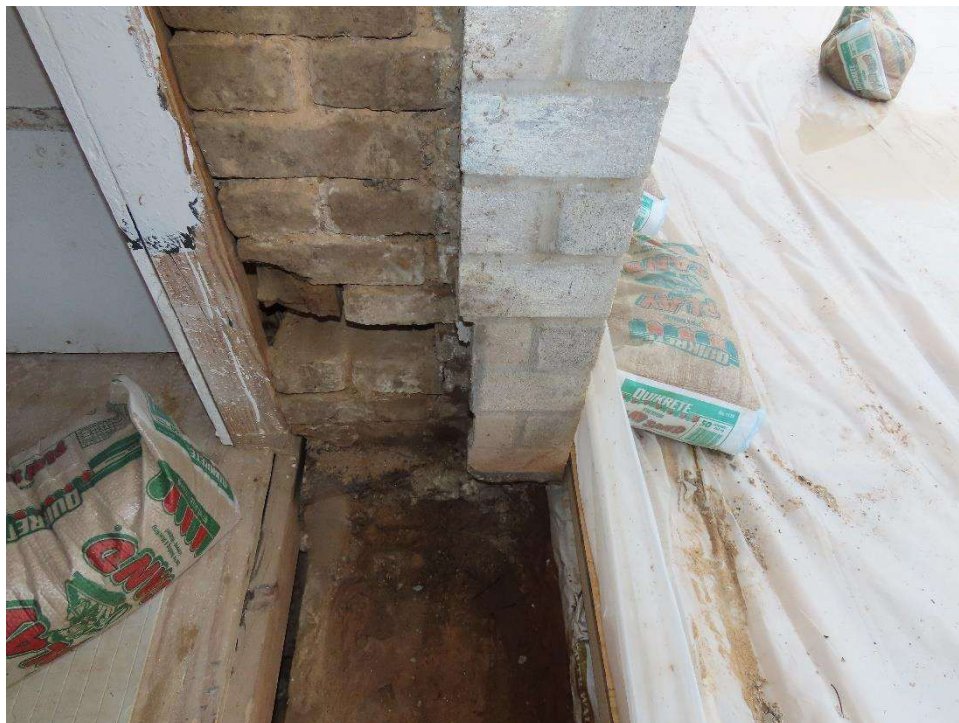
The onsite evidence, including the gap between the top of the grade beam and the bottom of the veneer, and the locations where the original sidewalk remained, indicated that the brick veneer was immediately supported by the sidewalk, which was in turn supported by the grade beam. This also makes chronological sense as the structural brick behind the veneer was directly supported by the grade beam and the sidewalk was originally cast against it. The veneer was placed sometime after, bearing on the sidewalk. Section 2.07 of the contract documents also empowers the contractor to decide the means and methods to accomplish the work, provided it does not adversely affect the outcome of the work. The methodology employed by CSC and its demolition subcontractor was a nominally viable approach for removing the sidewalk adjacent to the building but allowed for a very small margin of error. The sidewalk was saw cut through a few inches

Photo 6: The structural brick was directly supported by the grade beam, but there was a several-inch-tall gap between the top of the grade beam and the veneer brick.

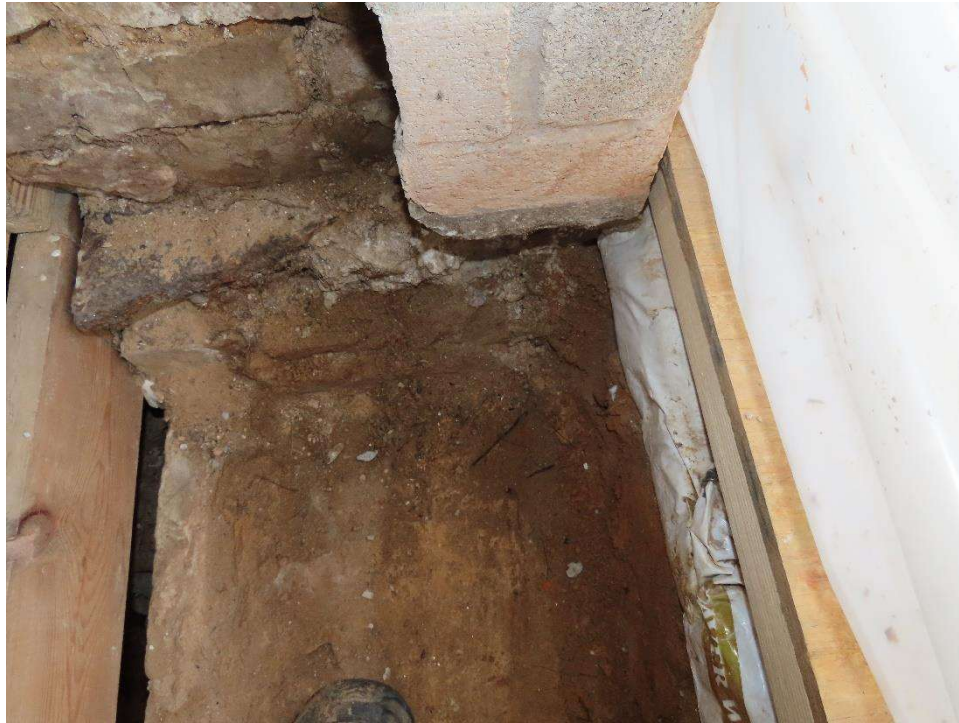
Photo 7: Close-up of the condition depicted in **Photo 6**.

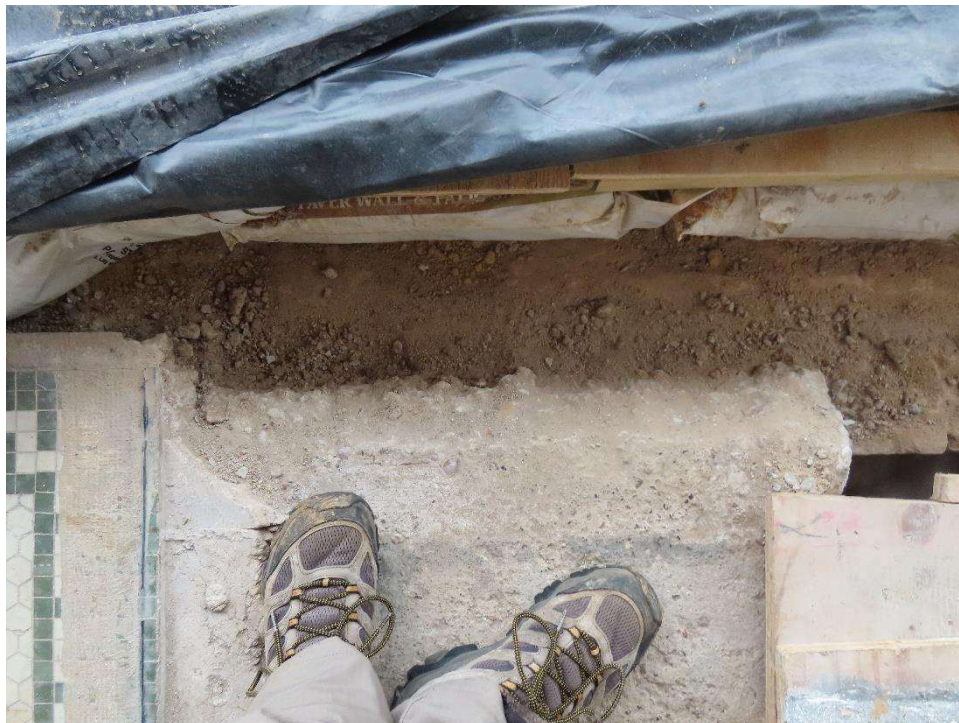
Photo 8: View showing the distinction between the sidewalk base and the top of the grade beam.

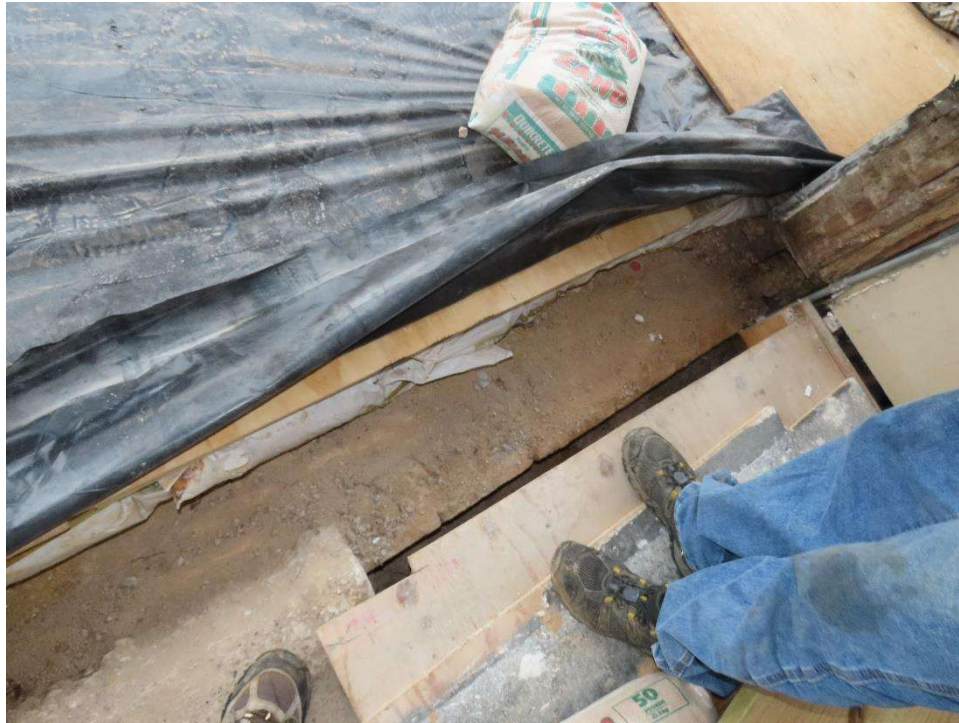
Photo 9: Alternate view of the condition depicted in **Photo 9**.

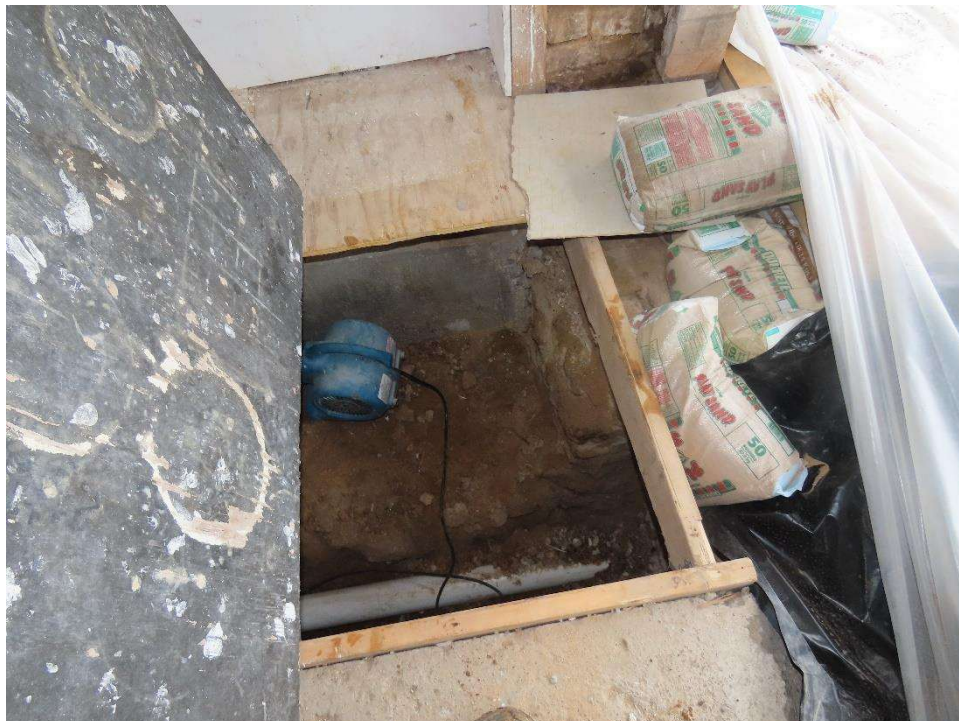
- There was a rectangular opening leading to the crawlspace and eventually the basement. According to Mr. Watts, this was not the utility hole that was discovered during demolition. This opening was kept open to install a replacement polyvinyl chloride (PVC) sewer line to tie into the main (**Photo 10**).

Photo 10: Rectangular opening leading to the crawlspace with a PVC sanitary sewer line visible.

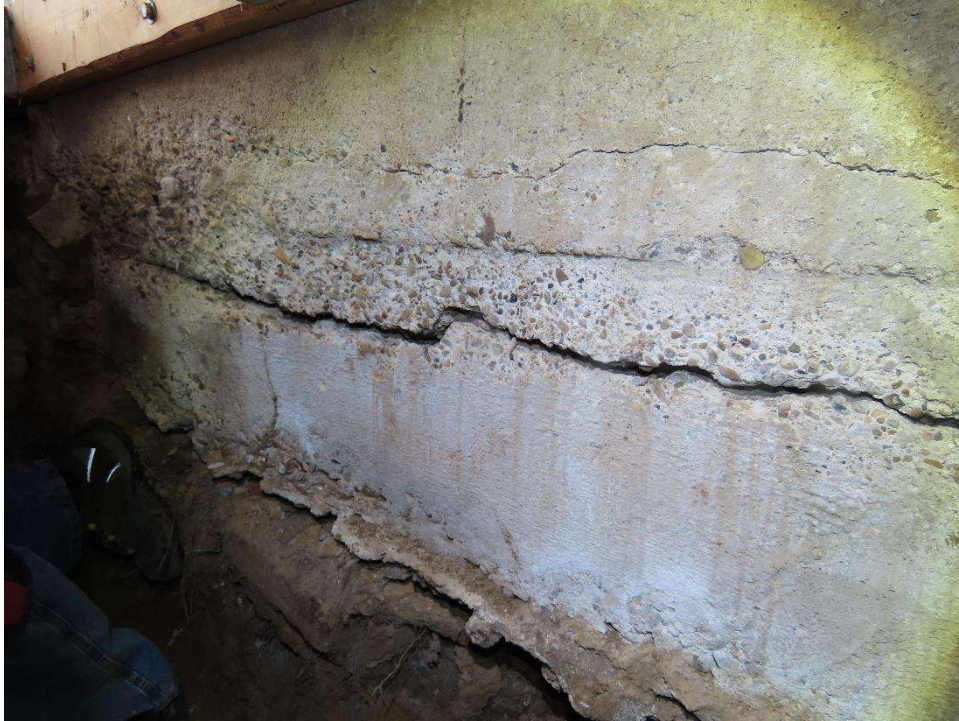
- Nearly under the above-described rectangular opening, there was a tall concrete beam with a longitudinal fracture approximately down the middle where there was an unusually high concentration of exposed aggregate. The edges of this fracture were generally rounded. There was a void in the soil under the fracture, and where the soil remained, the soil was probed with both a finger and a metal ruler and found to have weak strength (**Photos 11 through 16**).
- A new PVC sanitary sewer line was present in the crawlspace (**Photo 17**).

However, the assertion that the water caused the distress to the concrete beam in the crawlspace is unfounded for several reasons. First, while the soil was of poor structural strength, and water likely did erode some of the soil under the beam, a concrete beam that is more than 2 feet tall should easily be able to span a void of such size. That being said, with the void there, there were currently stresses on the beam that were not there before, and soil support should be restored to its pre-flood condition. Second, the surfaces of the fracture were rounded, indicating an aged condition and inconsistent with the timeframe of February 14, 2024. Third, the fracture was through a section of the beam that clearly had a deficiency

in the concrete mixing process, as there was a drastically higher concentration of exposed aggregate, weakening the beam at that location.

Photo 11: Longitudinal fracture approximately down the middle of a concrete beam where there was an unusually high concentration of exposed aggregate.

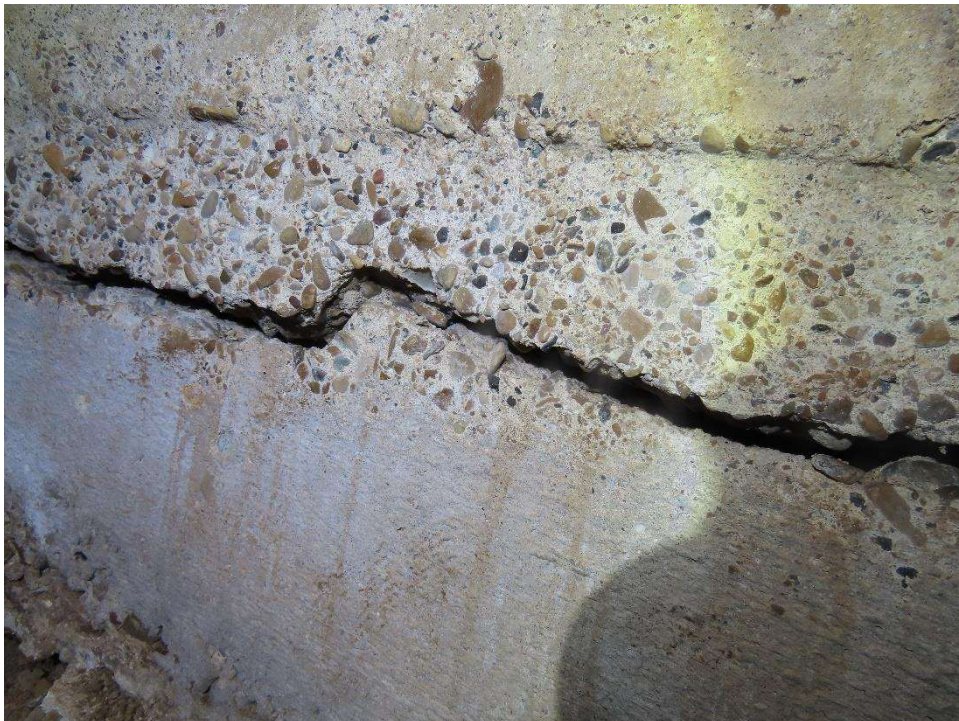
Photo 12: Close-up of the condition depicted in **Photo 11**, showing the rounded edges of the fracture.

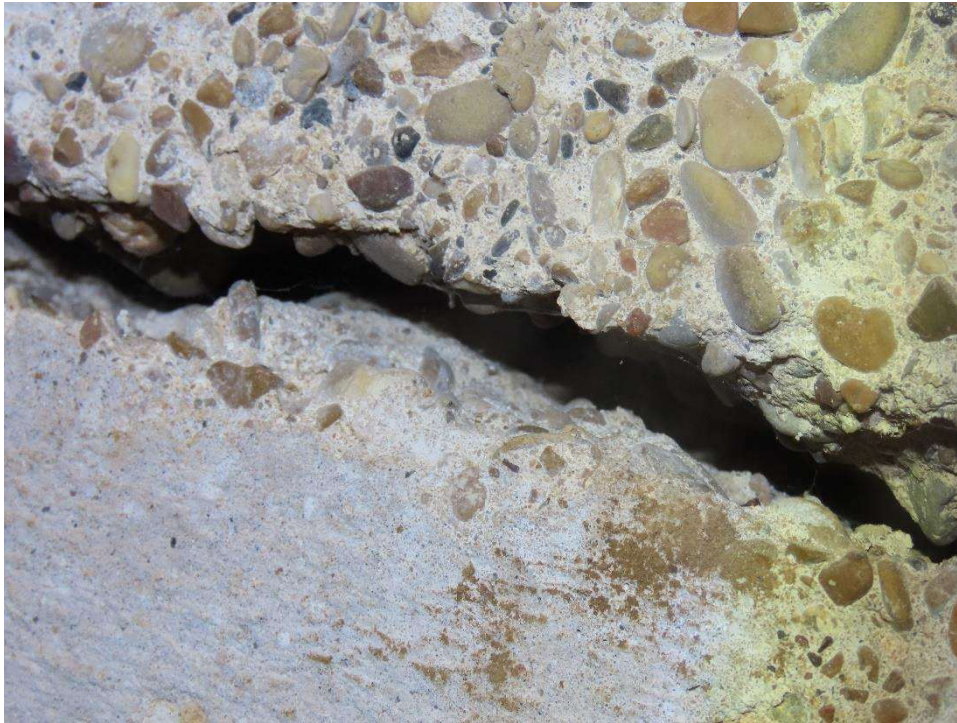
Photo 13: Close-up of the condition depicted in **Photo 12**, showing the rounded edges of the fracture.

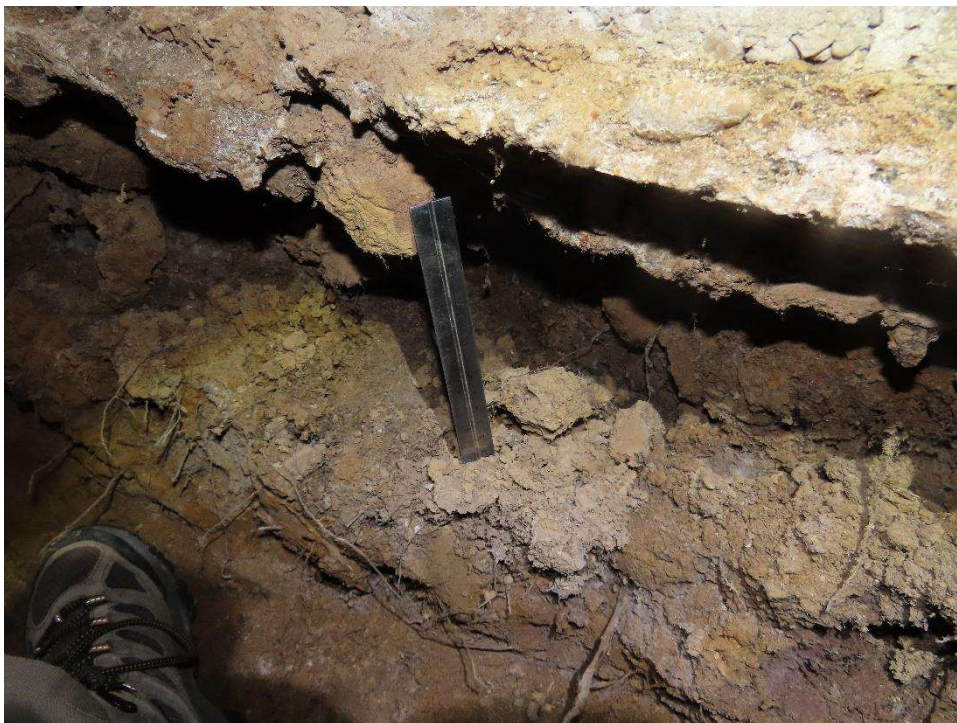
Photo 14: Void in the soil under the beam depicted in **Photos 11 through 13**.

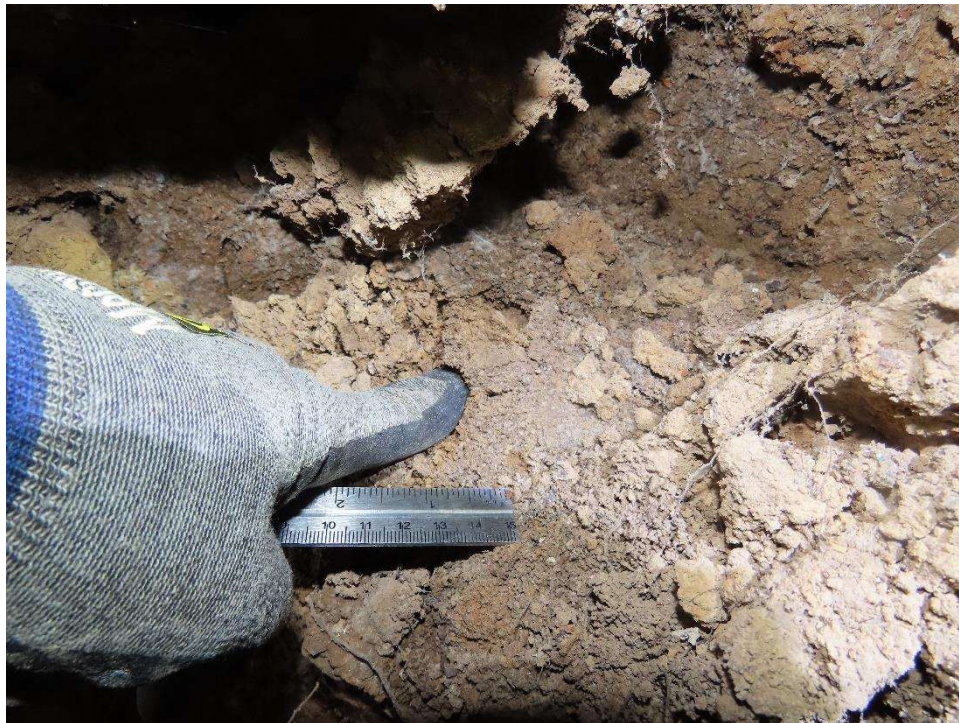
Photo 15: The soil yielded to finger pressure.

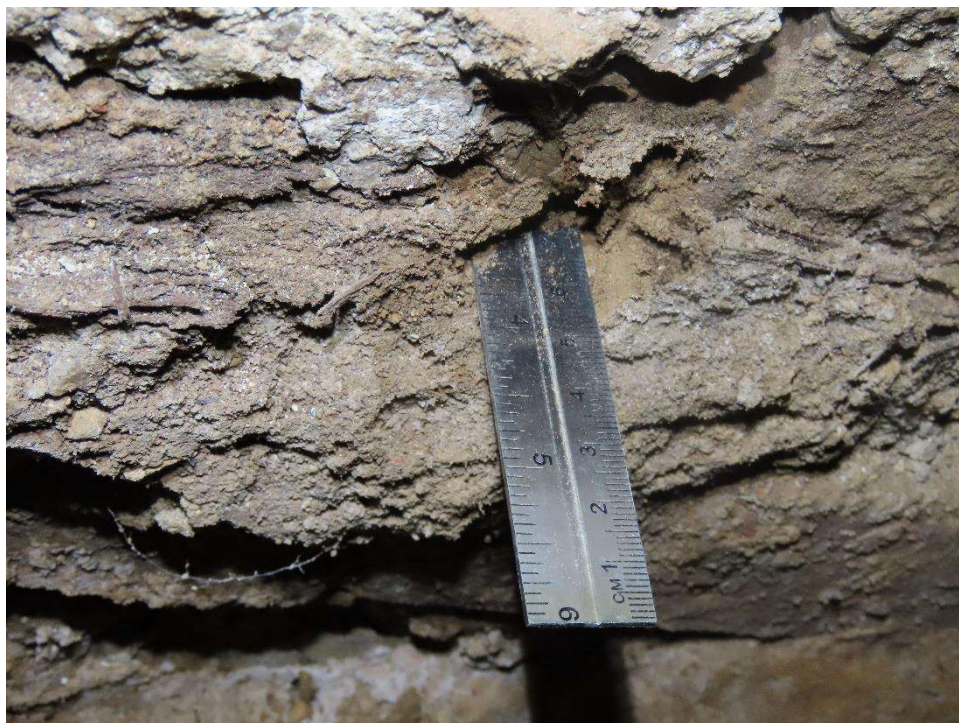
Photo 16: A metal ruler was easily inserted into the supporting soil.

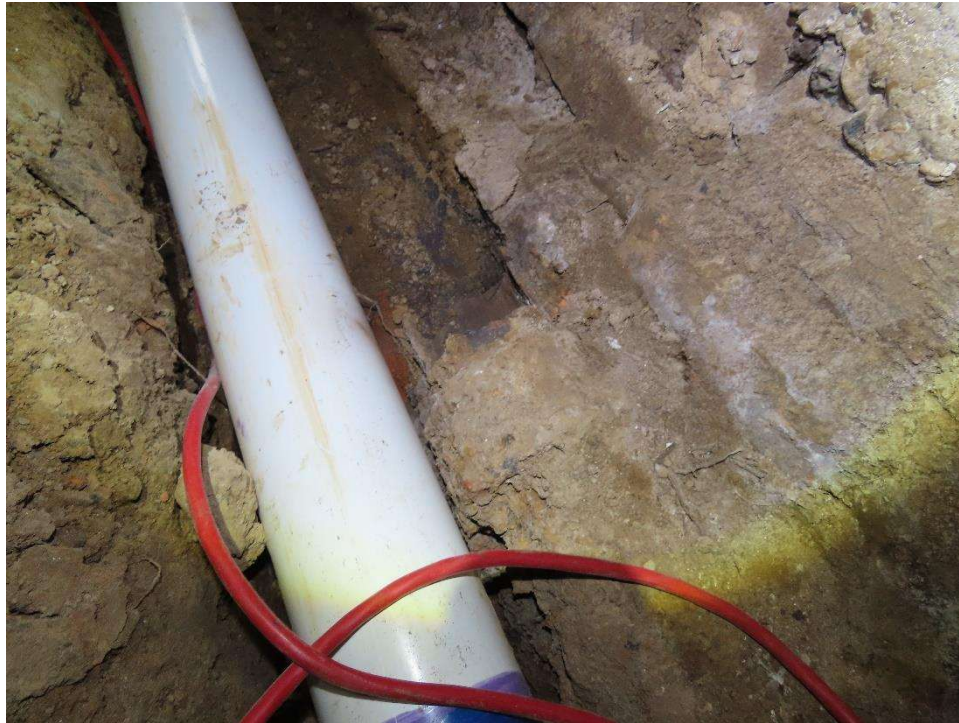
Photo 17: New PVC pipe in the crawlspace.

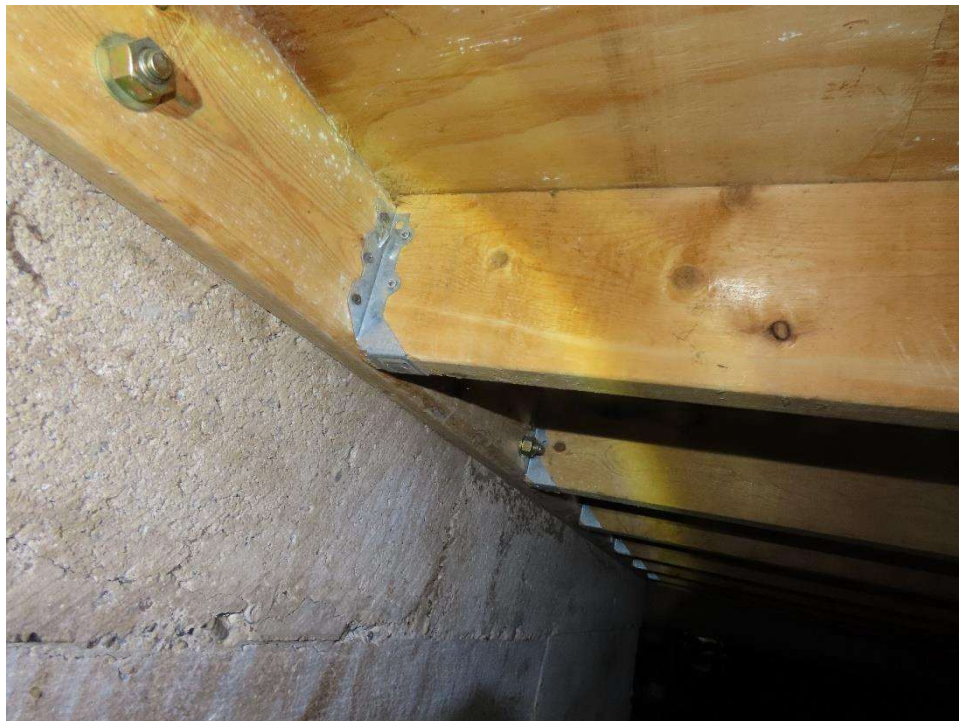
Photo 18: Newer wood framing and metal joist hangers on the ceiling of the crawlspace (the floor framing for the interior above).

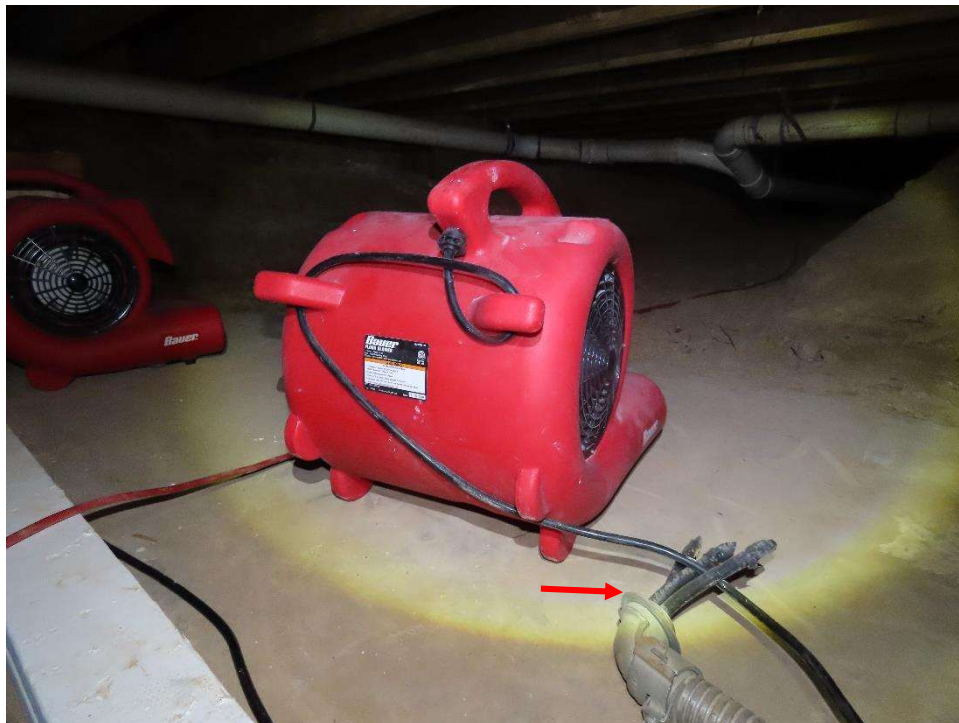
Photo 20: The conduit (indicated) for the A/C air handling unit was still present.

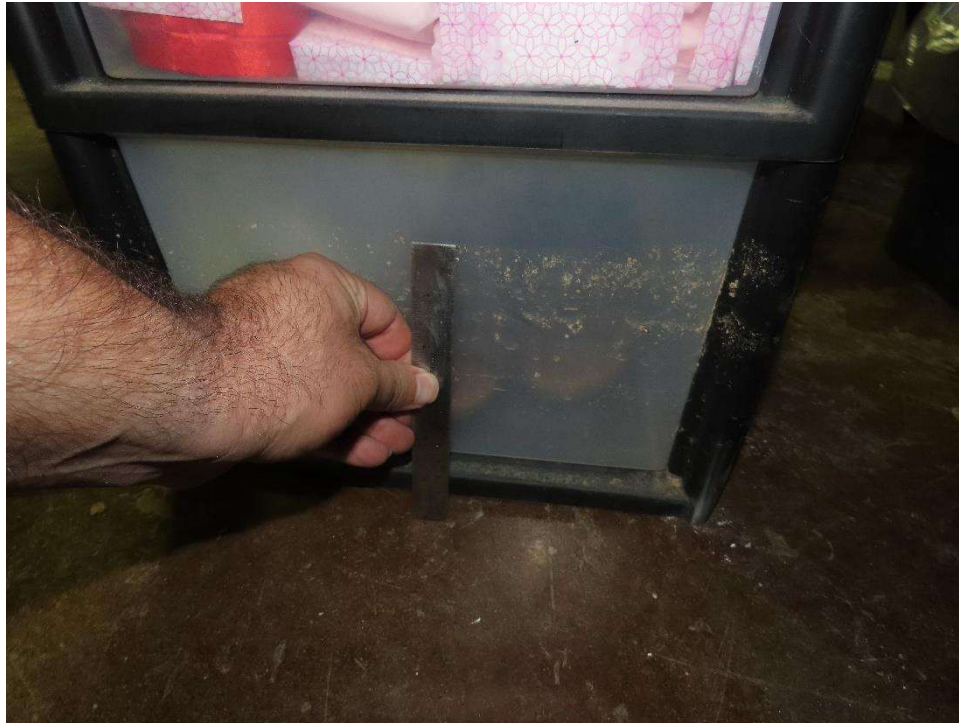
Photo 21: Dirt and water marks on a plastic storage bin.

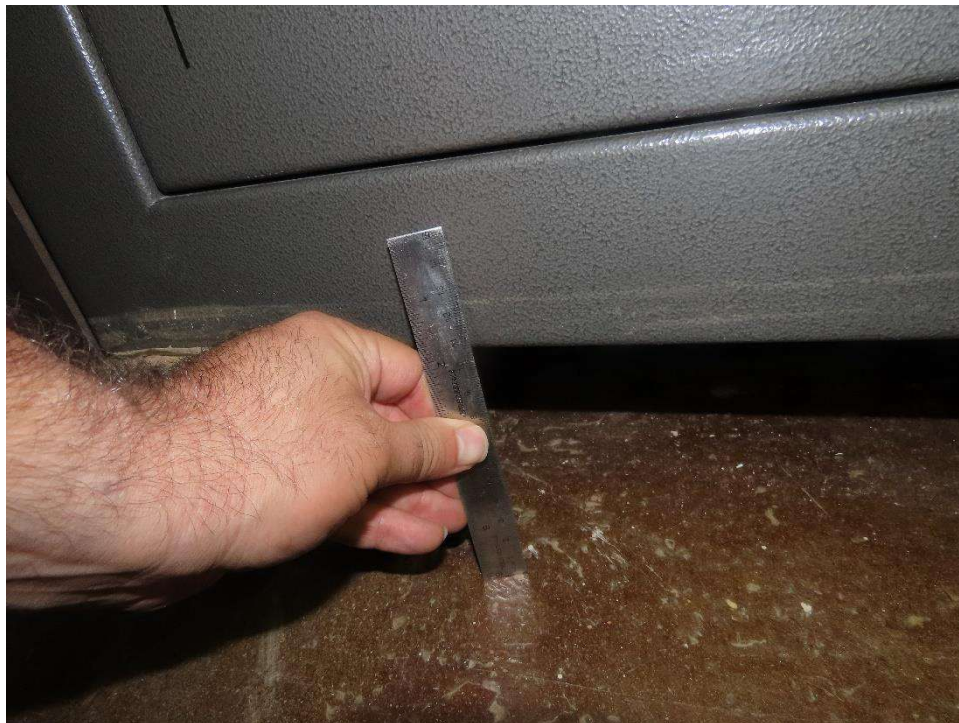
Photo 22: Dirt and water marks on a metal safe.

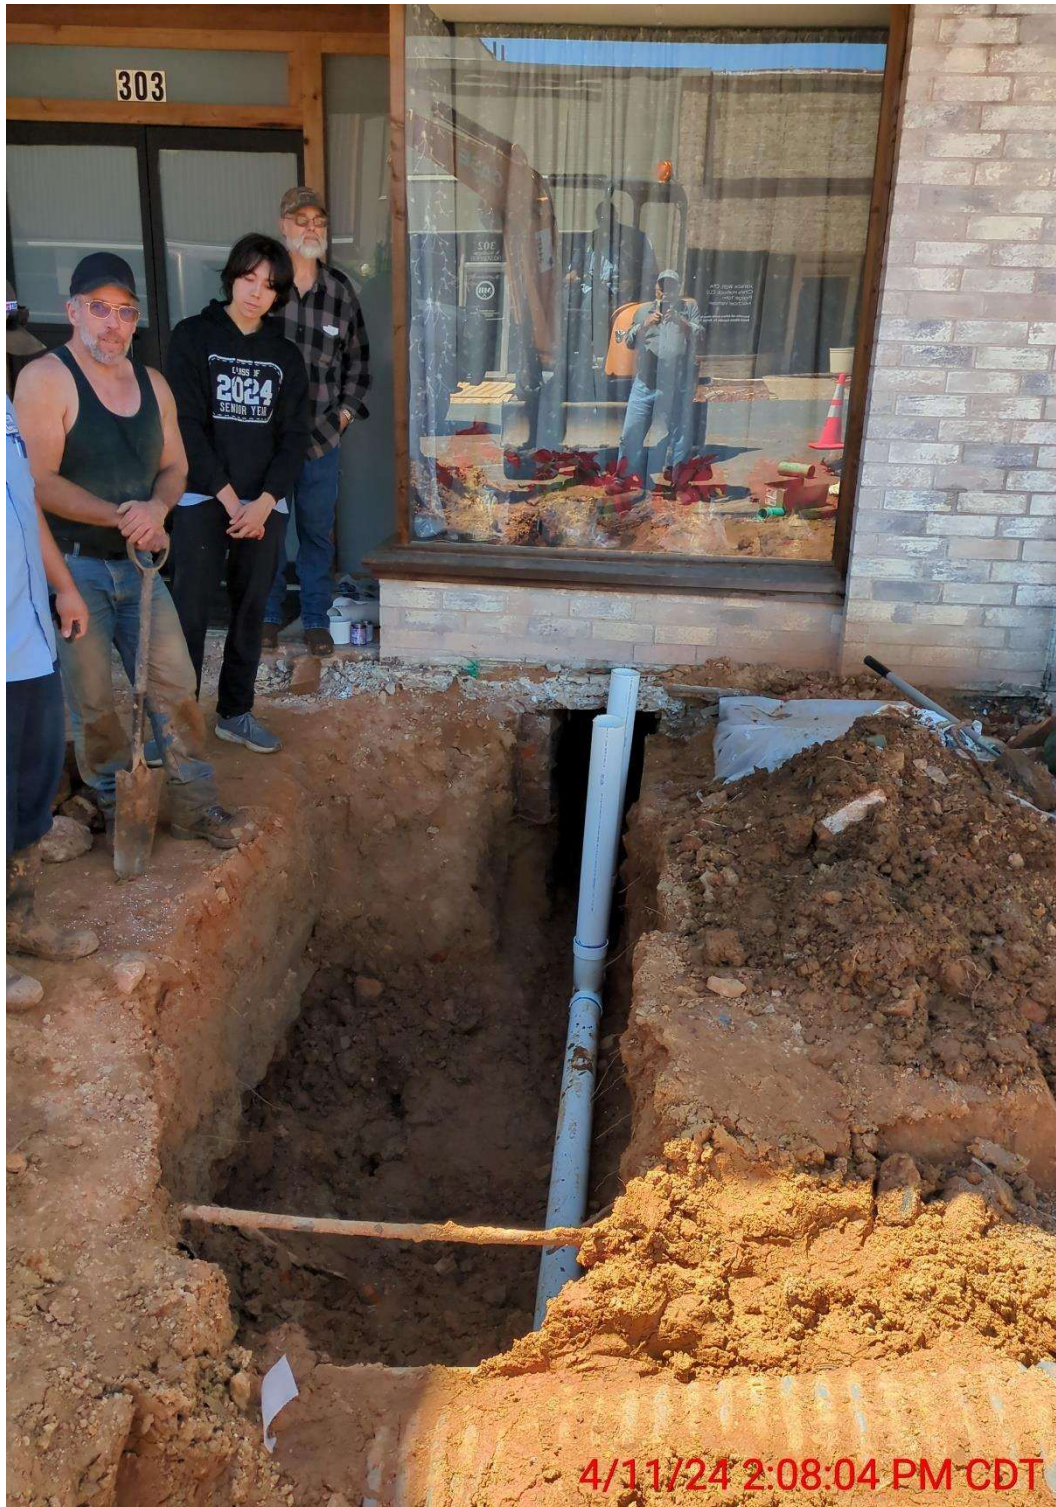
Photo 1: New PVC sanitary sewer line was constructed leading from the crawlspace to the sewer main.

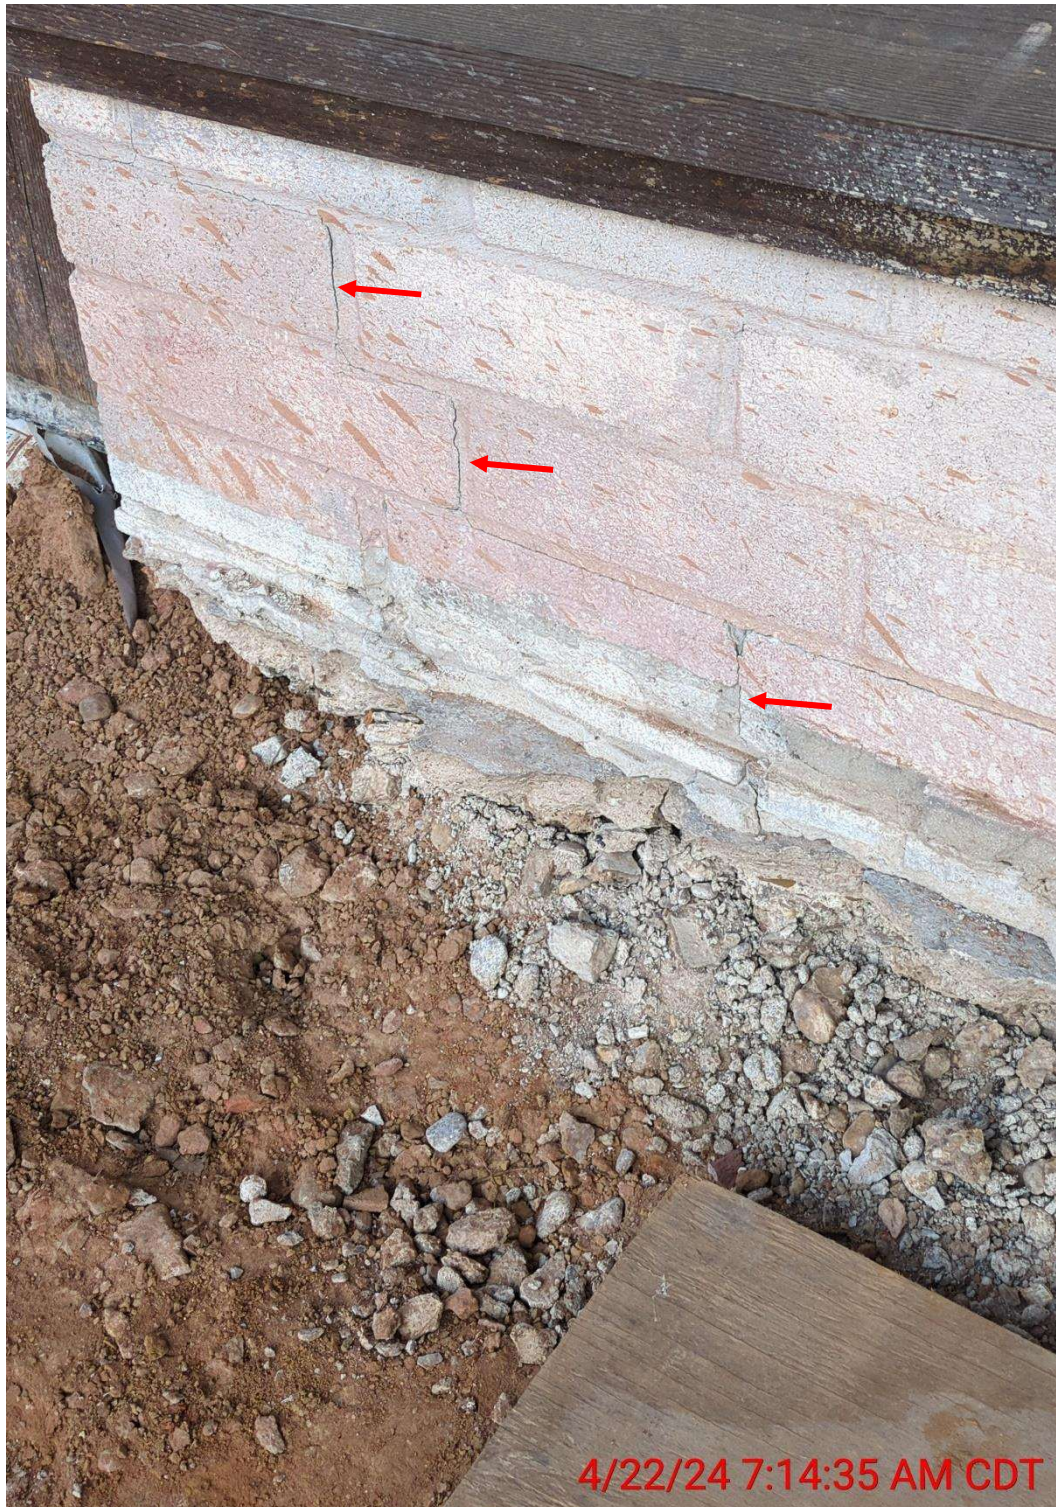
- Prior to the placement of the concrete, a new PVC sanitary sewer line was constructed leading from the crawlspace to the sewer main (**Photo 1**).
- There were photographs that were taken after the sawcut, removal, and chipping process. Due to the red dust emitted when the brick was saw cut, the nominally neutral colored brick wainscot was temporarily tainted with a pink hue, with a distinct line separating where the brick was tinted (above the top of the prior, now-demolished walkway surface) and where it was still neutral colored (below the walkway surface). At the north, east-facing wainscot, there were hairline, stairstep cracks in the brick (**Photos 2 and 3**).

from the building and pulled away using an excavator and further chipped out to be flush. This created a condition in which for a time, only a strip of sidewalk roughly the same width as the brick veneer/wainscot was providing support for the veneer, a precarious condition until the new slab is poured against it. There was a location where, for unknown reasons, the remaining piece of sidewalk supporting the brick wainscot was chipped out from under the wainscot. This action was accompanied by a visible chip in the brick itself. This created an isolated unsupported condition in the brick, approximately two bricks wide, resulting in hairline stair-step cracking in the aged veneer. As a still image from a preconstruction video taken by CSC showed the brick without a chip or hairline cracks, it is reasonable to conclude that the construction activity by CSC caused this distress.

Photo 2: North side of the brick storefront wainscot, having been saw cut and chipped, with a distinct line indicating the location of the finished walkway surface. Note the fine stair-step cracks (indicated).

However, based on the available documentation to J.S. Held, there does not appear to be a reason why the wainscot required demolition and reconstruction (and the other side as well for matching), when the condition could have been repaired in place. Grout or slurry (mud jacking) could have been injected under the wainscot to restore the integrity of the support and simultaneously lift the elevation of the wainscot to a higher elevation if it was felt that it had subsided. The brick could have been repointed to address the hairline cracking and maintain uniformity, and according to the color difference between the brick originally below the surface of the pavers and the brick above, a small portion of the chip in the brick would have been visible above the finished surface, which could have been spot addressed. The glass for the storefront would have had to be removed and reset/replaced regardless.

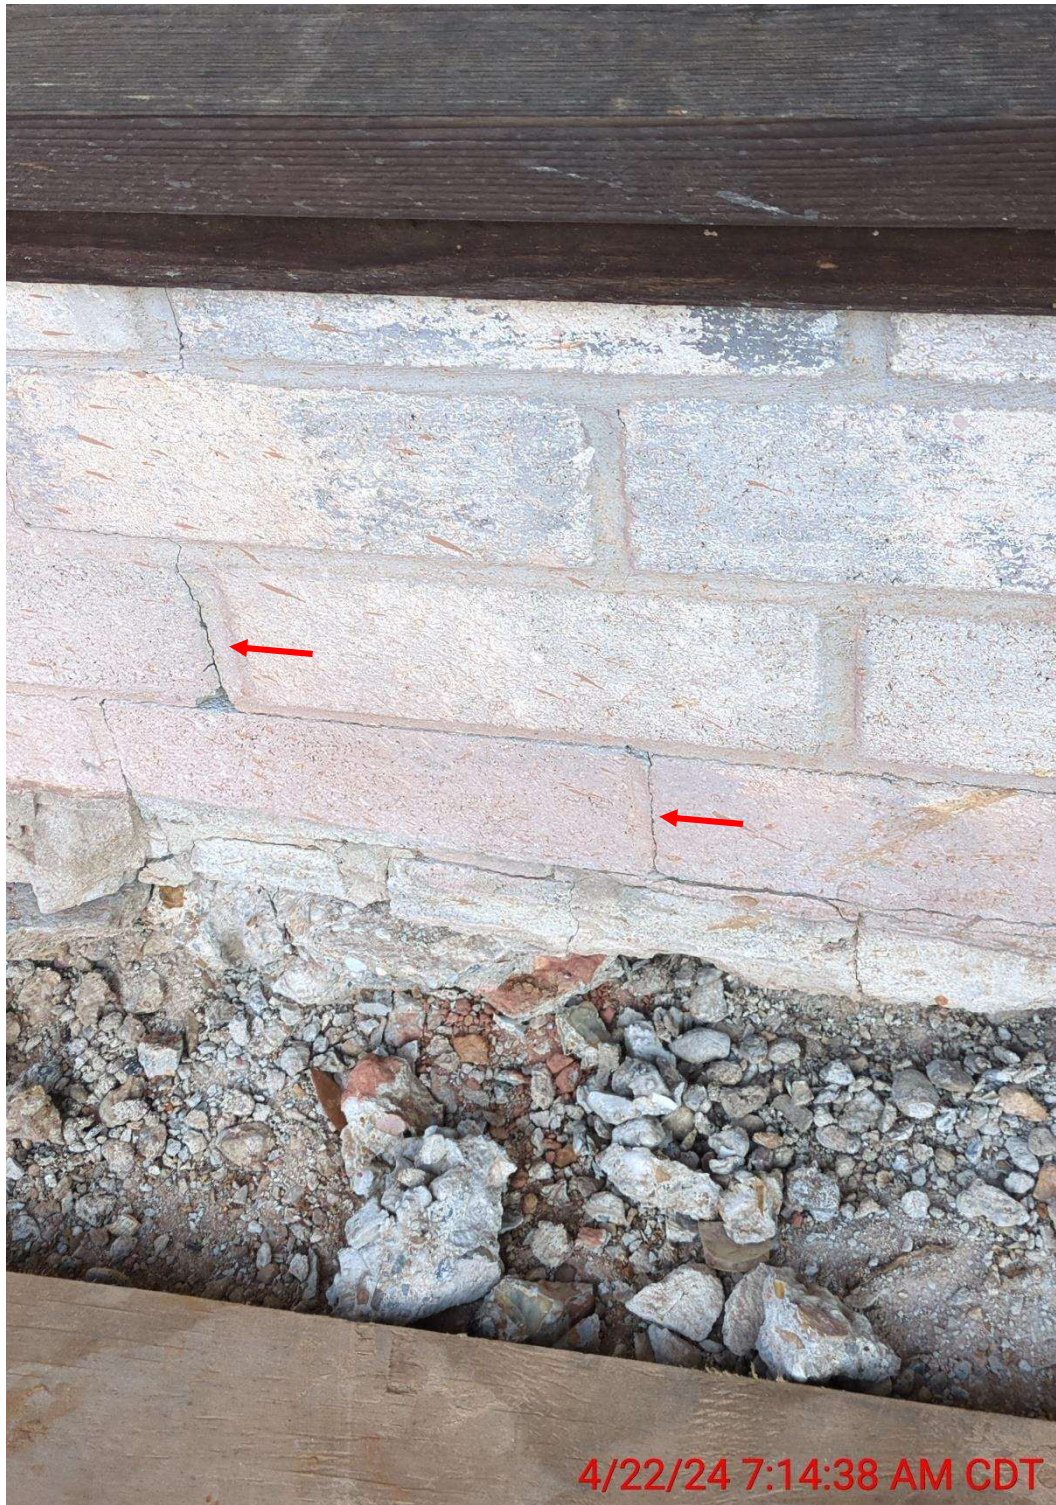
Photo 3: North side of the brick storefront wainscot, having been saw cut and chipped, with a distinct line indicating the location of the finished walkway surface. Note the fine stair-step cracks (indicated).
