Re: Construction Damage Assessment - Engineering Report

File Name:	Casey Slone
Address:	303 North Washington Avenue, Marshall, Texas 75670
Claim No.:	W2C22131
Reported Date of Damage:	February 14, 2024
J.S. Held No.:	240500935

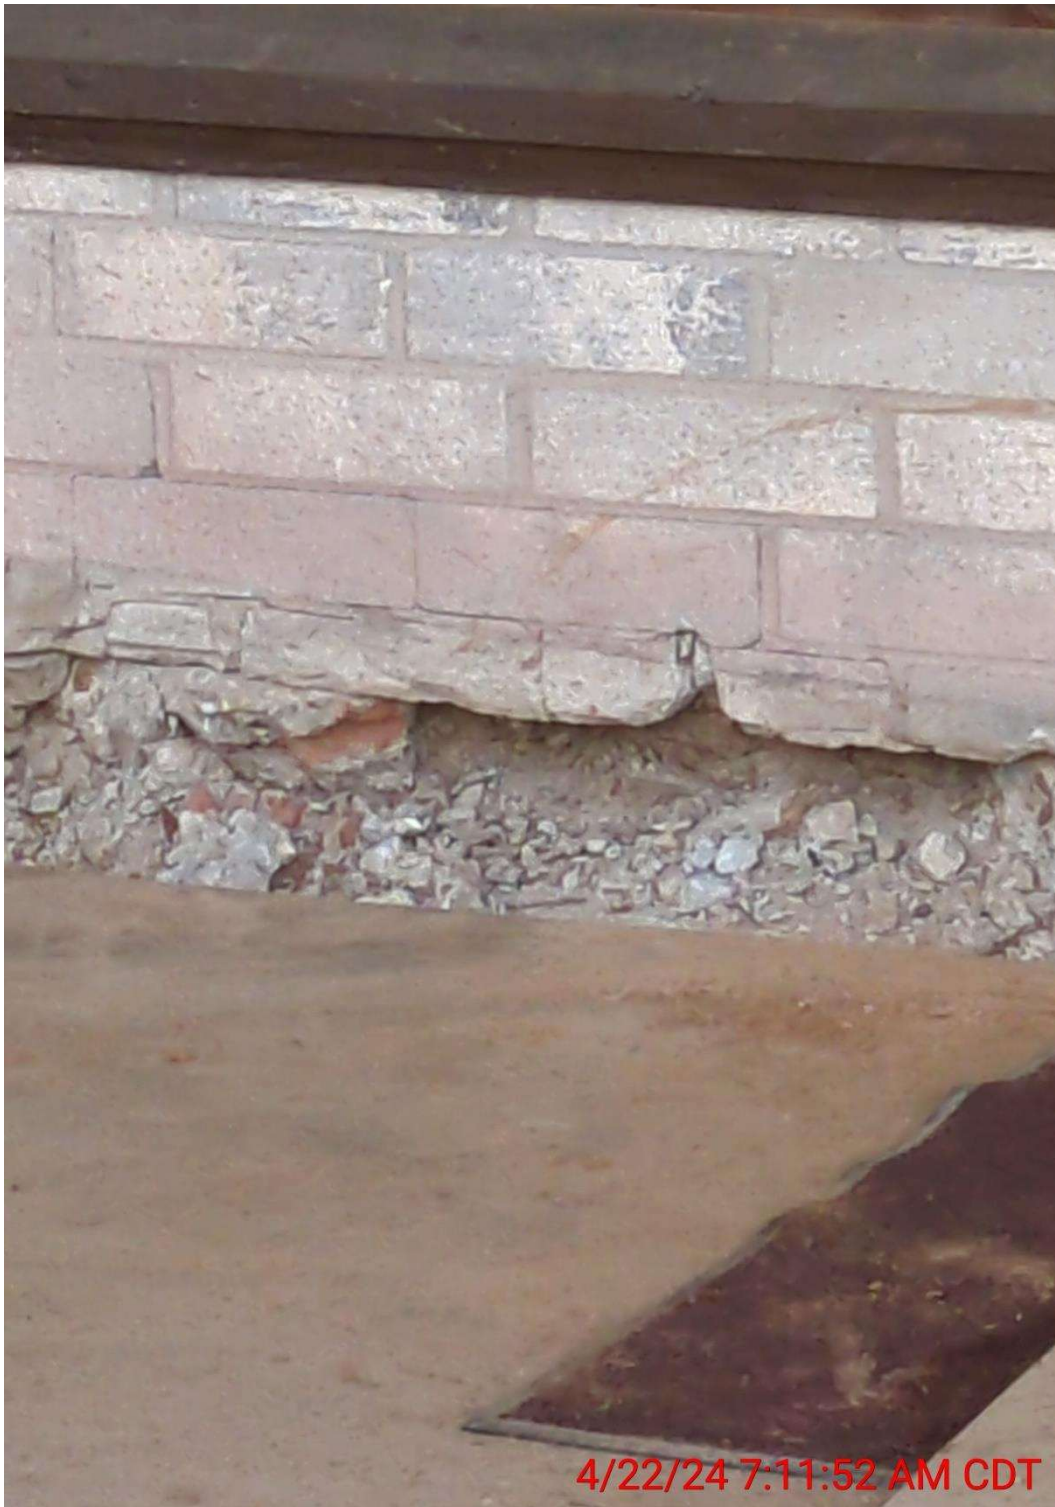
- On the north side of the entry, there was a brick that had been chipped, with a small portion of that chip protruding above the above-described line between the neutral and pink colored areas. Under this chip there was a void, approximately two bricks wide, where the concrete had been chipped out from under the wainscot as well (**Photo 4**).

Photo 4: Chip in the brick and a void under the wainscot.

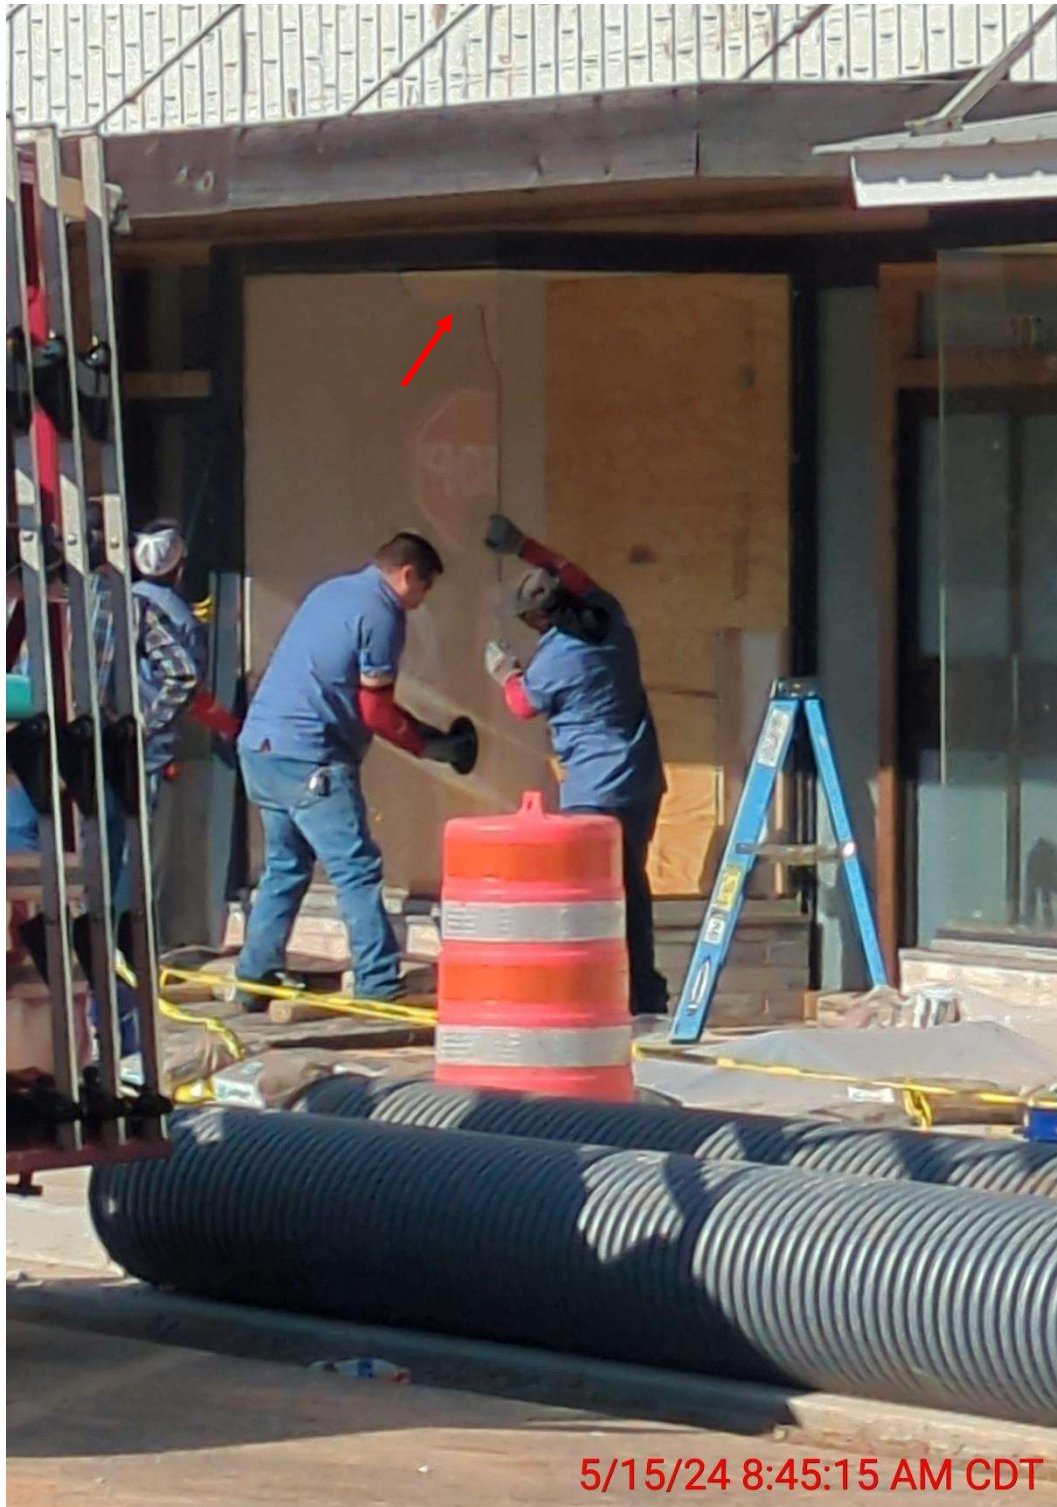
Photo 5: Broken storefront glass (indicated) being removed.

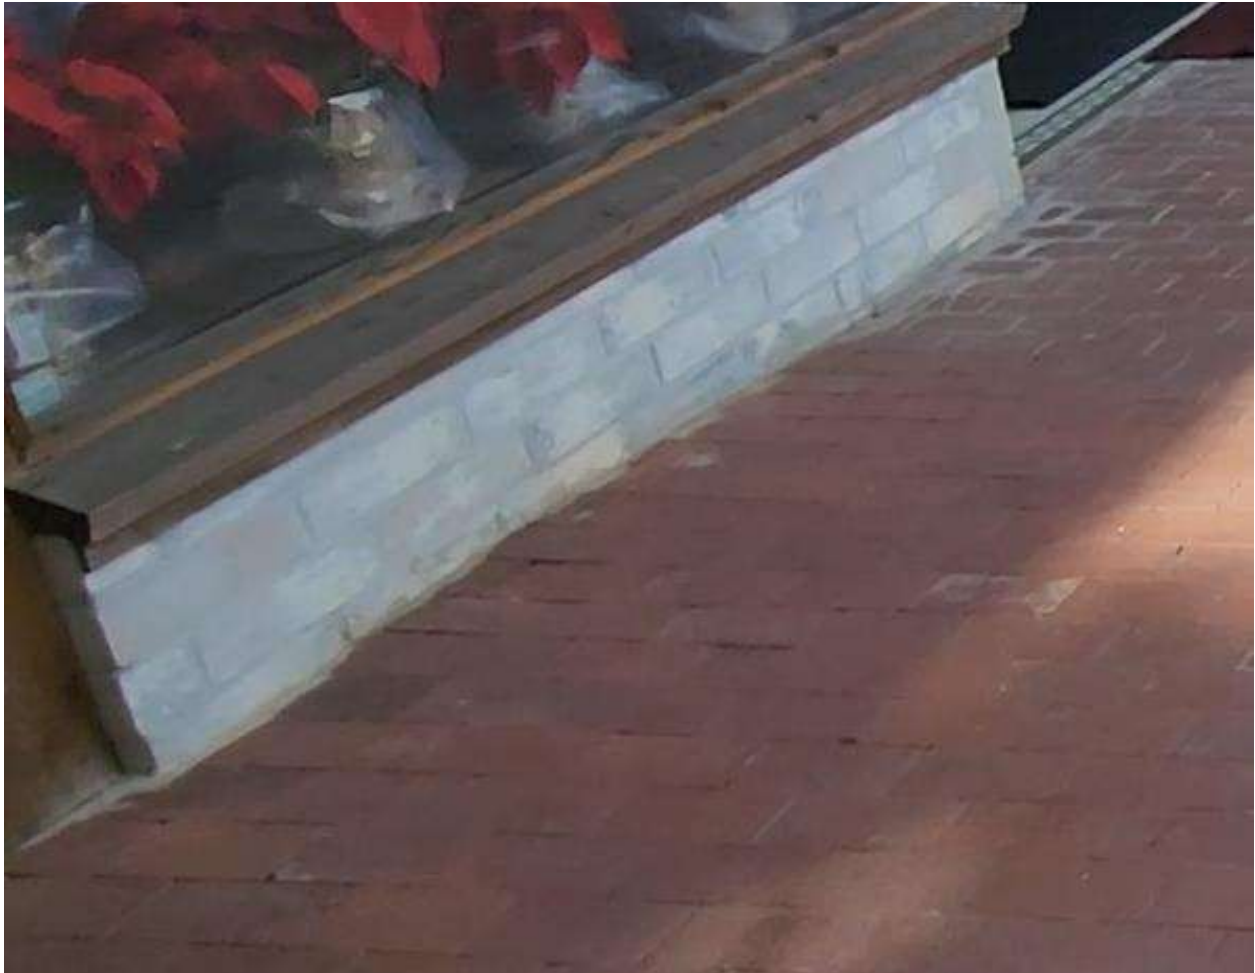
Photo 6: No distress in the brick wainscot prior to construction.

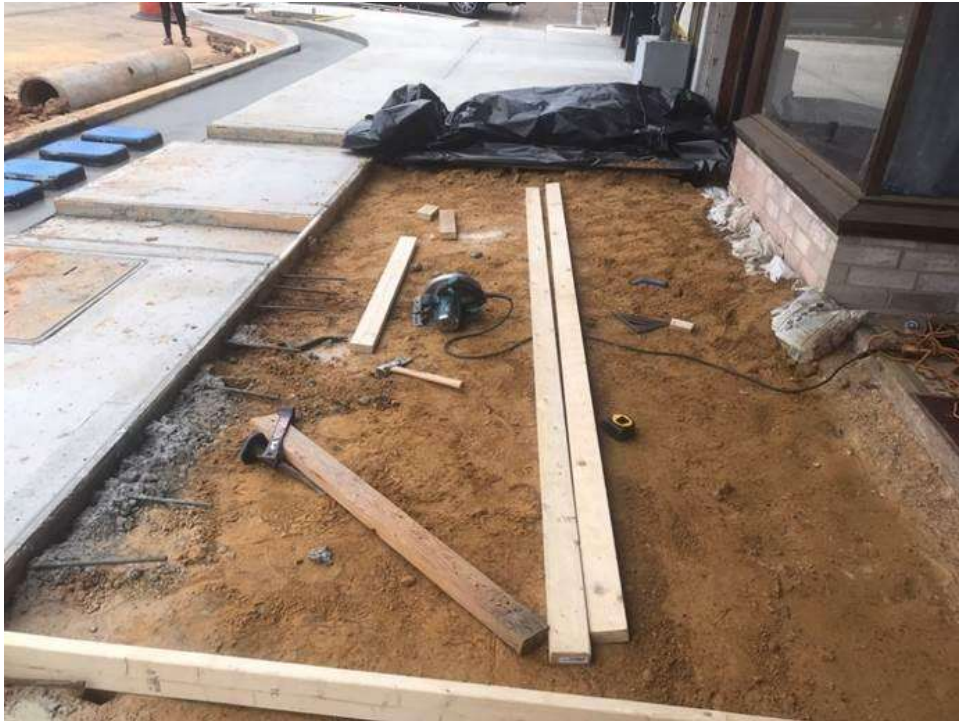
Photo 1: No concrete poured adjacent to the building.

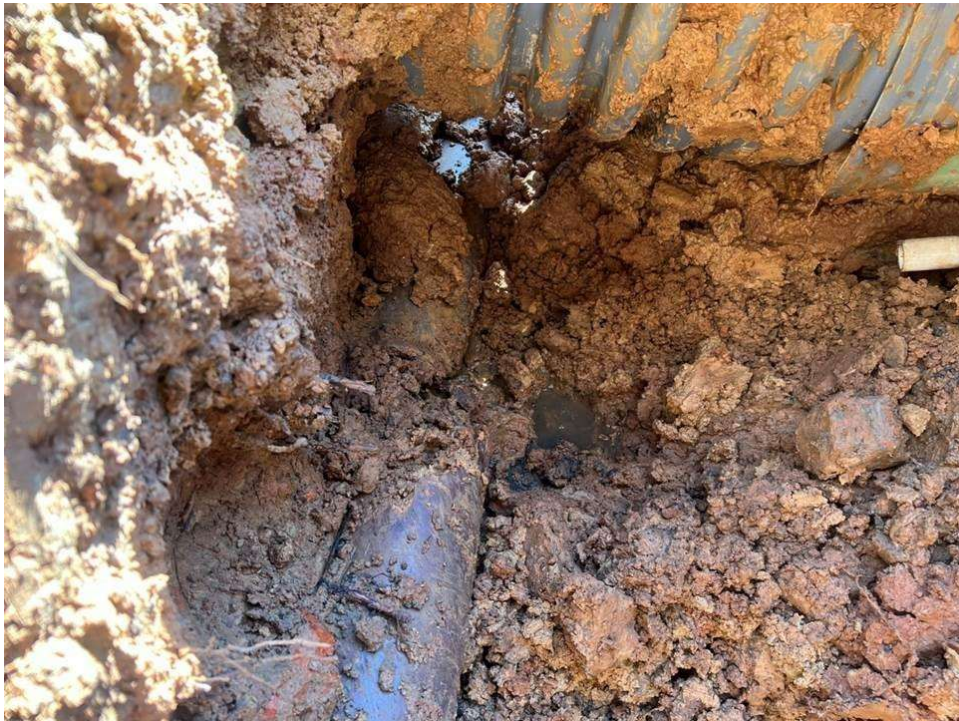
The break in the sanitary sewer line was immediately below a newly constructed corrugated stormwater pipe. Since the area had to be excavated to place the stormwater line in, the excavator would have had to get dangerously close to the sanitary sewer line to properly excavate. Given that there were no breaks anywhere else except where the sanitary sewer line and stormwater pipe excavation crossed, it can be reasonably concluded that the excavator accidentally hit the sanitary sewer line. It is worth noting that none of the sanitary sewer lines from the buildings along North Washington Avenue were depicted in the construction drawings, so CSC had no way of knowing that they were excavating near the line.

Photo 2: Fractured sanitary sewer line directly under the location of a new corrugated stormwater pipe.

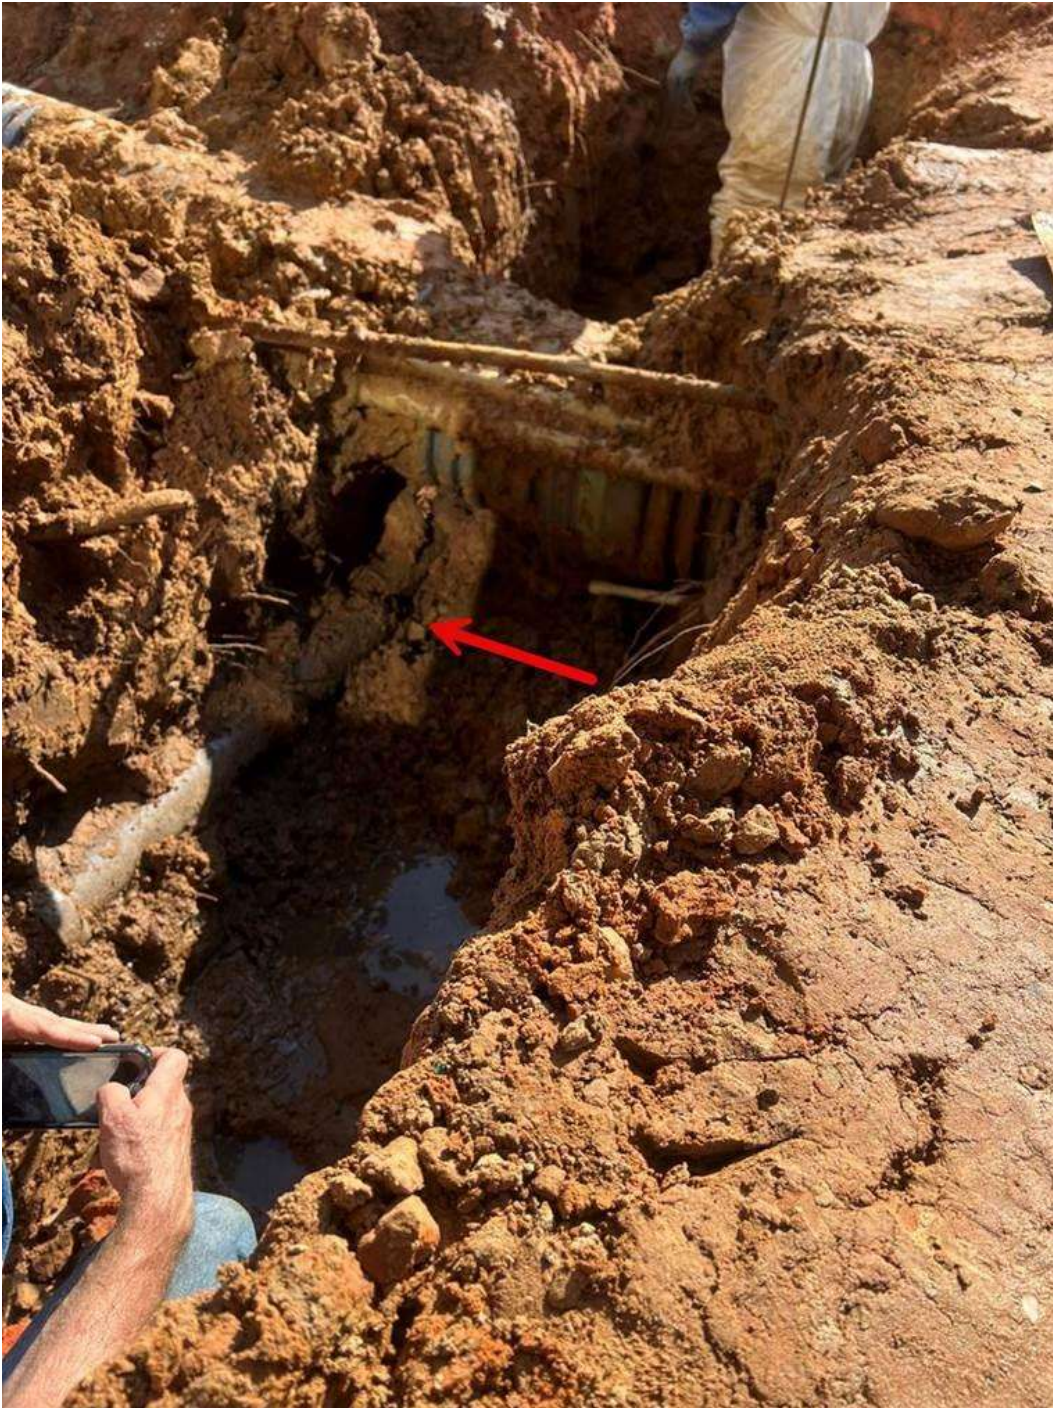
Photo 3: Zoomed out view of **Photo 2** showing the position of the break relative to the stormwater pipe.

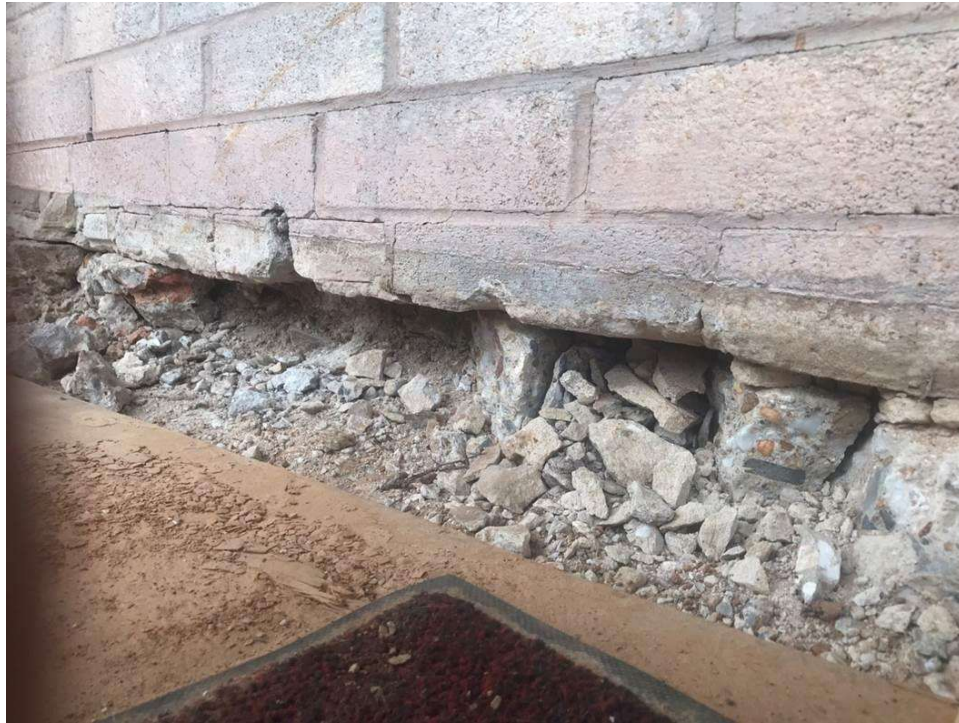
Photo 4: Chip in the brick and a void under the wainscot.

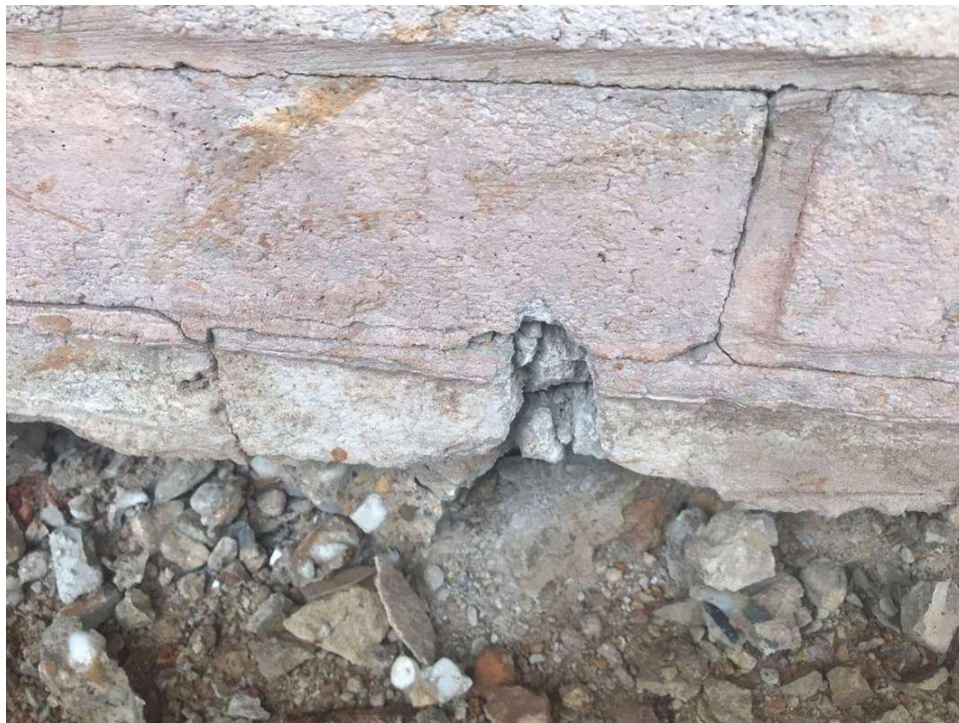
Photo 5: Chip in the brick and a void under the wainscot.

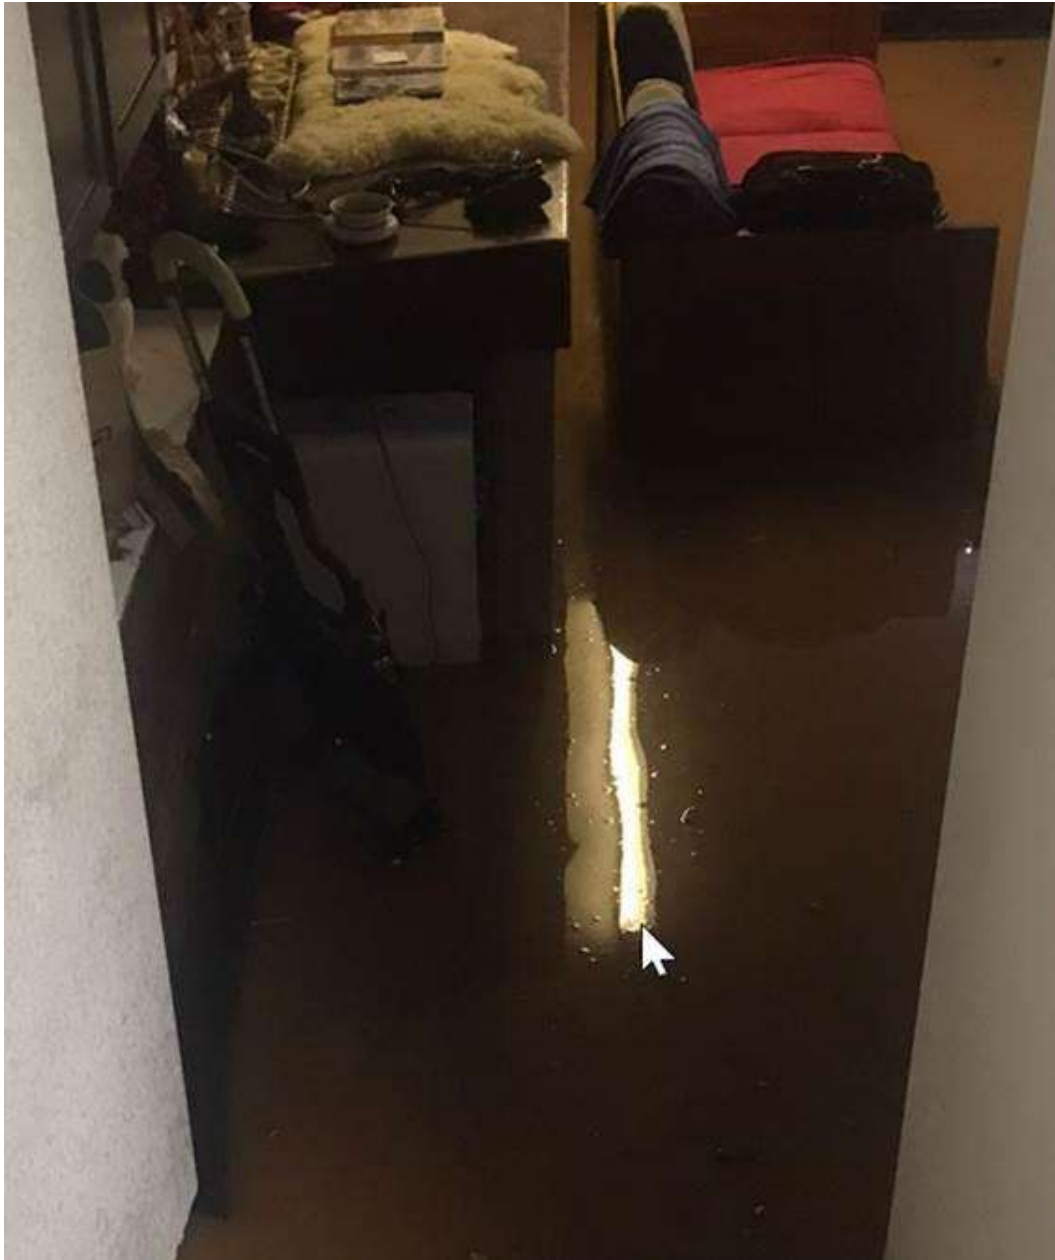
Photo 7: Flooded basement.

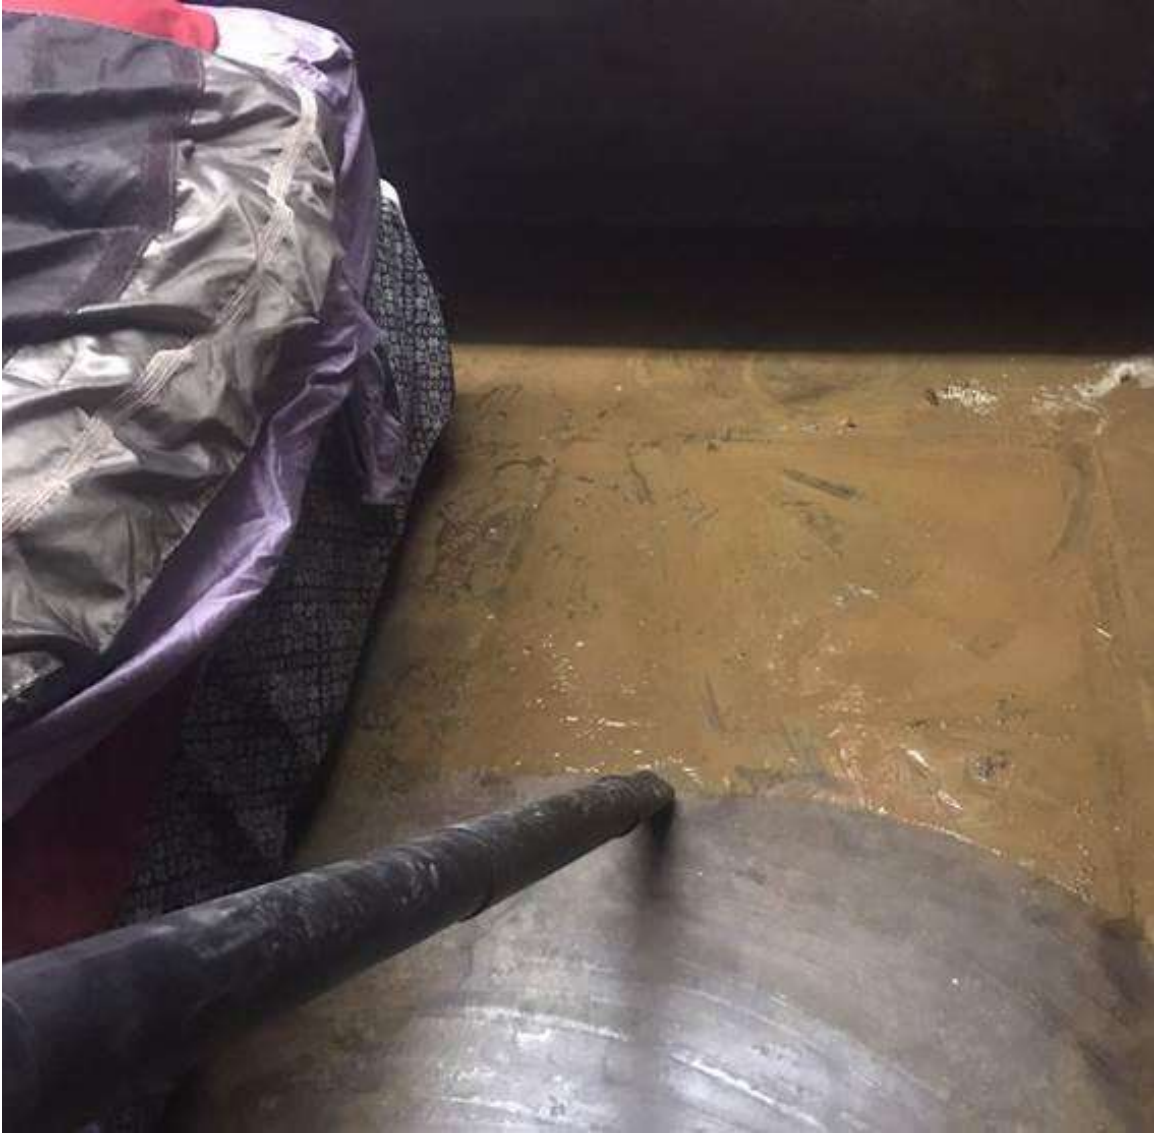
Photo 8: Vacuuming the mud from the basement.

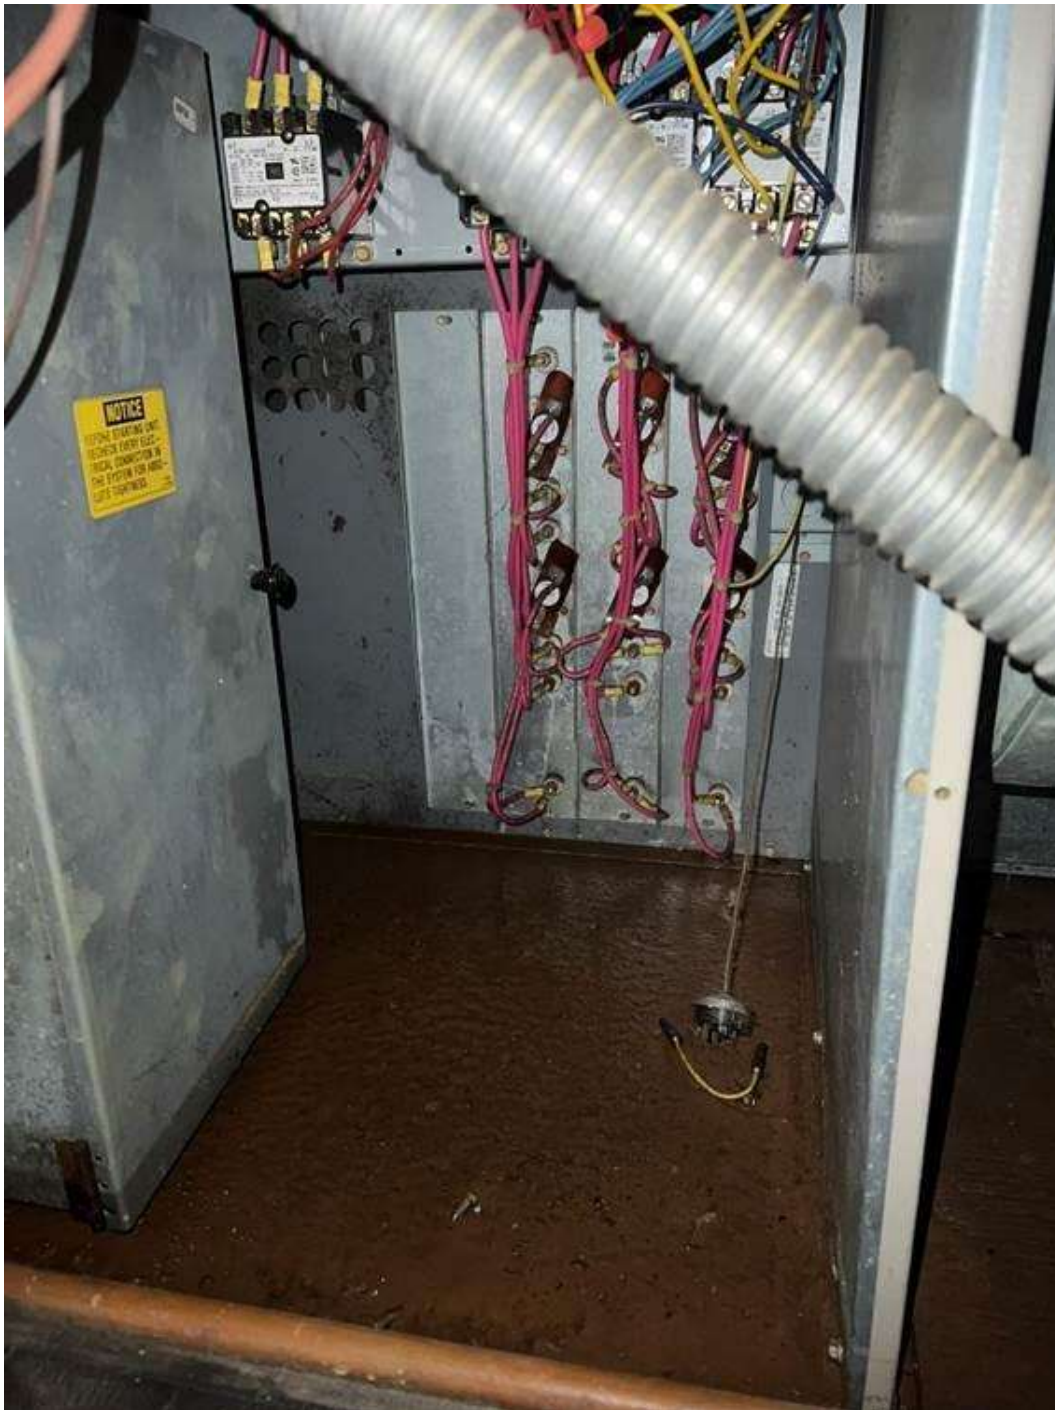
The A/C unit was not able to be inspected during J.S. Held's site assessment. However, Mr. Watts provided photographs of the damaged condition of the A/C unit, and it was noted that there was residual water and mud as well as a water mark at a significant height relative to the bottom of the cabinet. In addition, J.S. Held did observe dirt and water lines up to six inches from the finished floor in the basement. Given that the water that flowed through the A/C unit would have had to have first gone through the predominantly earthen, easily eroded crawlspace, the water would have been filled with salts and particulate, easily conducting electricity. As such, it is highly unlikely that the A/C unit would have survived the flooding event.

Photo 9: Residual mud in the cabinet of the A/C air handling unit.

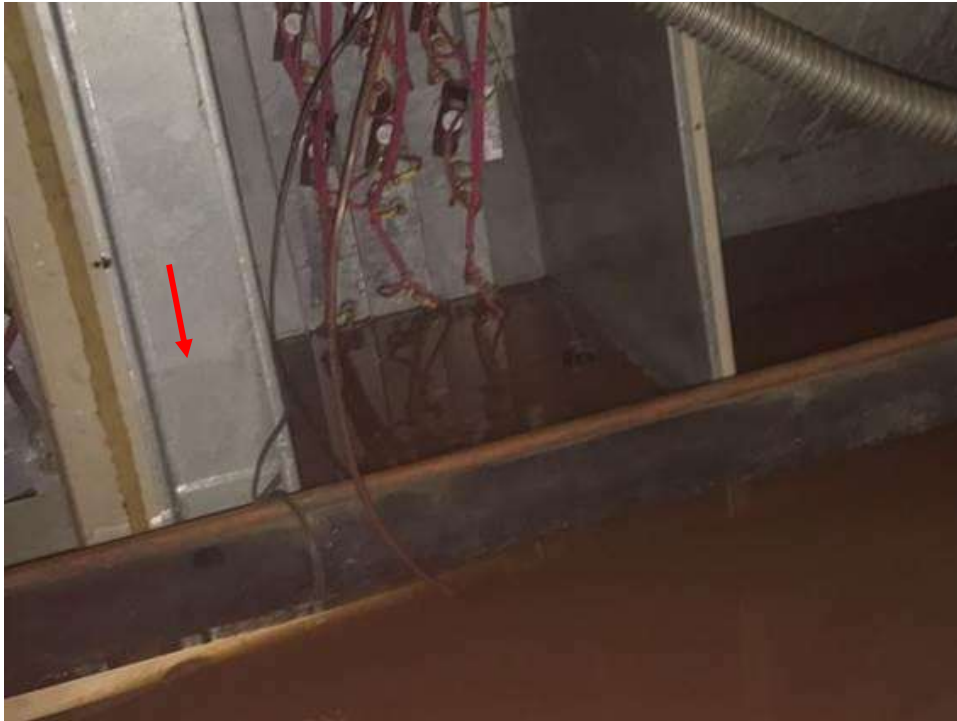
Photo 10: Residual water and mud in the cabinet of the A/C air handling unit. Note the water line (indicated).
