June 27, 2024

Re: **Construction Damage Assessment - Engineering Report**

File Name:	Casey Slone
Address:	303 North Washington Avenue, Marshall, Texas 75670
Claim No.:	W2C22131
Reported Date of Damage:	February 14, 2024
J.S. Held No.:	240500935

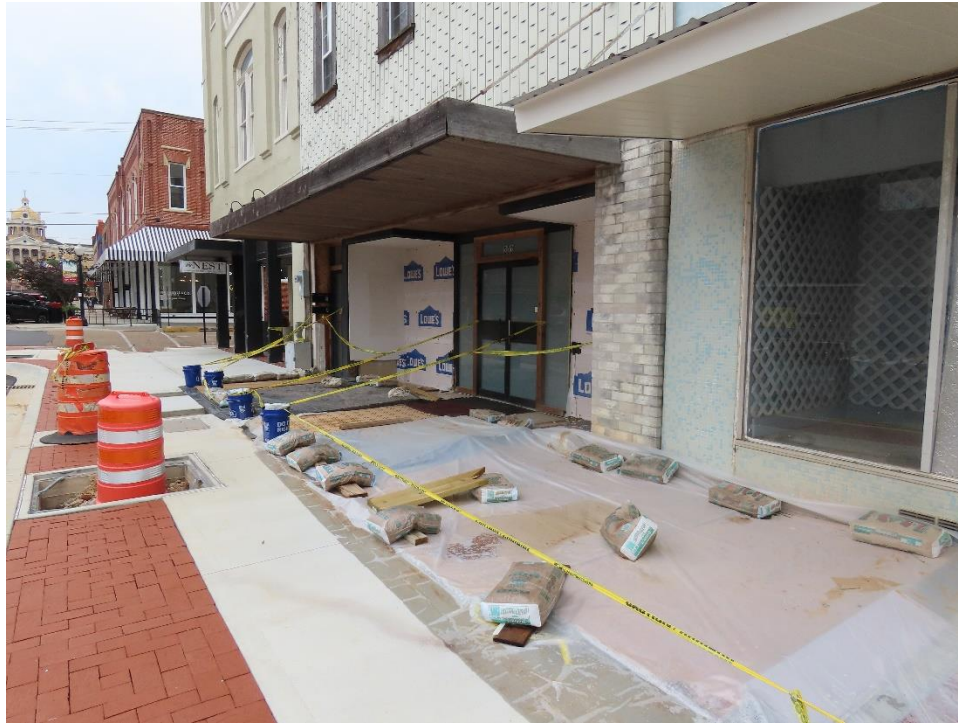
- The storefront windows at the entrance to the building had been demolished, and the ground was covered with sloped plywood and tarps to address alleged insufficient drainage (**Photos 1 through 3**).

Photo 1: Overview of the east-facing storefront showing the absence of the allegedly damaged storefront windows and brick.

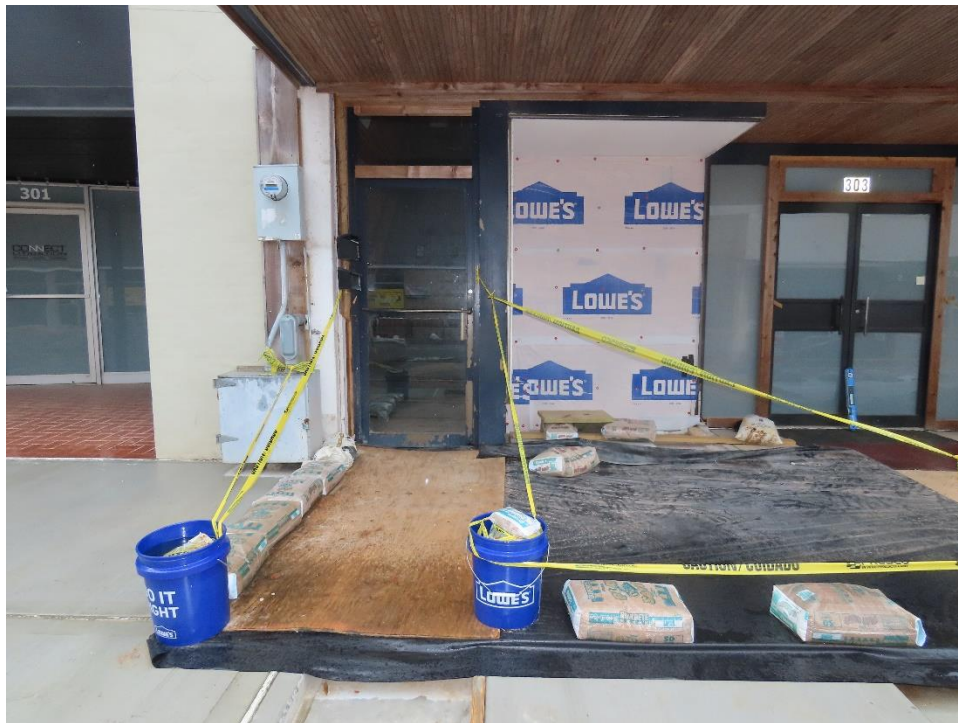
Photo 2: Overview of the south portion of the east-facing storefront showing the absence of the allegedly damaged storefront windows and brick.

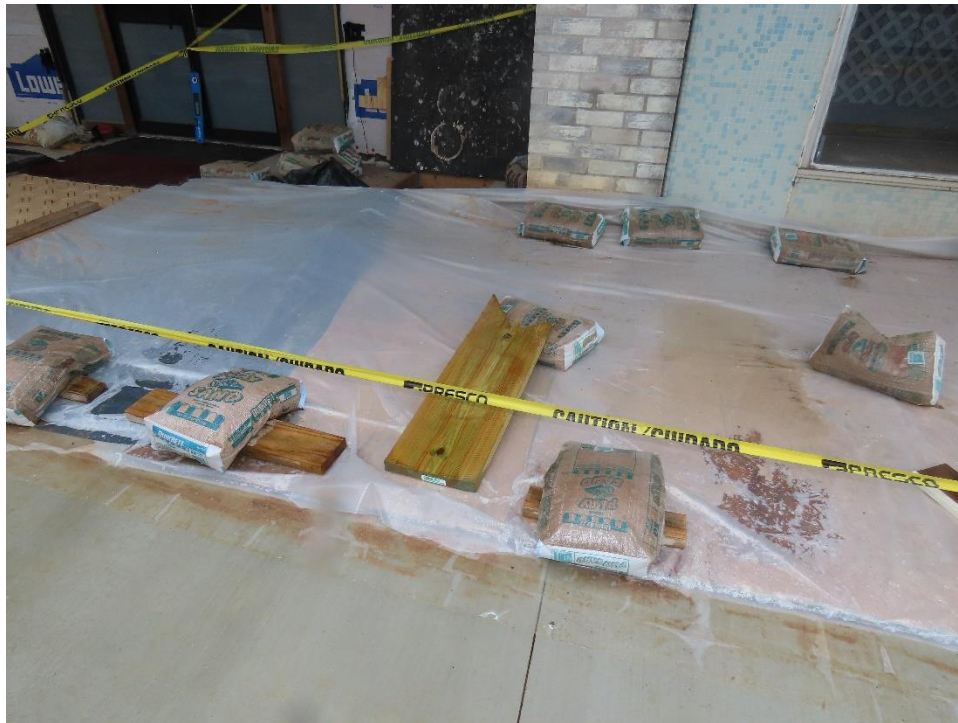
Photo 3: Overview of the north portion of the east-facing storefront showing the absence of the allegedly damaged storefront windows and brick.

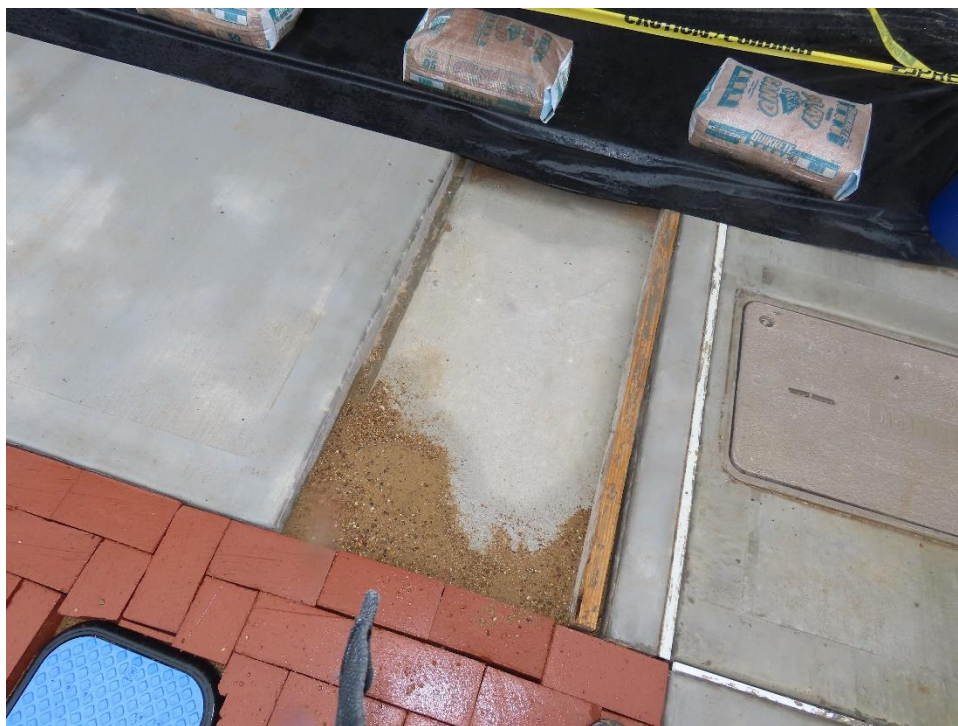
- There were two concrete troughs in the concrete adjacent to the property that were meant to be filled with brick paving (accent) that had accumulated dirt and sediment (**Photo 4**).

Photo 4: Accumulated dirt and sediment in a concrete trough not yet filled with brick.

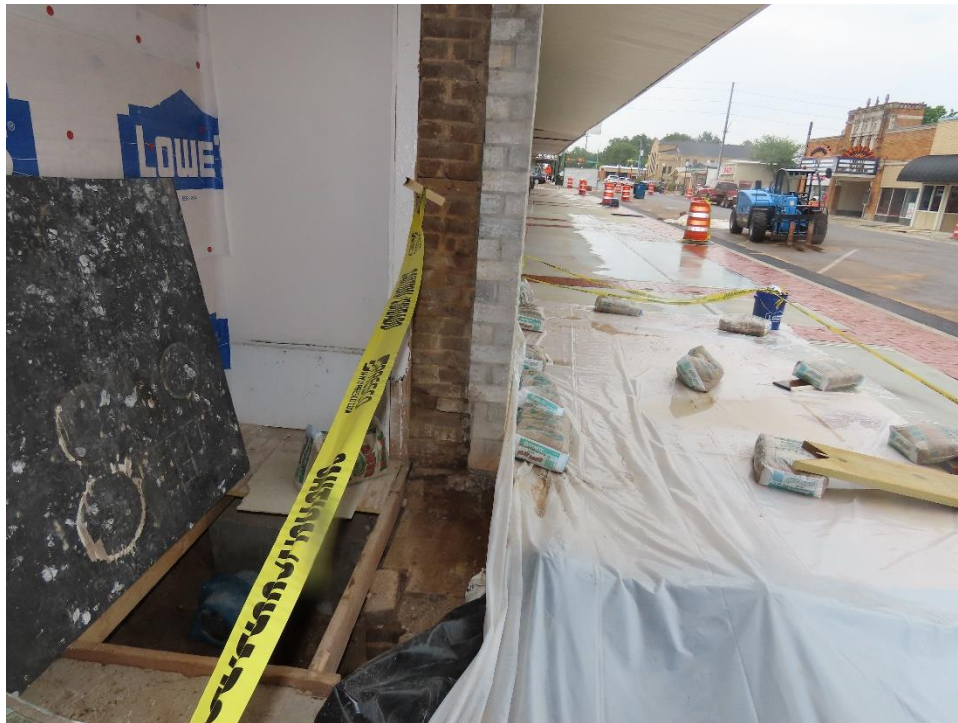
- A small portion of the brick veneer remained at the edges of the property, and it could be seen that demolition had been performed down to the top of a concrete grade beam that supported the structural brick behind the brick veneer. However, while the structural brick was directly supported by the grade beam, there was a several inch tall gap between the top of the grade beam and the veneer brick. The landing leading to the front door, which still had the concrete base intact, illustrated that the concrete base (sidewalk), that supported the veneer was not integral with the top of the grade beam (**Photos 5 through 9**).

Photo 5: Remaining veneer brick and structural brick behind it at the north edge of the entryway.

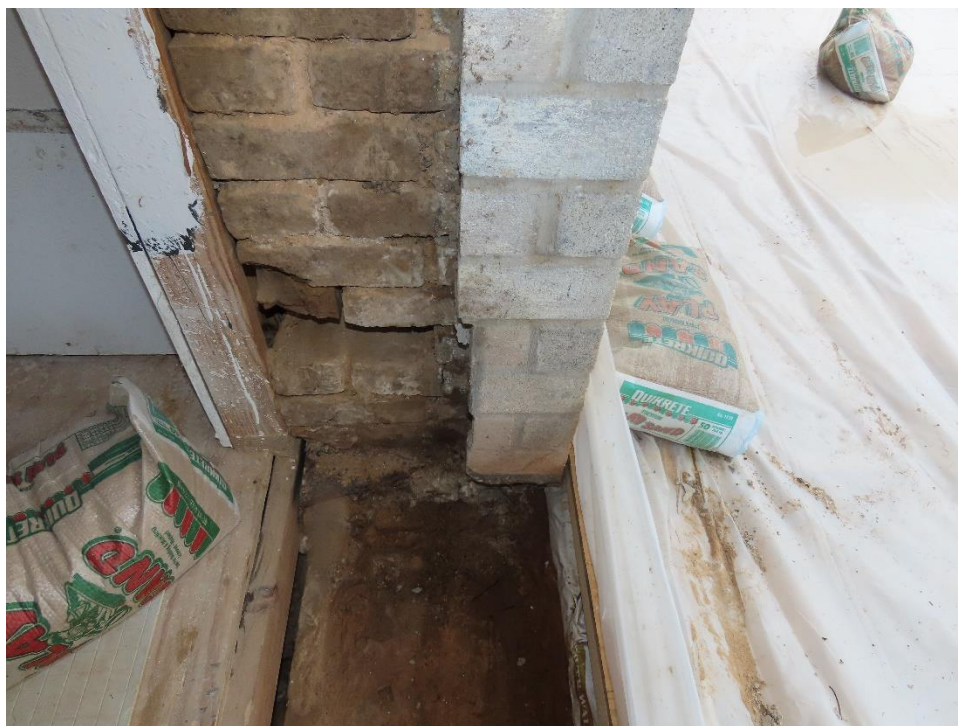
The onsite evidence, including the gap between the top of the grade beam and the bottom of the veneer, and the locations where the original sidewalk remained, indicated that the brick veneer was immediately supported by the sidewalk, which was in turn supported by the grade beam. This also makes chronological sense as the structural brick behind the veneer was directly supported by the grade beam and the sidewalk was originally cast against it. The veneer was placed sometime after, bearing on the sidewalk. Section 2.07 of the contract documents also empowers the contractor to decide the means and methods to accomplish the work, provided it does not adversely affect the outcome of the work. The methodology employed by CSC and its demolition subcontractor was a nominally viable approach for removing the sidewalk adjacent to the building but allowed for a very small margin of error. The sidewalk was saw cut through a few inches

Photo 6: The structural brick was directly supported by the grade beam, but there was a several-inch-tall gap between the top of the grade beam and the veneer brick.

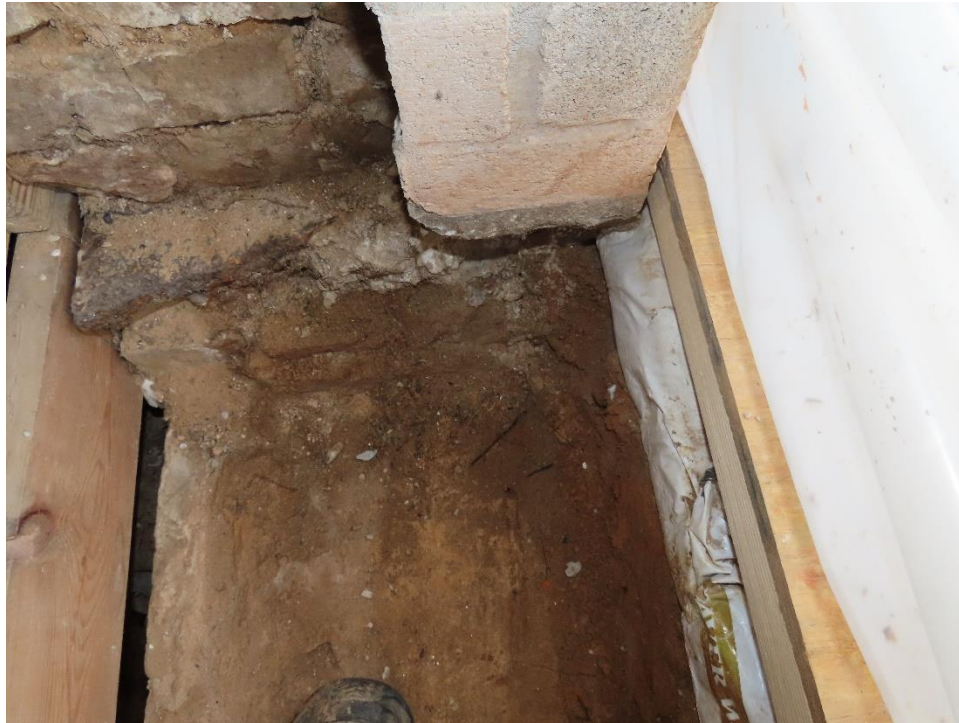
Photo 7: Close-up of the condition depicted in **Photo 6**.

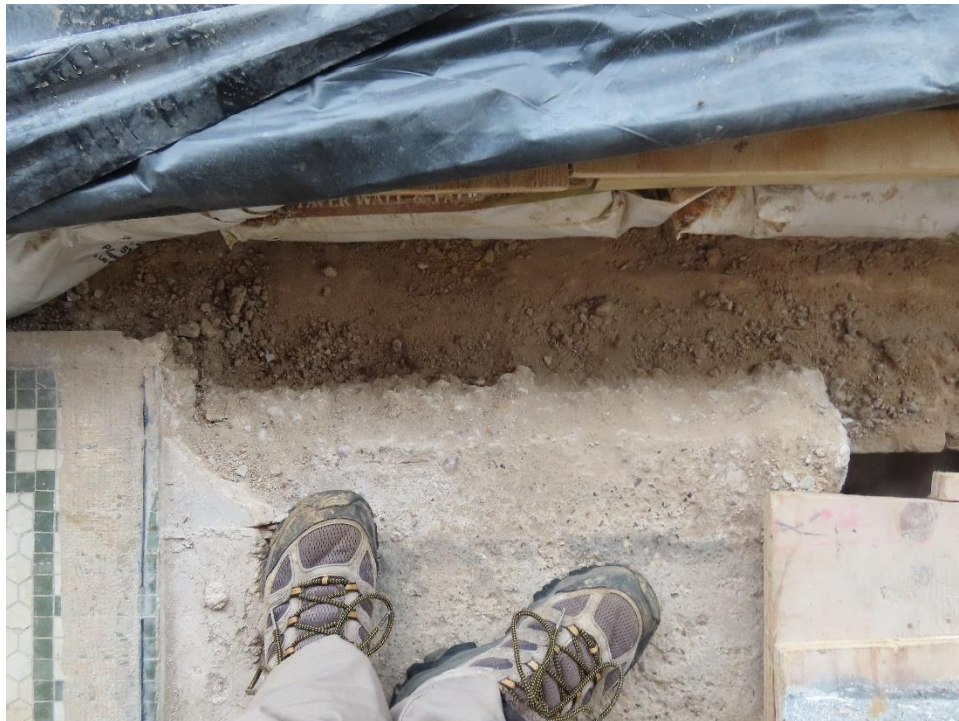
Photo 8: View showing the distinction between the sidewalk base and the top of the grade beam.

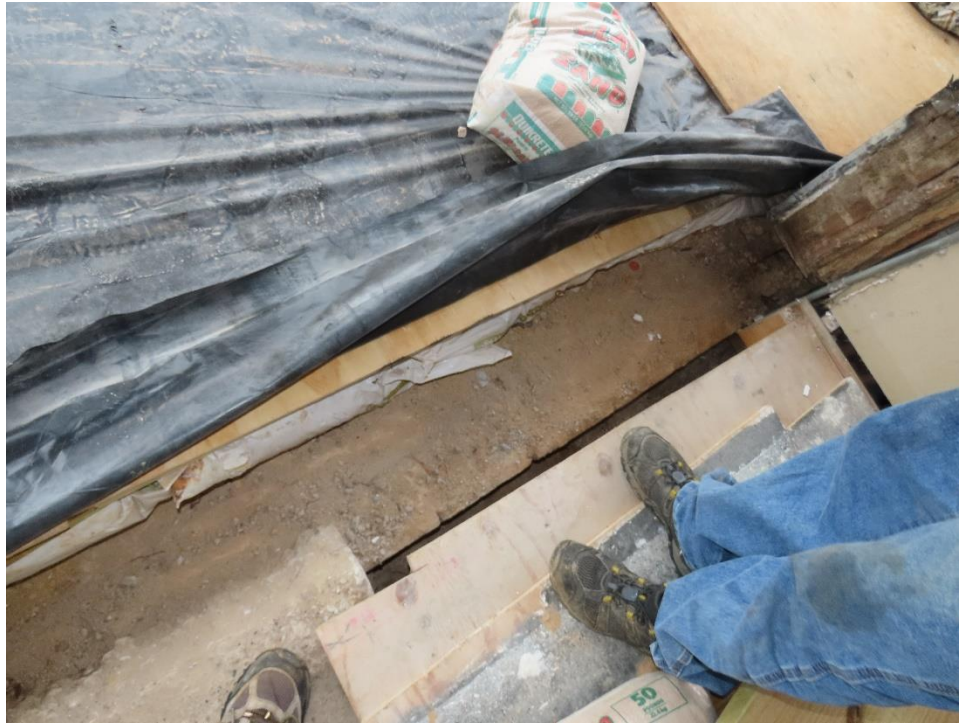
Photo 9: Alternate view of the condition depicted in **Photo 9**.

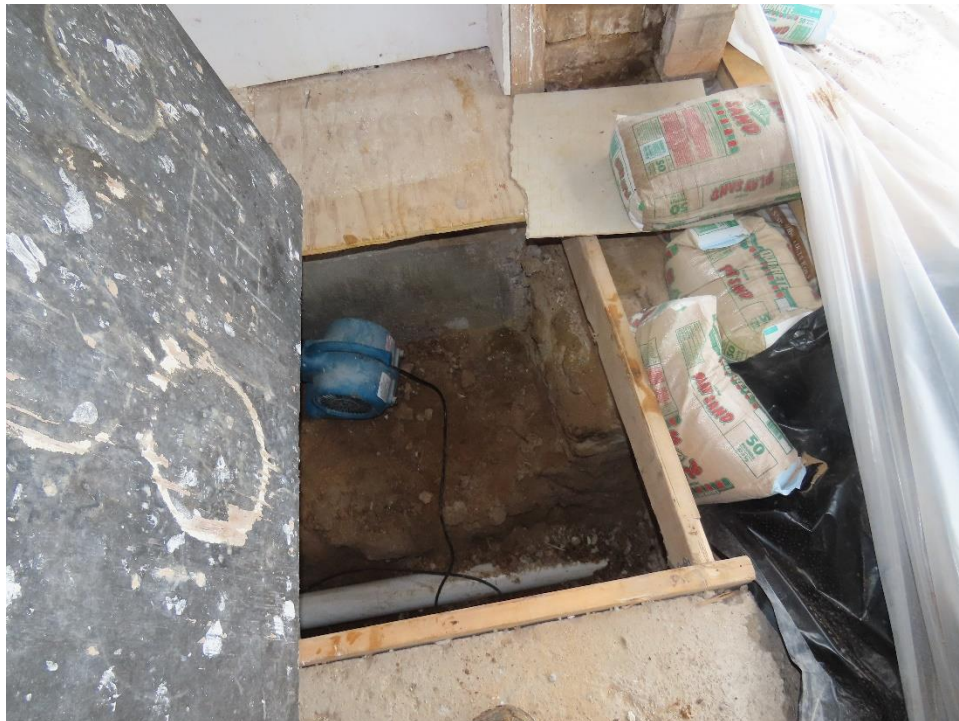
- There was a rectangular opening leading to the crawlspace and eventually the basement. According to Mr. Watts, this was not the utility hole that was discovered during demolition. This opening was kept open to install a replacement polyvinyl chloride (PVC) sewer line to tie into the main (**Photo 10**).

Photo 10: Rectangular opening leading to the crawlspace with a PVC sanitary sewer line visible.

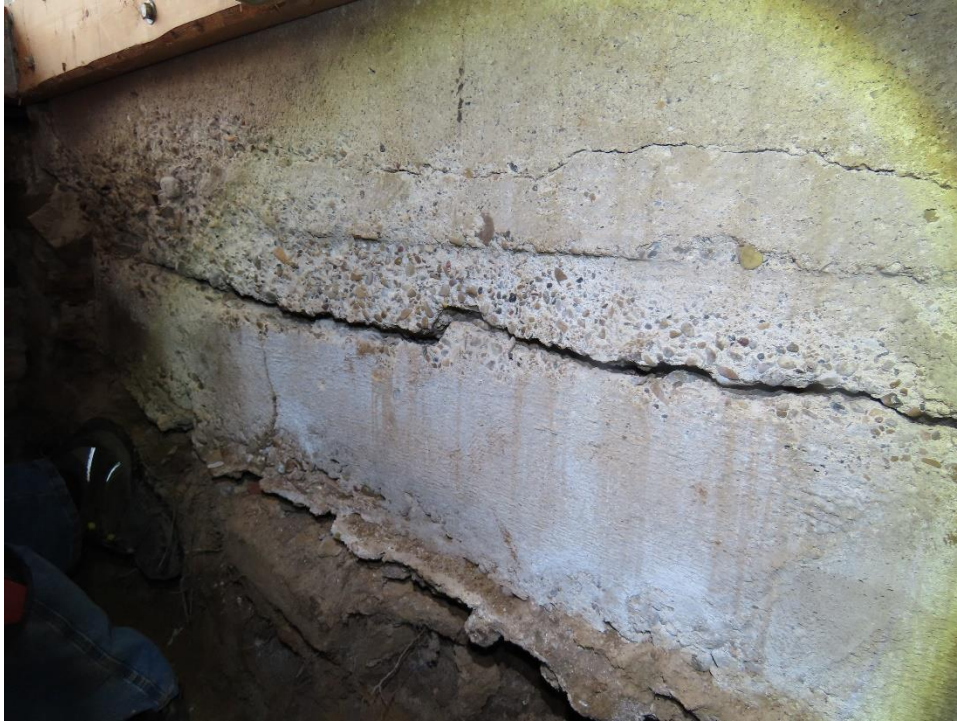
- Nearly under the above-described rectangular opening, there was a tall concrete beam with a longitudinal fracture approximately down the middle where there was an unusually high concentration of exposed aggregate. The edges of this fracture were generally rounded. There was a void in the soil under the fracture, and where the soil remained, the soil was probed with both a finger and a metal ruler and found to have weak strength (**Photos 11 through 16**).
- A new PVC sanitary sewer line was present in the crawlspace (**Photo 17**).

However, the assertion that the water caused the distress to the concrete beam in the crawlspace is unfounded for several reasons. First, while the soil was of poor structural strength, and water likely did erode some of the soil under the beam, a concrete beam that is more than 2 feet tall should easily be able to span a void of such size. That being said, with the void there, there were currently stresses on the beam that were not there before, and soil support should be restored to its pre-flood condition. Second, the surfaces of the fracture were rounded, indicating an aged condition and inconsistent with the timeframe of February 14, 2024. Third, the fracture was through a section of the beam that clearly had a deficiency

in the concrete mixing process, as there was a drastically higher concentration of exposed aggregate, weakening the beam at that location.

Photo 11: Longitudinal fracture approximately down the middle of a concrete beam where there was an unusually high concentration of exposed aggregate.

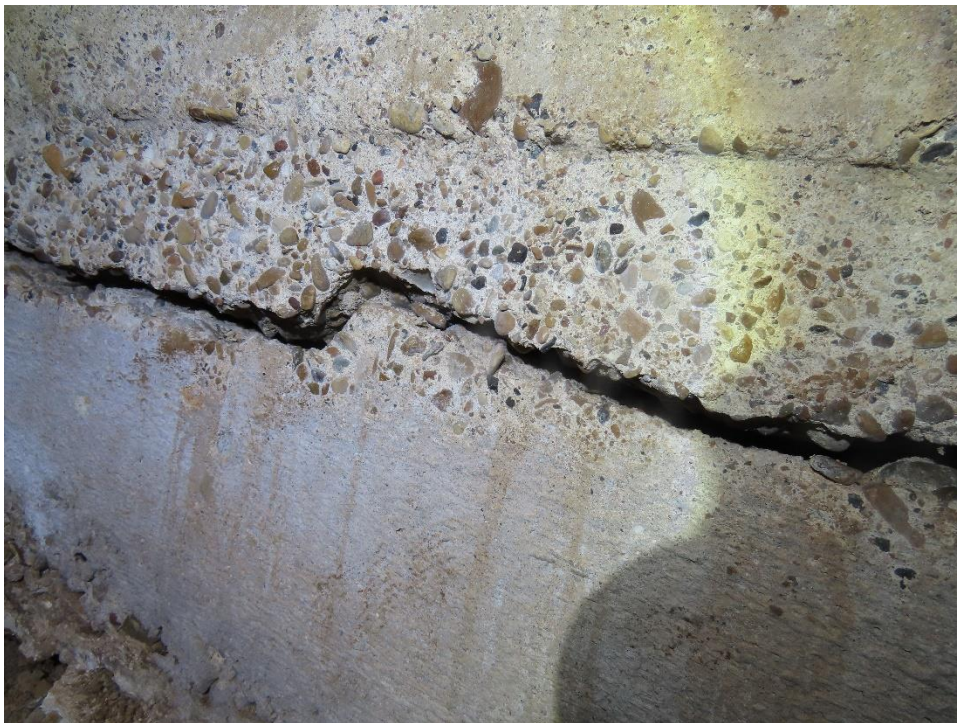
Photo 12: Close-up of the condition depicted in **Photo 11**, showing the rounded edges of the fracture.

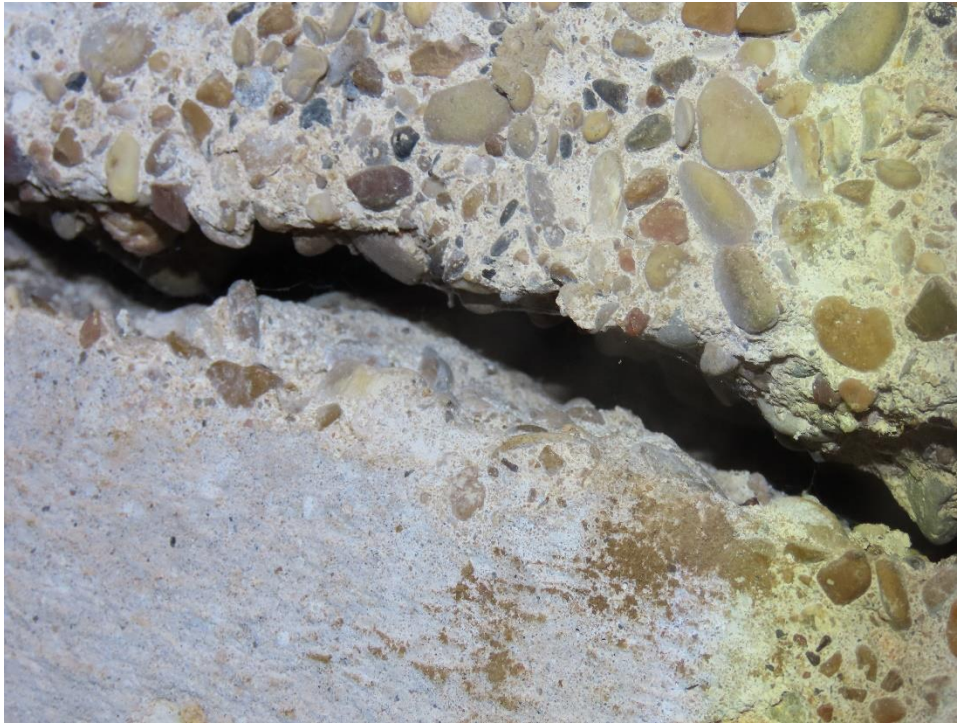
Photo 13: Close-up of the condition depicted in **Photo 12**, showing the rounded edges of the fracture.

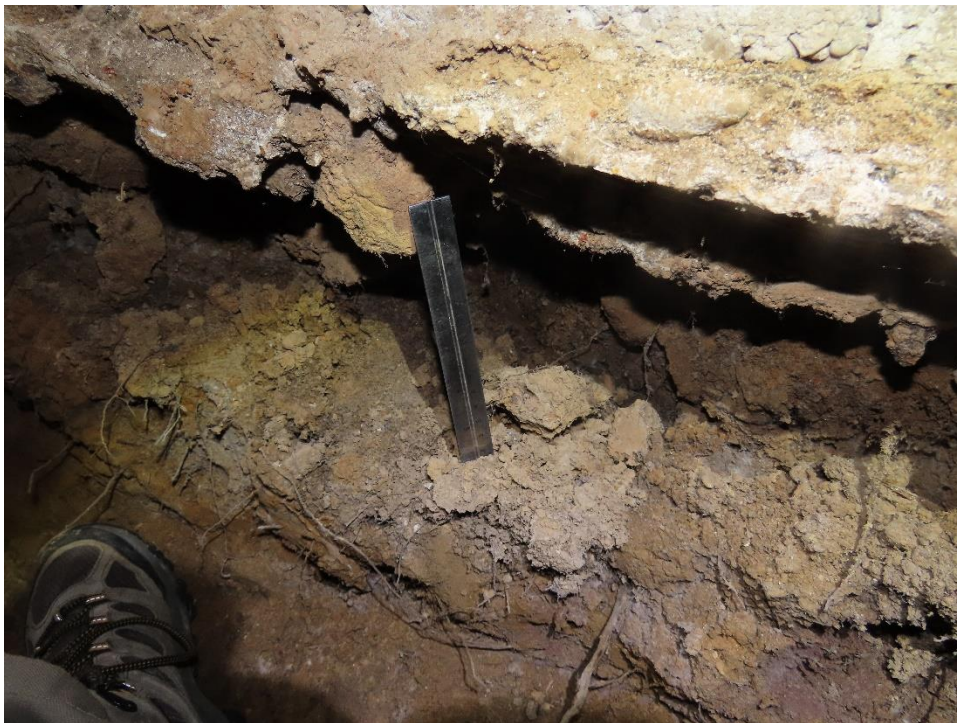
Photo 14: Void in the soil under the beam depicted in **Photos 11 through 13**.

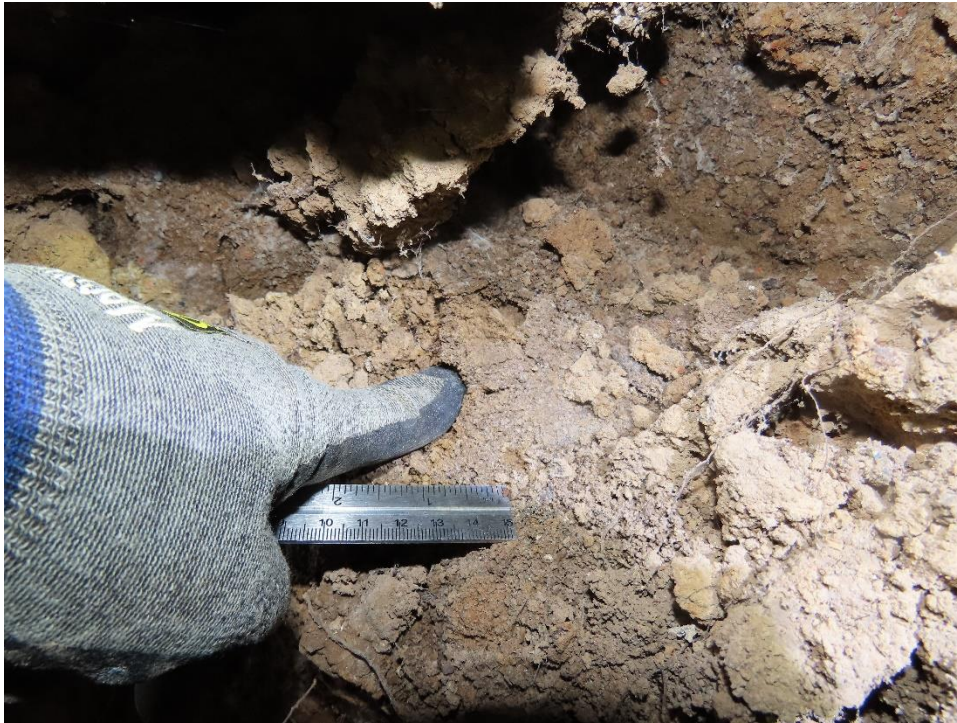
Photo 15: The soil yielded to finger pressure.

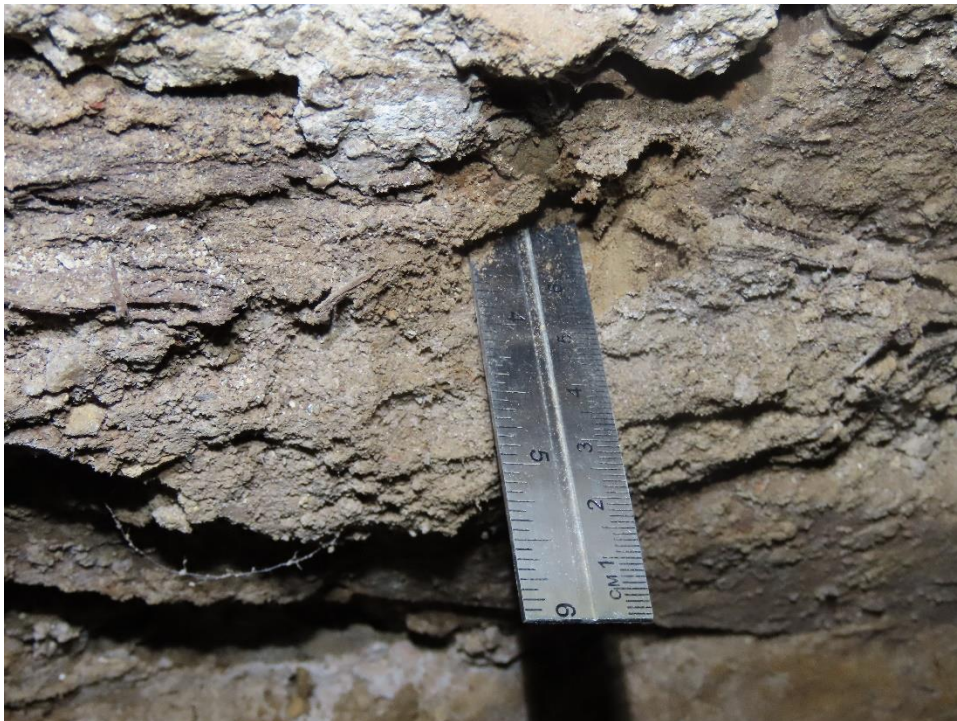
Photo 16: A metal ruler was easily inserted into the supporting soil.

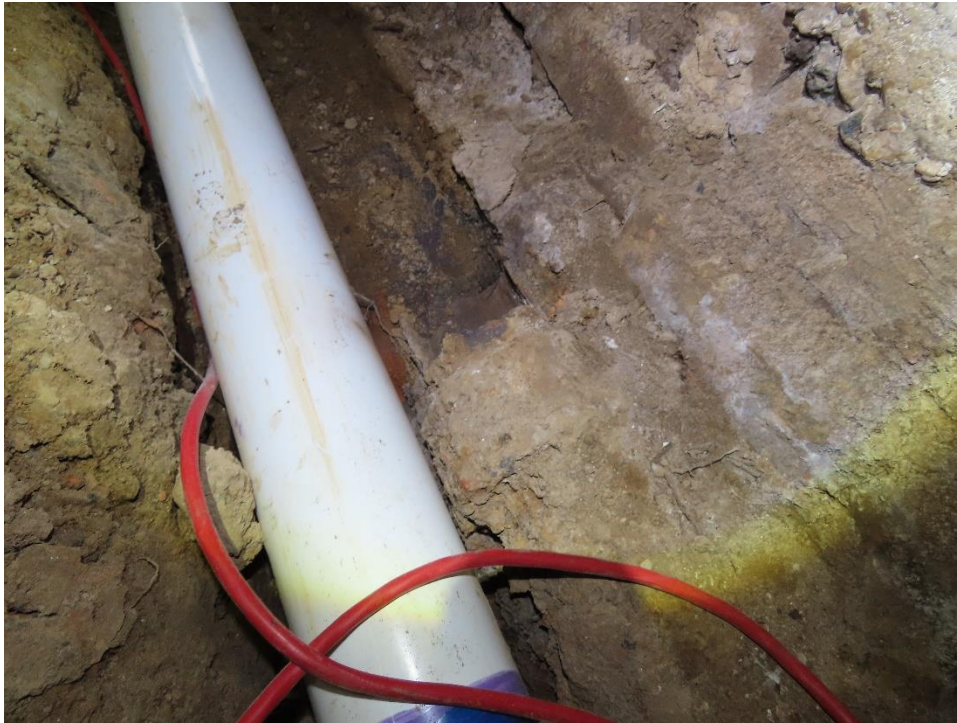
Photo 17: New PVC pipe in the crawlspace.

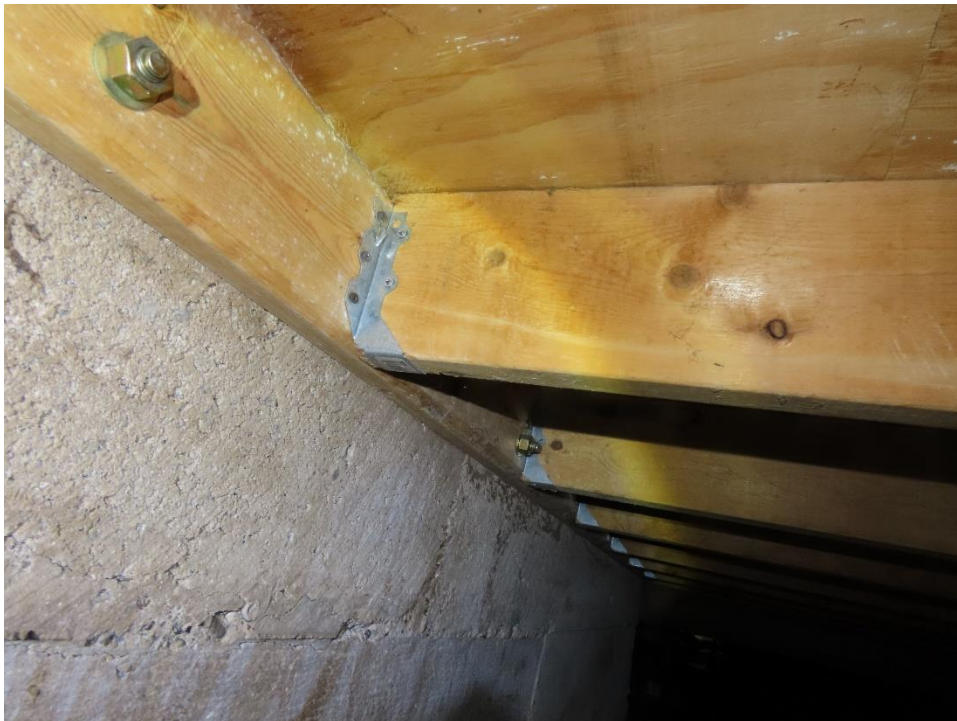
Photo 18: Newer wood framing and metal joist hangers on the ceiling of the crawlspace (the floor framing for the interior above).

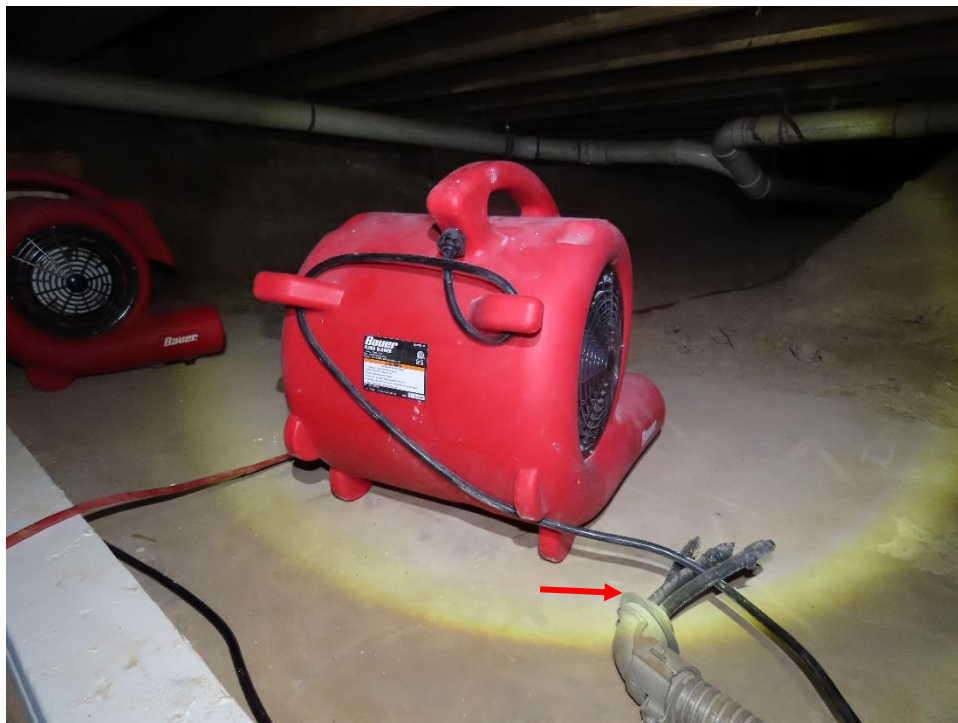
Photo 20: The conduit (indicated) for the A/C air handling unit was still present.

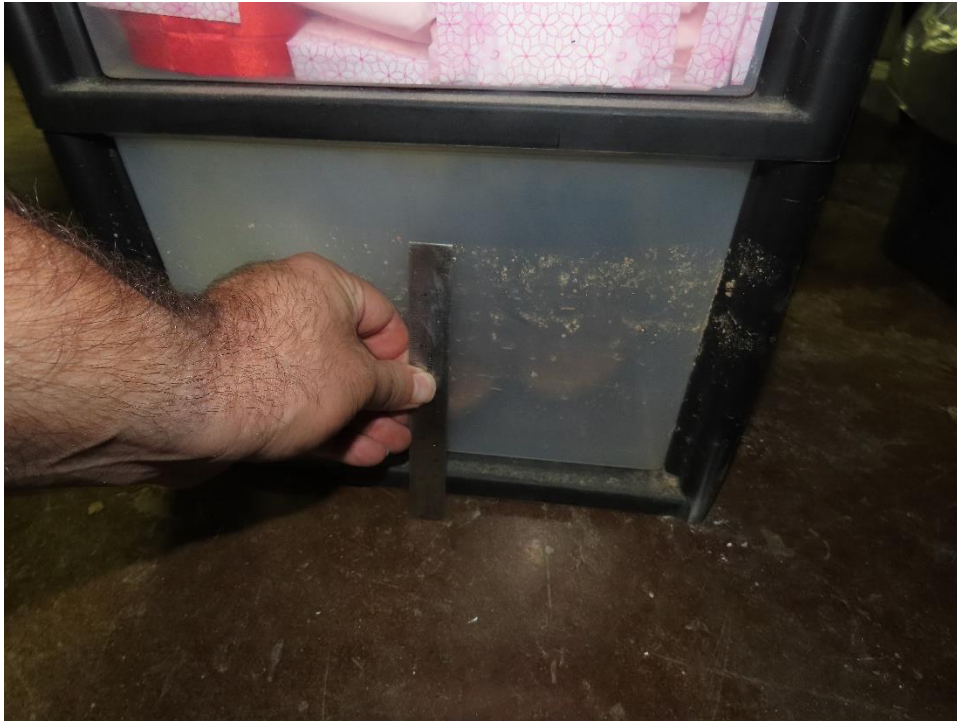
Photo 21: Dirt and water marks on a plastic storage bin.

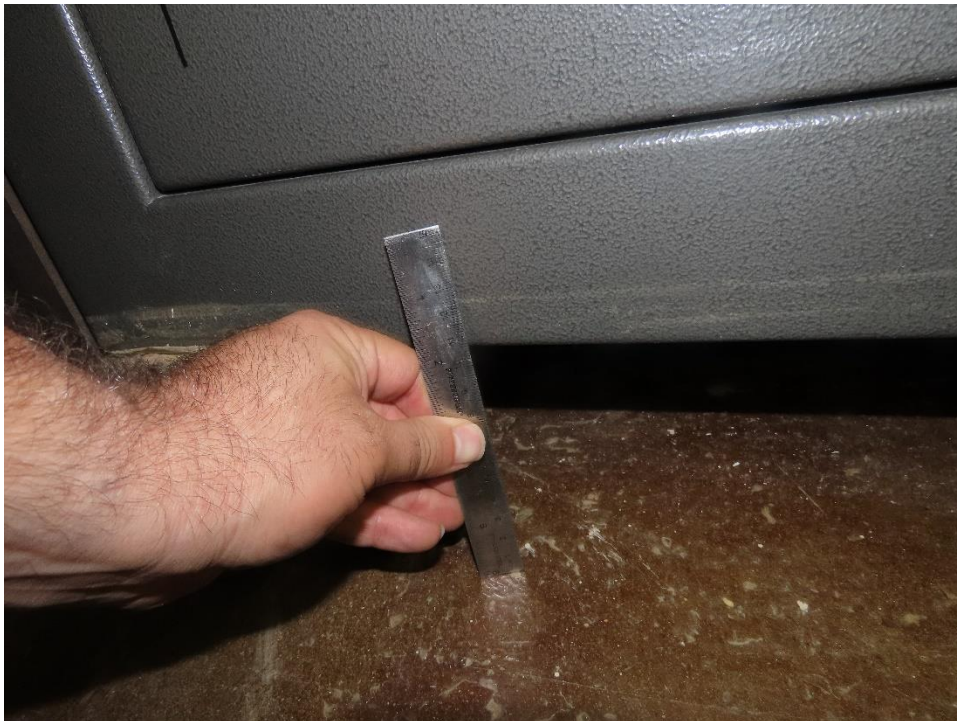
Photo 22: Dirt and water marks on a metal safe.

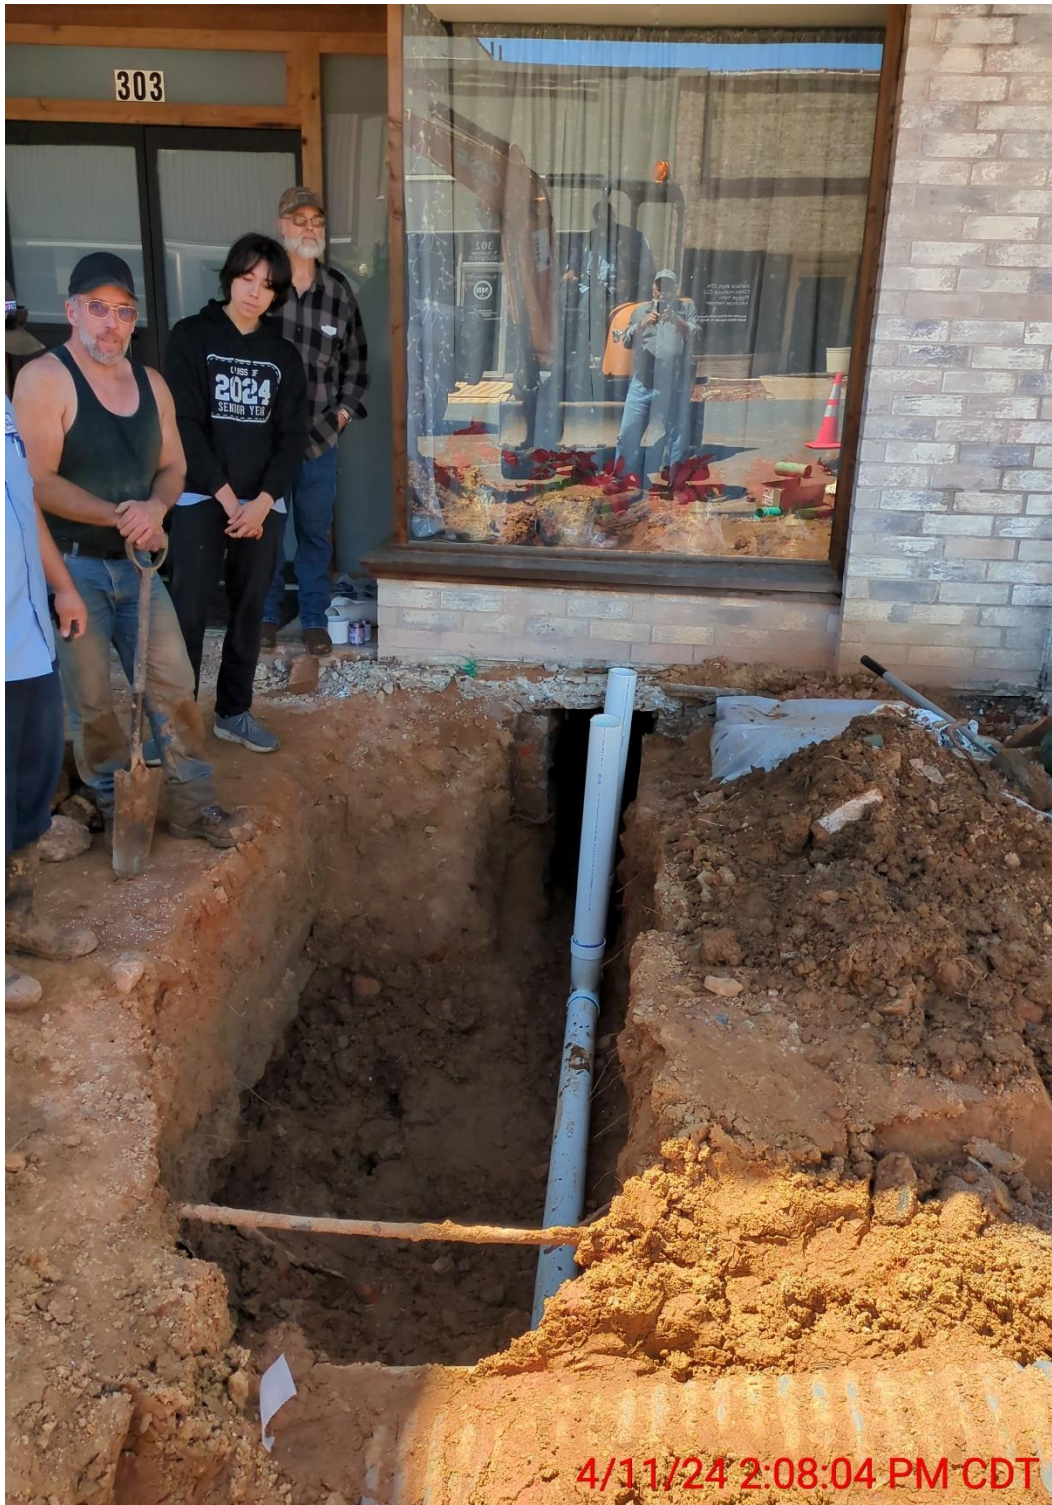
- Prior to the placement of the concrete, a new PVC sanitary sewer line was constructed leading from the crawlspace to the sewer main (**Photo 1**).
- There were photographs that were taken after the sawcut, removal, and chipping process. Due to the red dust emitted when the brick was saw cut, the nominally neutral colored brick wainscot was temporarily tainted with a pink hue, with a distinct line separating where the brick was tinted (above the top of the prior, now-demolished walkway surface) and where it was still neutral colored (below the walkway surface). At the north, east-facing wainscot, there were hairline, stairstep cracks in the brick (**Photos 2 and 3**).

Photo 1: New PVC sanitary sewer line was constructed leading from the crawlspace to the sewer main.

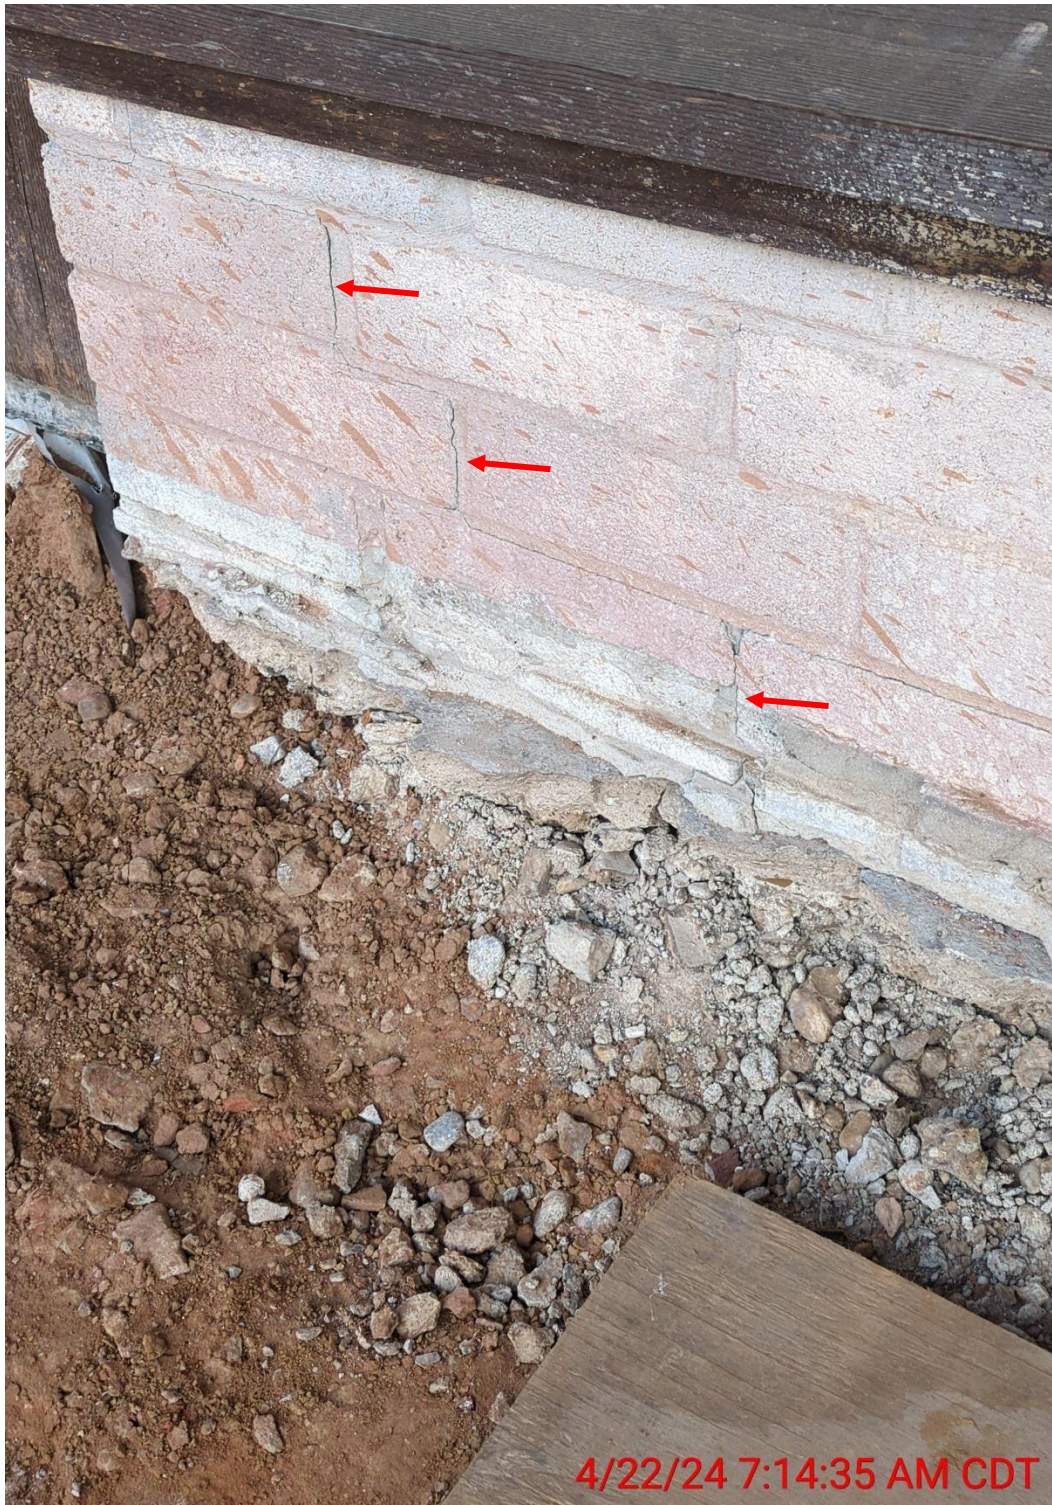
from the building and pulled away using an excavator and further chipped out to be flush. This created a condition in which for a time, only a strip of sidewalk roughly the same width as the brick veneer/wainscot was providing support for the veneer, a precarious condition until the new slab is poured against it. There was a location where, for unknown reasons, the remaining piece of sidewalk supporting the brick wainscot was chipped out from under the wainscot. This action was accompanied by a visible chip in the brick itself. This created an isolated unsupported condition in the brick, approximately two bricks wide, resulting in hairline stair-step cracking in the aged veneer. As a still image from a preconstruction video taken by CSC showed the brick without a chip or hairline cracks, it is reasonable to conclude that the construction activity by CSC caused this distress.

Photo 2: North side of the brick storefront wainscot, having been saw cut and chipped, with a distinct line indicating the location of the finished walkway surface. Note the fine stair-step cracks (indicated).

However, based on the available documentation to J.S. Held, there does not appear to be a reason why the wainscot required demolition and reconstruction (and the other side as well for matching), when the condition could have been repaired in place. Grout or slurry (mud jacking) could have been injected under the wainscot to restore the integrity of the support and simultaneously lift the elevation of the wainscot to a higher elevation if it was felt that it had subsided. The brick could have been repointed to address the hairline cracking and maintain uniformity, and according to the color difference between the brick originally below the surface of the pavers and the brick above, a small portion of the chip in the brick would have been visible above the finished surface, which could have been spot addressed. The glass for the storefront would have had to be removed and reset/replaced regardless.

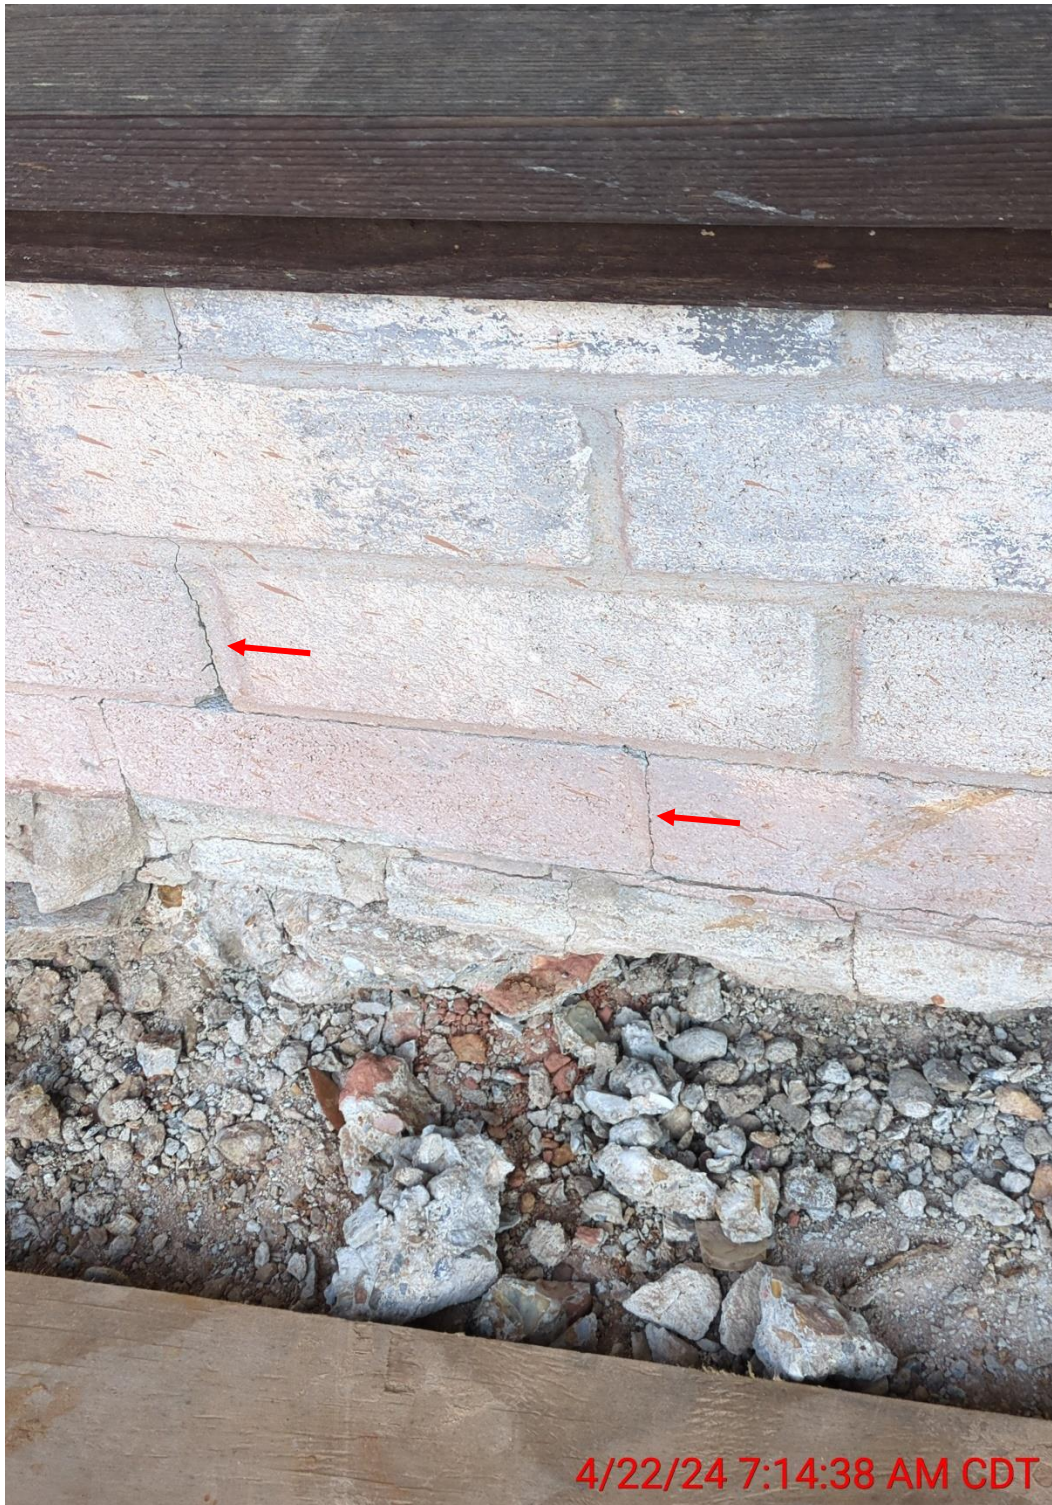
Photo 3: North side of the brick storefront wainscot, having been saw cut and chipped, with a distinct line indicating the location of the finished walkway surface. Note the fine stair-step cracks (indicated).
