June 27, 2024

Re: **Construction Damage Assessment - Engineering Report**

File Name:	Casey Slone
Address:	303 North Washington Avenue, Marshall, Texas 75670
Claim No.:	W2C22131
Reported Date of Damage:	February 14, 2024
J.S. Held No.:	240500935

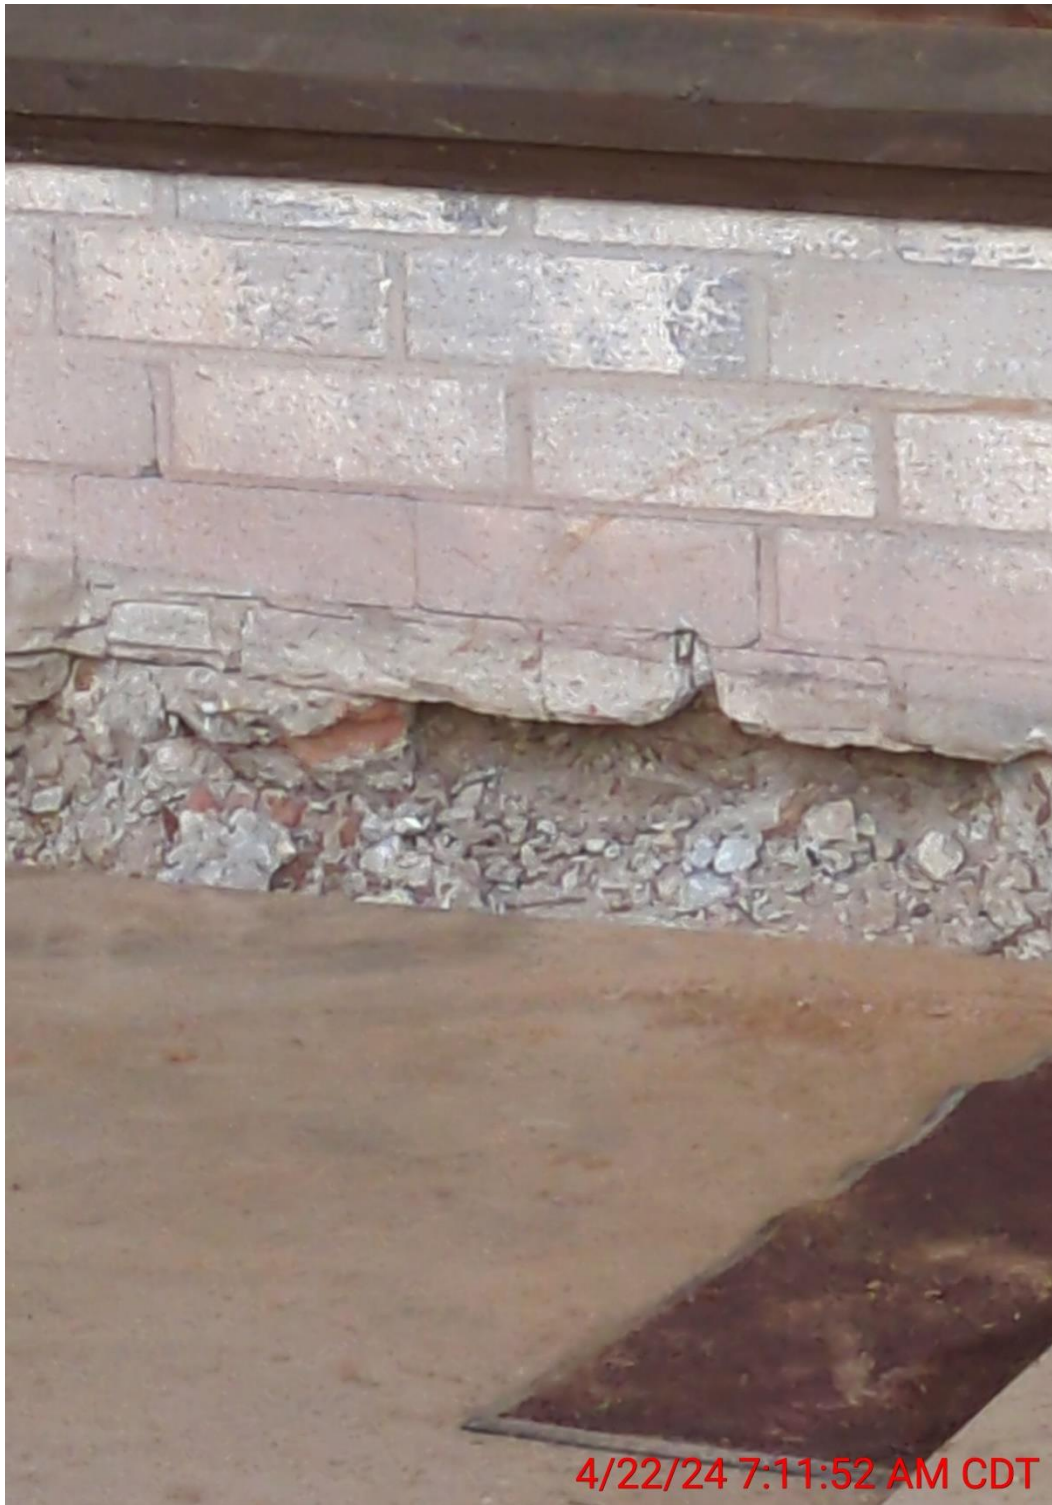
- On the north side of the entry, there was a brick that had been chipped, with a small portion of that chip protruding above the above-described line between the neutral and pink colored areas. Under this chip there was a void, approximately two bricks wide, where the concrete had been chipped out from under the wainscot as well (**Photo 4**).

Photo 4: Chip in the brick and a void under the wainscot.

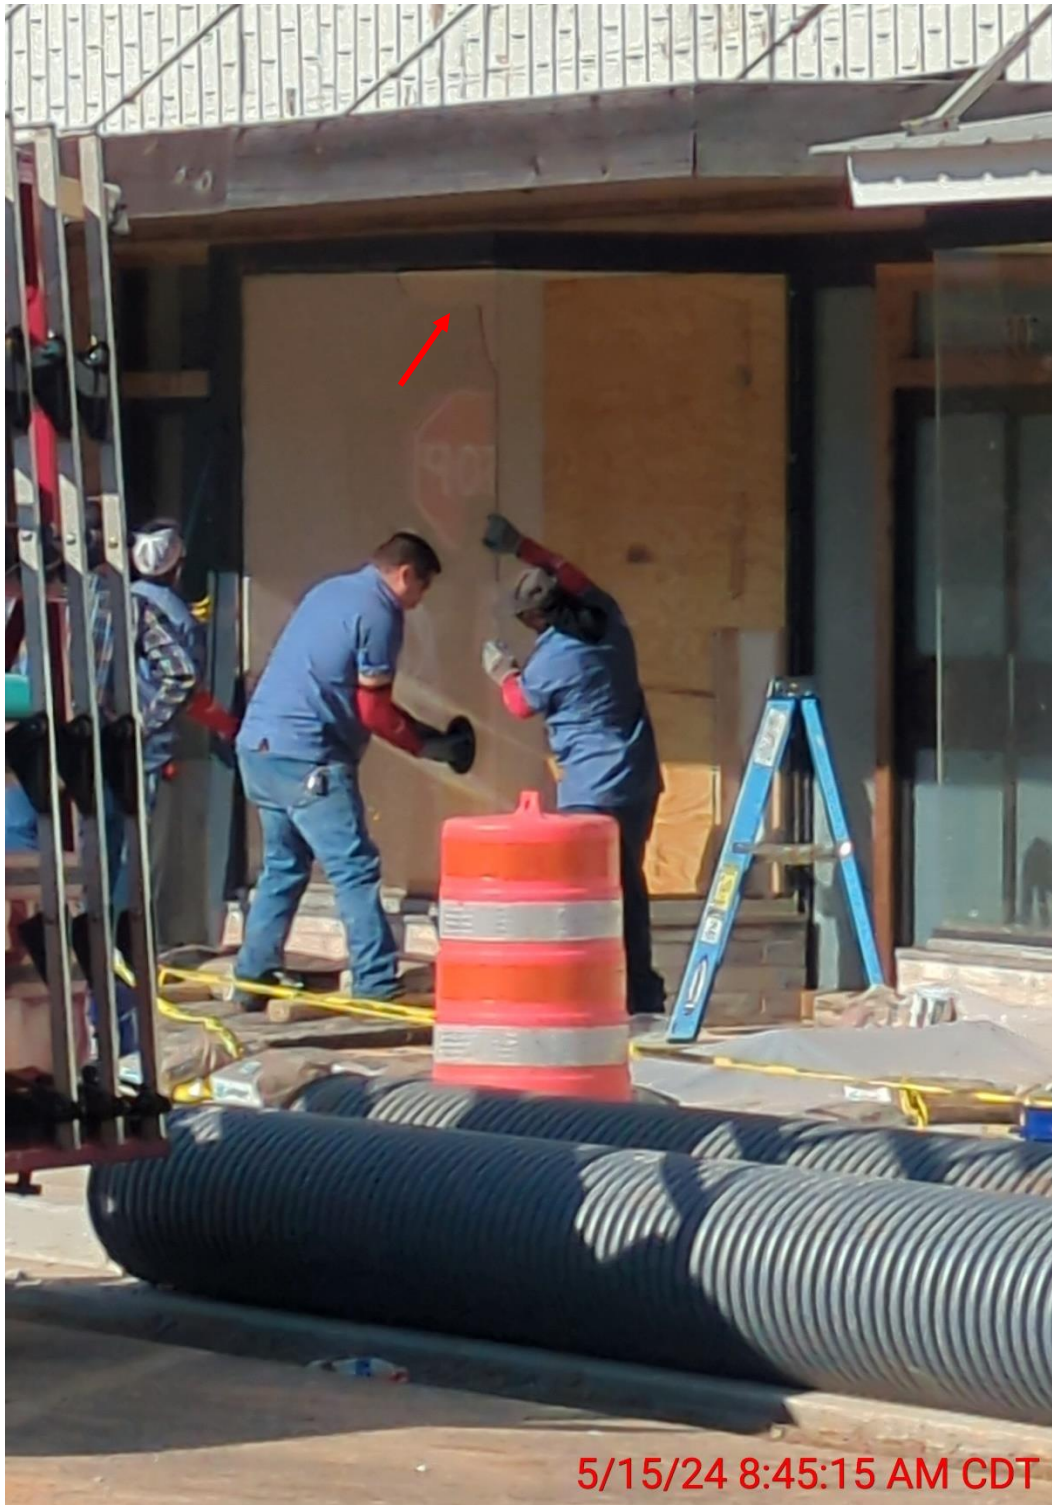
- The front-facing window for the store front on the north side of the entry had broken at the corner (**Photo 5**).
- In a still image taken from a video by CSC as they were walking by the subject property prior to construction commencing, the wainscot did not exhibit the distress, including the chip or hairline cracking that was present in the above-described photos (**Photo 6**).

Photo 5: Broken storefront glass (indicated) being removed.

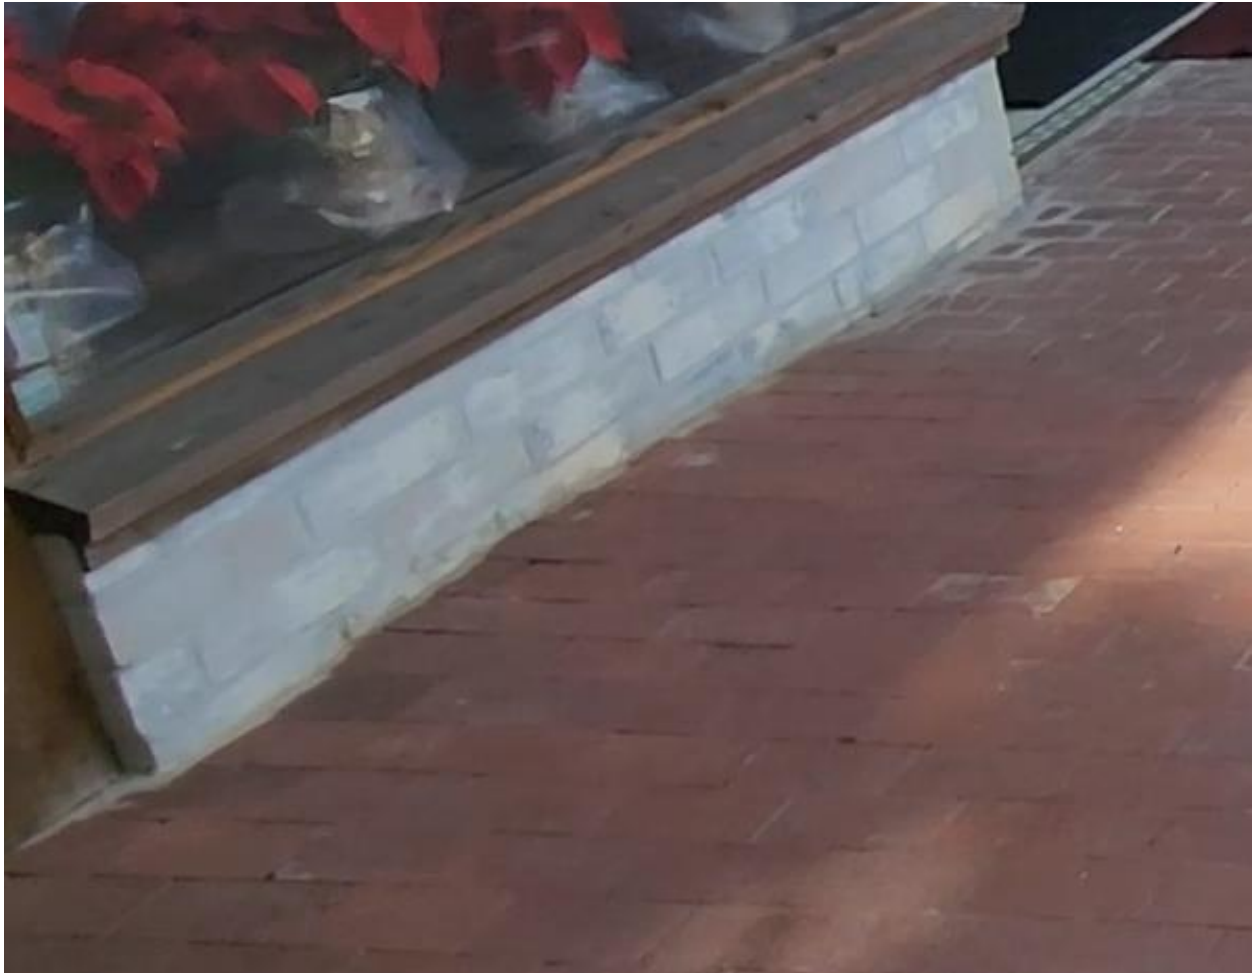
Photo 6: No distress in the brick wainscot prior to construction.

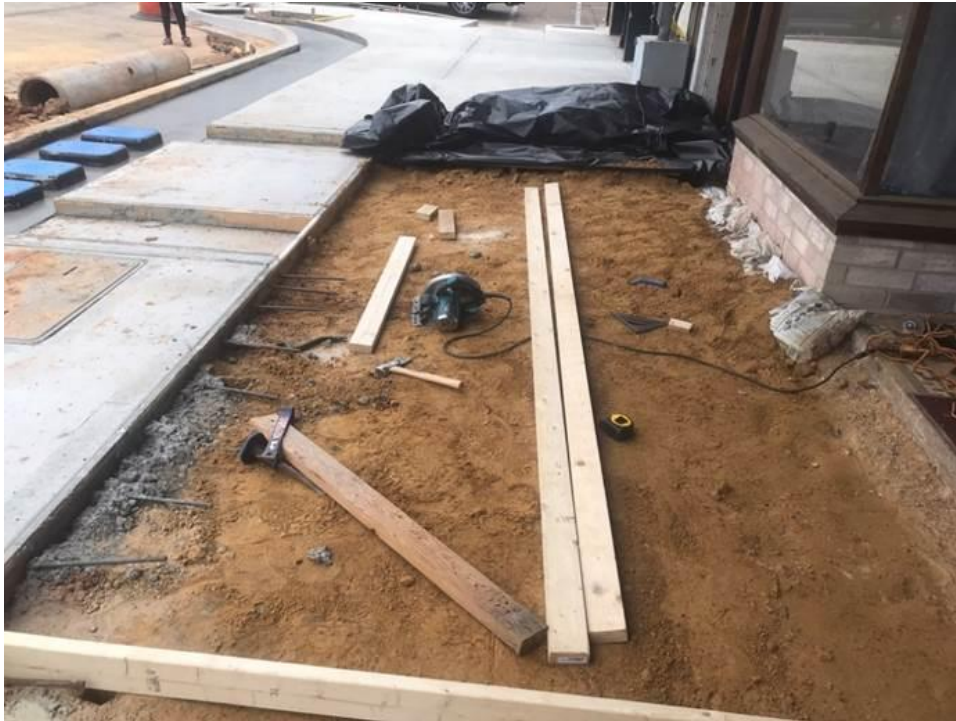
Photo 1: No concrete poured adjacent to the building.

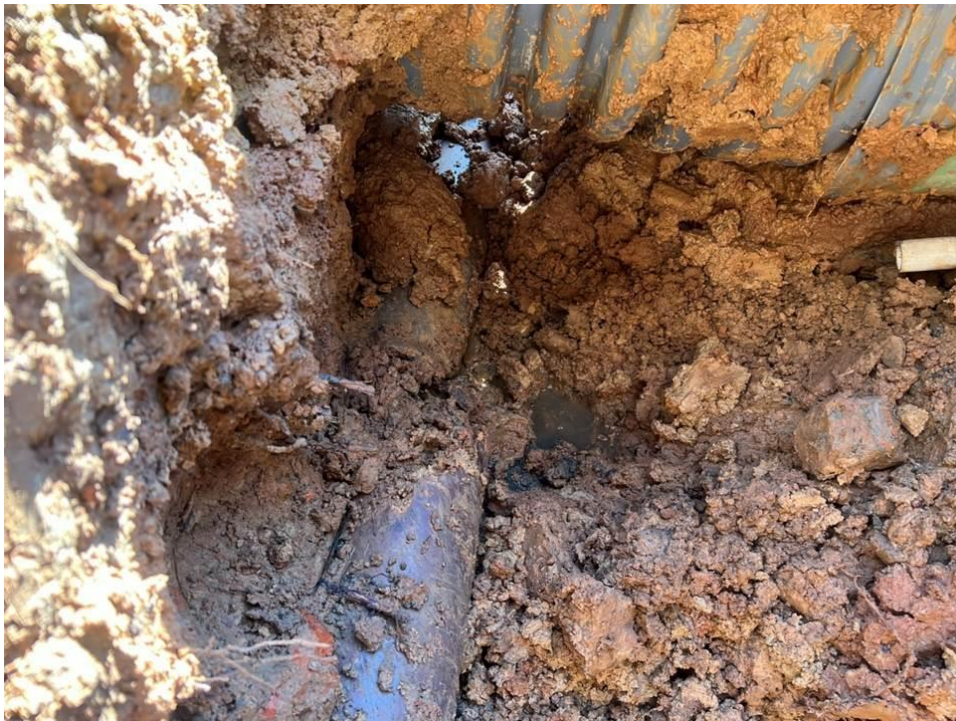
The break in the sanitary sewer line was immediately below a newly constructed corrugated stormwater pipe. Since the area had to be excavated to place the stormwater line in, the excavator would have had to get dangerously close to the sanitary sewer line to properly excavate. Given that there were no breaks anywhere else except where the sanitary sewer line and stormwater pipe excavation crossed, it can be reasonably concluded that the excavator accidentally hit the sanitary sewer line. It is worth noting that none of the sanitary sewer lines from the buildings along North Washington Avenue were depicted in the construction drawings, so CSC had no way of knowing that they were excavating near the line.

Photo 2: Fractured sanitary sewer line directly under the location of a new corrugated stormwater pipe.

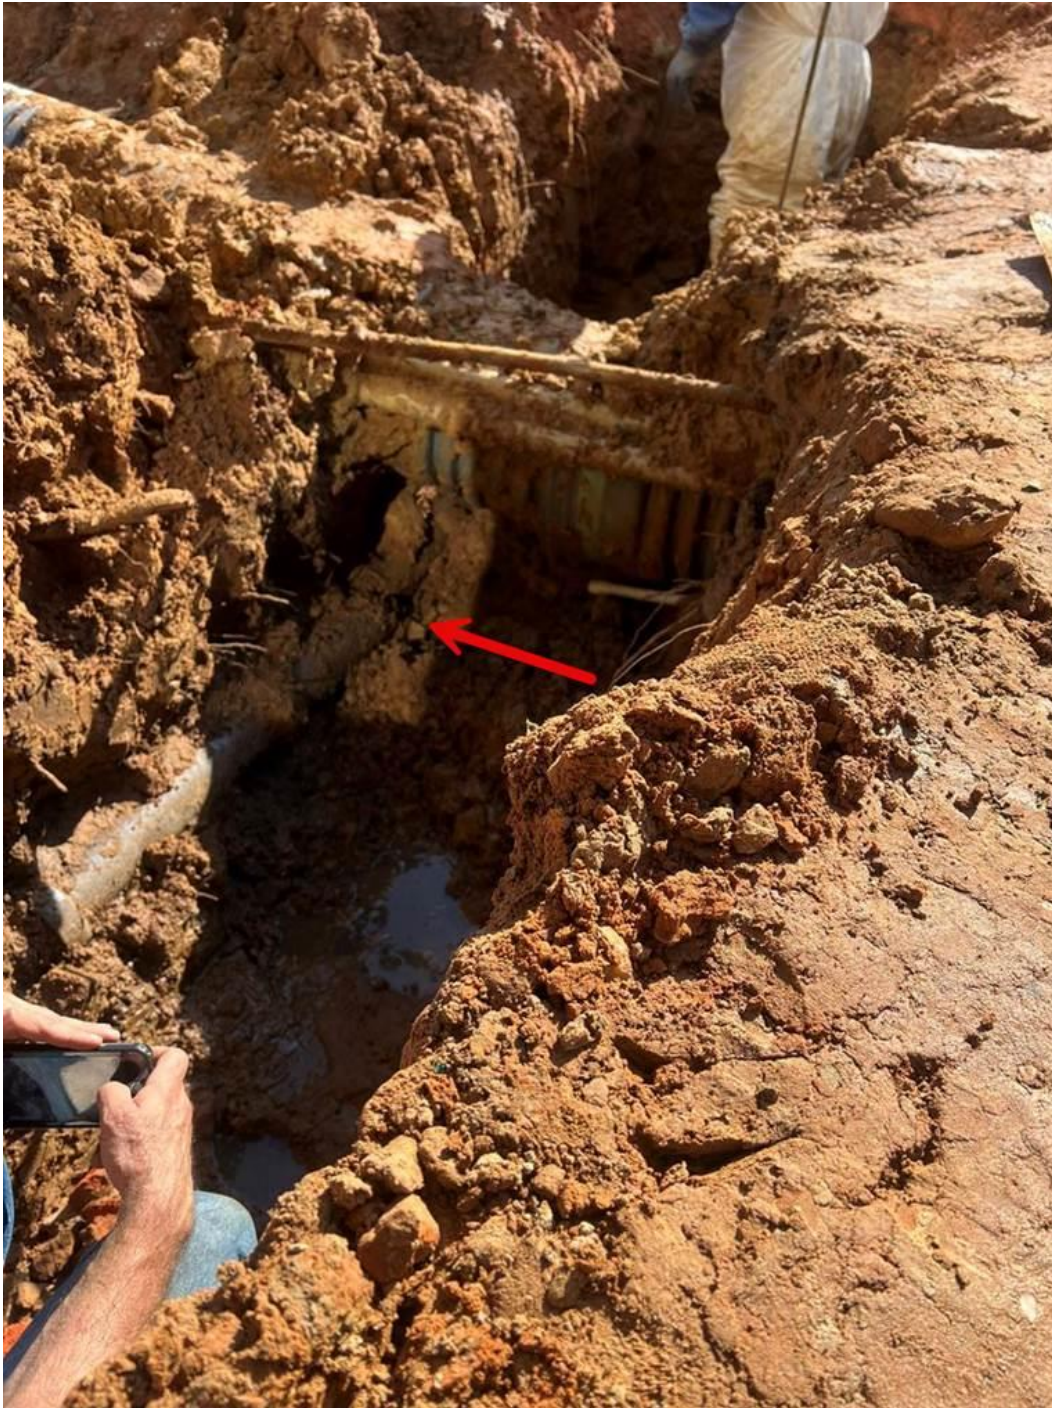
Photo 3: Zoomed out view of **Photo 2** showing the position of the break relative to the stormwater pipe.

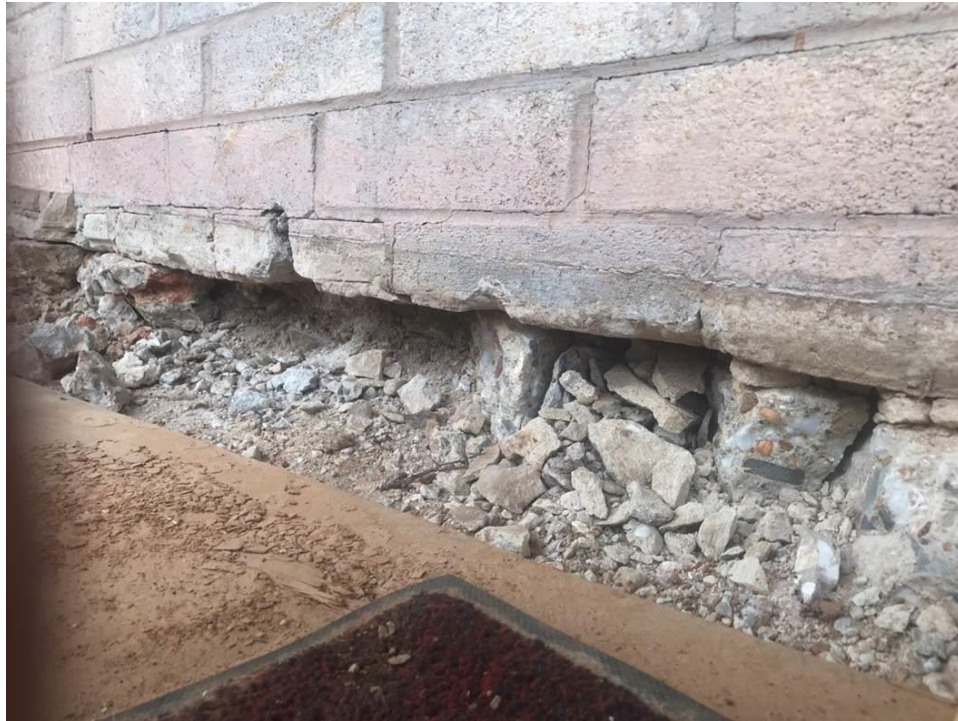
Photo 4: Chip in the brick and a void under the wainscot.

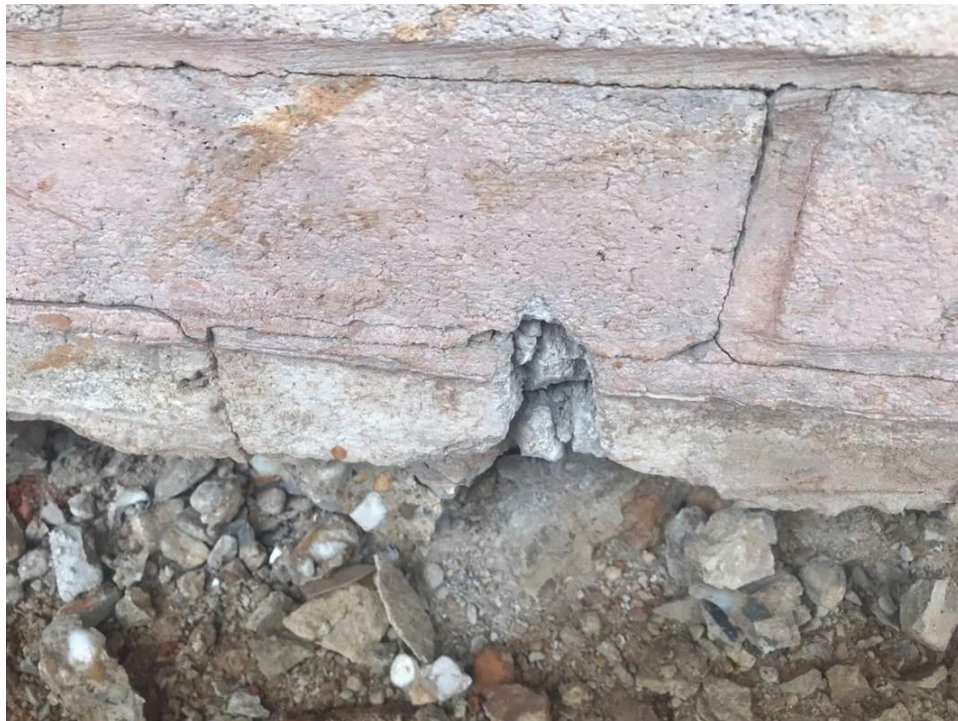
Photo 5: Chip in the brick and a void under the wainscot.

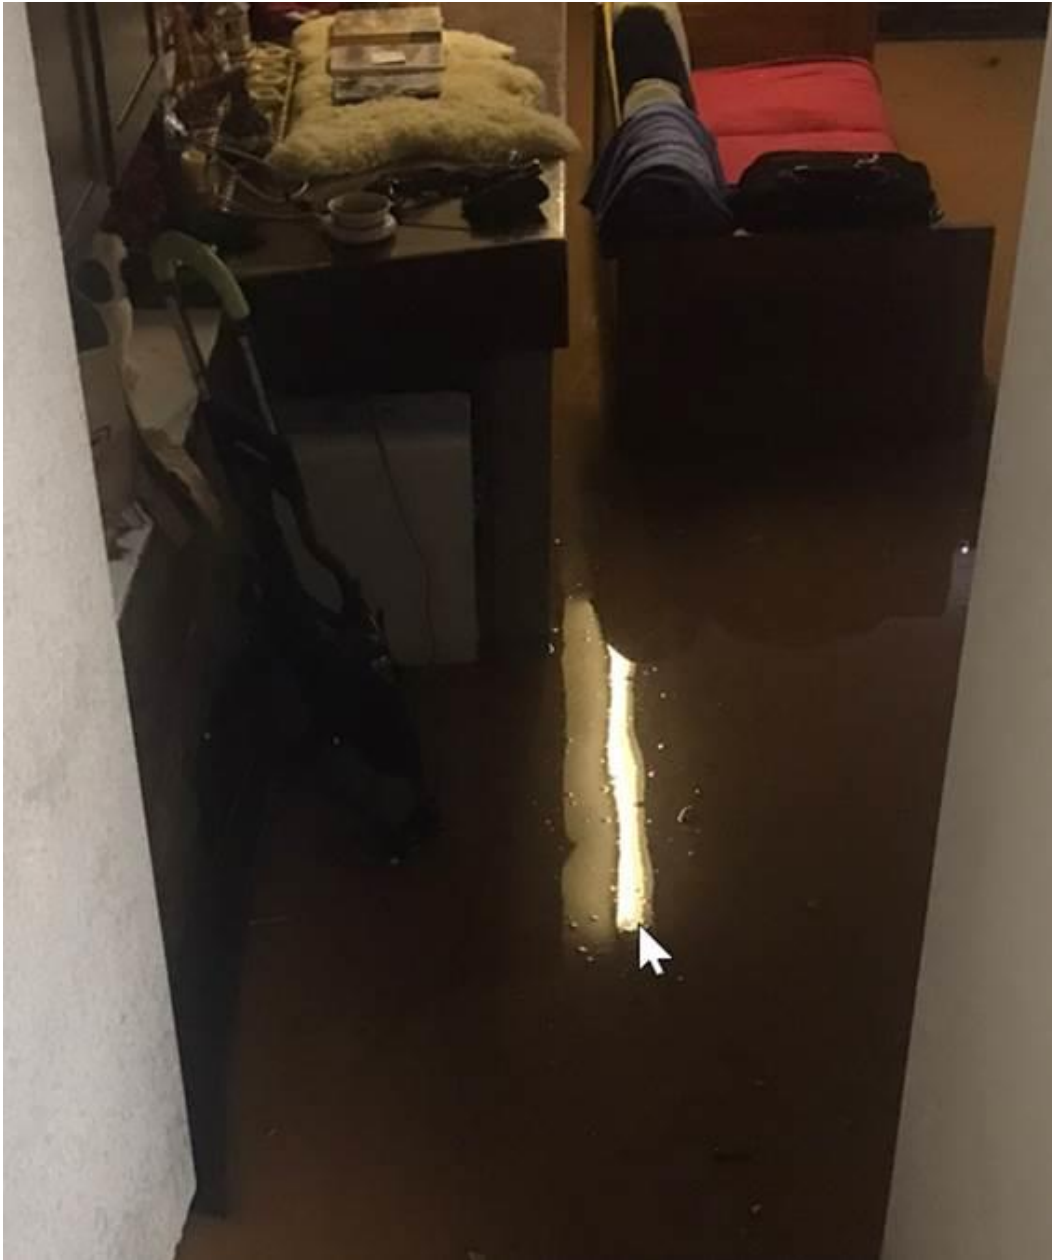
Photo 7: Flooded basement.

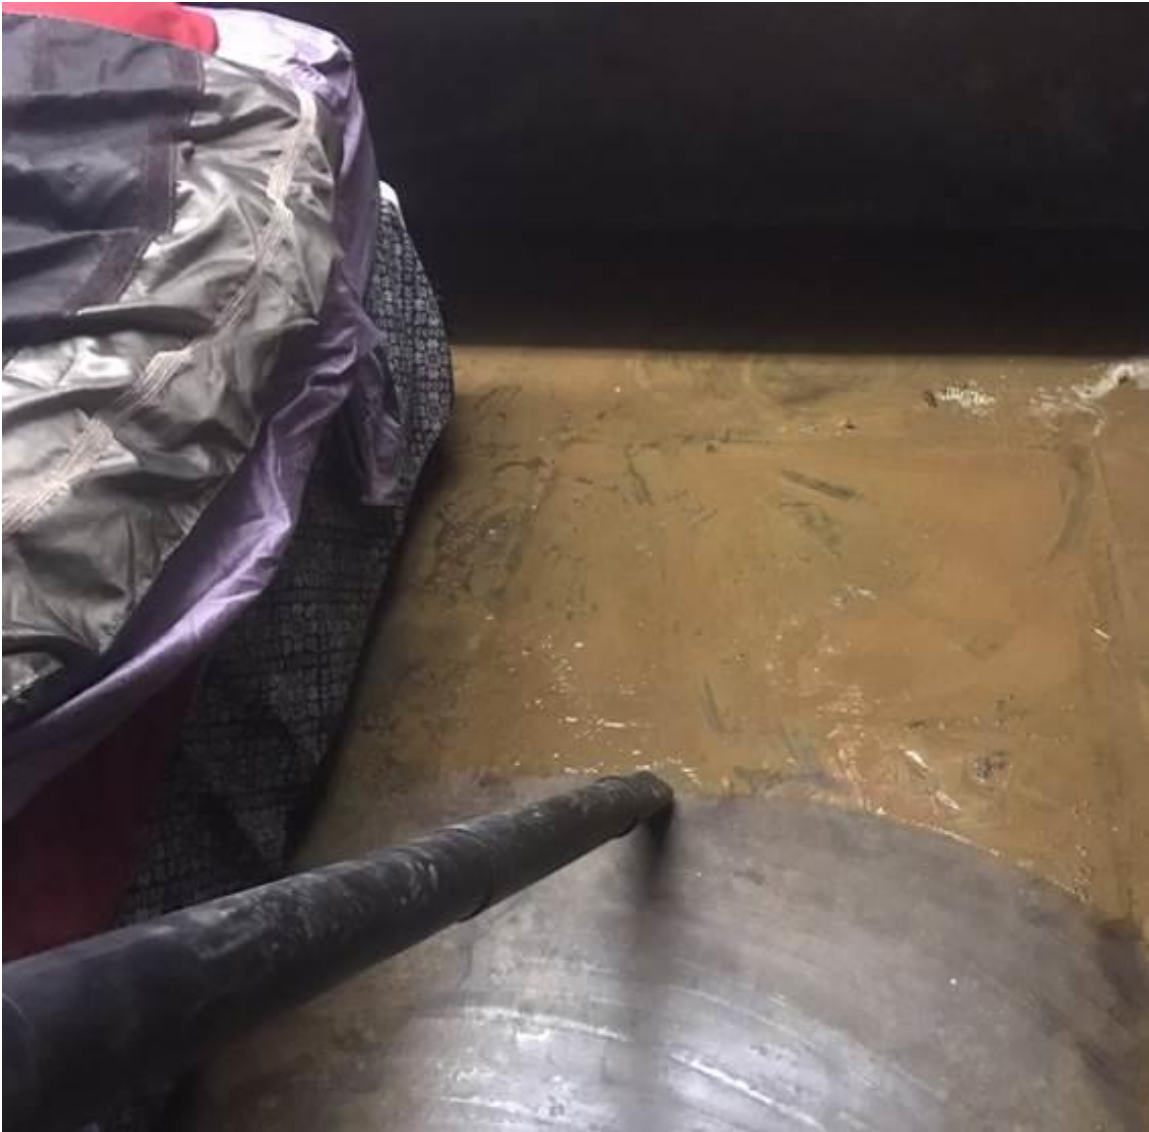
Photo 8: Vacuuming the mud from the basement.

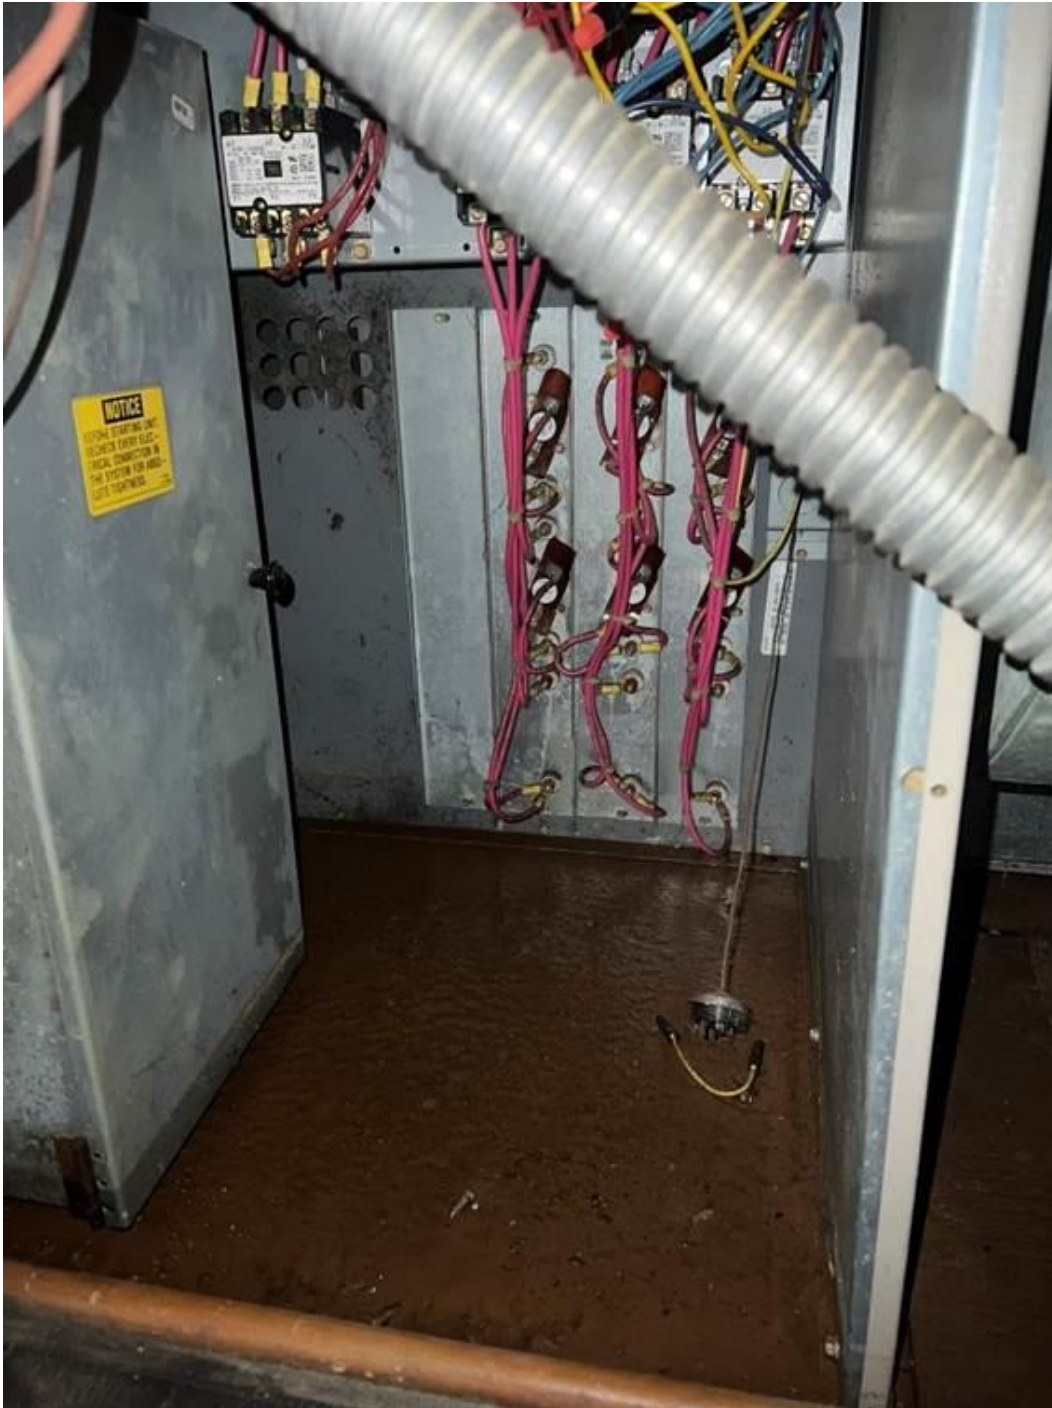
The A/C unit was not able to be inspected during J.S. Held's site assessment. However, Mr. Watts provided photographs of the damaged condition of the A/C unit, and it was noted that there was residual water and mud as well as a water mark at a significant height relative to the bottom of the cabinet. In addition, J.S. Held did observe dirt and water lines up to six inches from the finished floor in the basement. Given that the water that flowed through the A/C unit would have had to have first gone through the predominantly earthen, easily eroded crawlspace, the water would have been filled with salts and particulate, easily conducting electricity. As such, it is highly unlikely that the A/C unit would have survived the flooding event.

Photo 9: Residual mud in the cabinet of the A/C air handling unit.

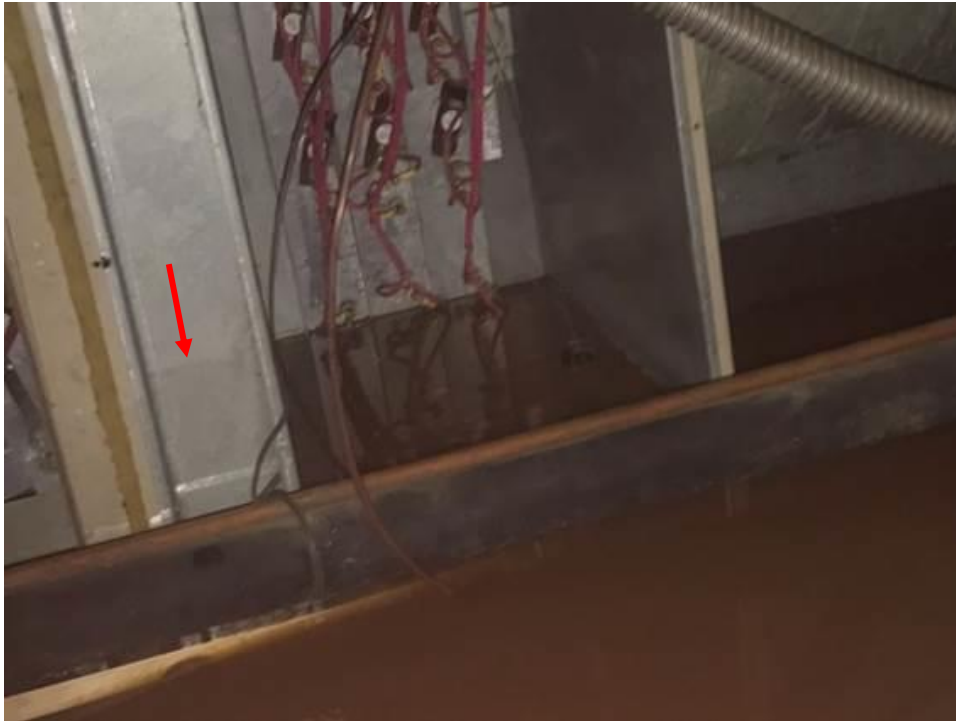
Photo 10: Residual water and mud in the cabinet of the A/C air handling unit. Note the water line (indicated).
