Re: **Construction Damage Assessment – Supplemental Engineering Report**

File Name:	Casey Slone
Address:	303 North Washington Avenue, Marshall, Texas 75670
Claim No.:	W2C22131
Reported Date of Damage:	February 14, 2024
J.S. Held No.:	240500935

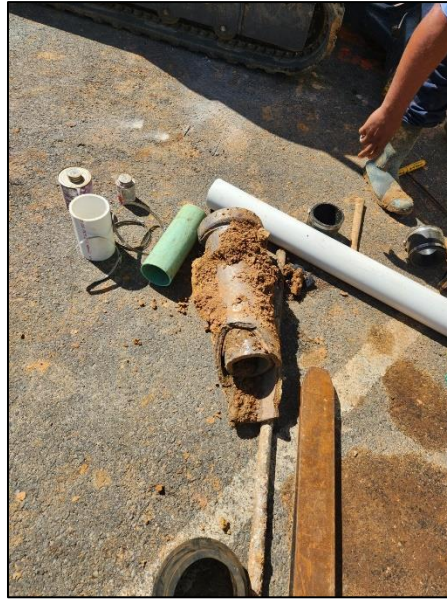
"OI [sic] didn't see any specific damage to the sewer pipe when it was exposed. As far as why the pipe was not flowing we didn't find anything specific but the section where the 4" was pushed into the 6" could have certainly created a snag point. The City decided to repair it while we were there and had it exposed. The owner at 305 decided to replace the section into his building as well."

Figure 1 – Smaller diameter pipe shoved into a larger diameter pipe at the break, as described in Mr. Slone's and Mr. Powell's emails.

Based on the location of the break with respect to the new storm drainage pipe, and without additional information to indicate otherwise, the correlational evidence seemed to indicate that the break in the sewer line and installation of the new stormwater drain were causally related. Further, the fracture in the sewer line, as depicted in Mr. Watts' photographs in J.S. Held's initial report, was still in situ and had not been separated out for better viewing. However, in the recently provided photograph of the condition removed from the earth, it could be clearly seen that a smaller pipe had been inserted into a larger pipe, which was the cause of distress, as described in the emails between Mr. Slone and Mr. Powell. Further, in those emails, Mr. Powell stated that the City had decided to repair the condition when it was exposed. As such, it appears that CSC did not damage the sanitary sewer line and that any such damage was repaired by the City.

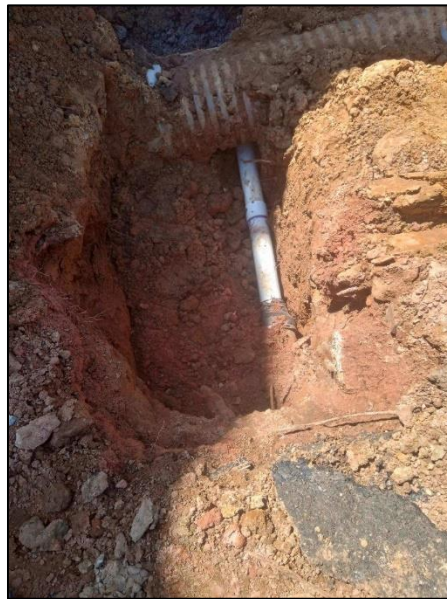
Figure 2 – New polyvinyl (PVC) pipe tie into the sewer main.

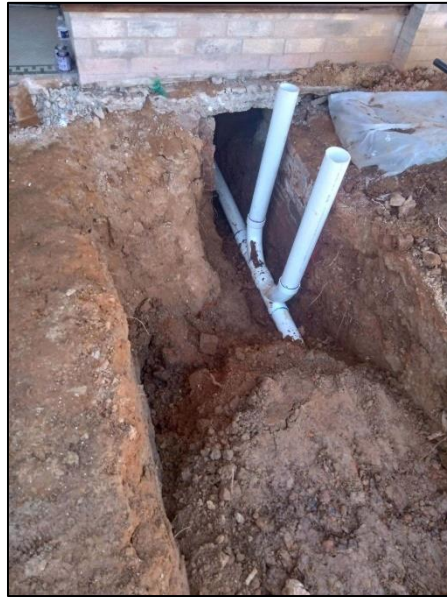
Figure 3 – Continuation of the PVC pipe depicted in **Figure 2** into the crawlspace of Mr. Watts' building. Note the cleanouts as described in Mr. Slone's and Mr. Powell's emails.

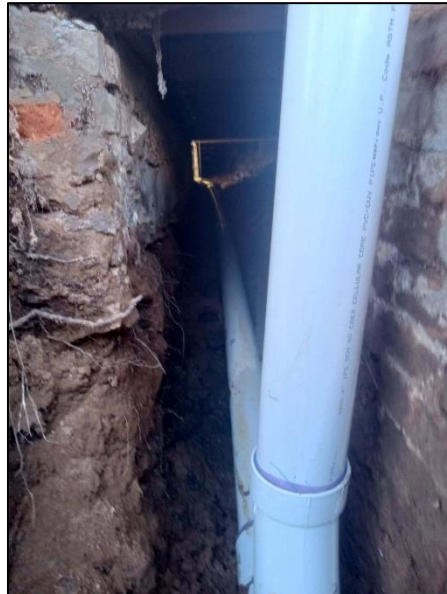
Figure 4 – Continuation of the PVC pipe depicted in **Figures 2 and 3** into the crawlspace of Mr. Watts' building. Note the cleanouts as described in Mr. Slone's and Mr. Powell's emails.
